RYERSON STATION STATE PARK

RYERSON STATION DAM

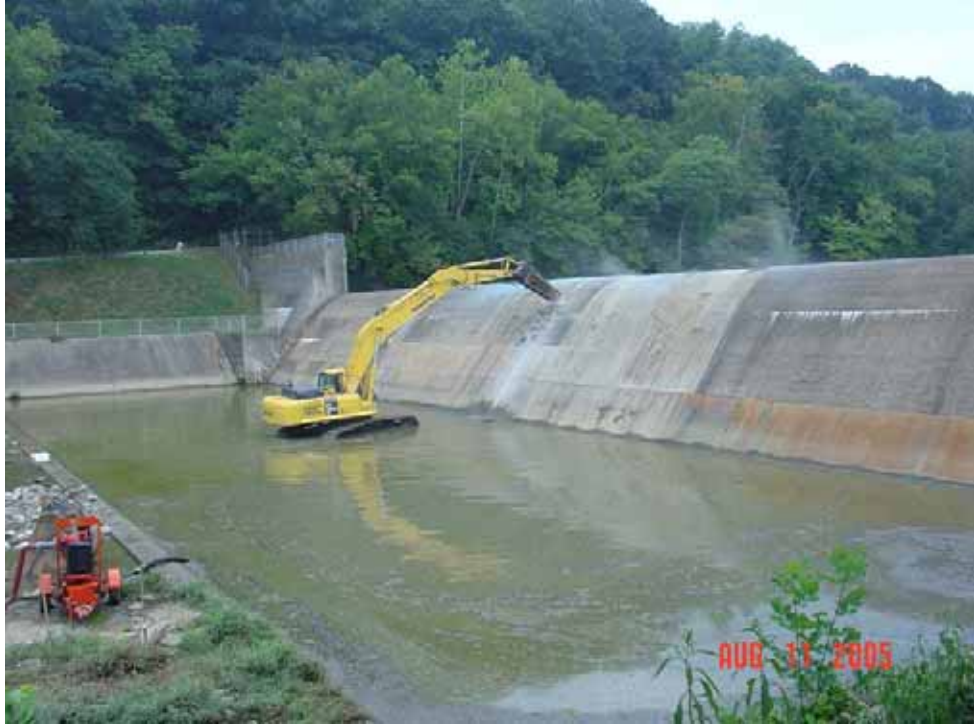
Photo II-8: DEP photograph, taken August 11, 2005, as Ryerson Station Dam began to be breached.

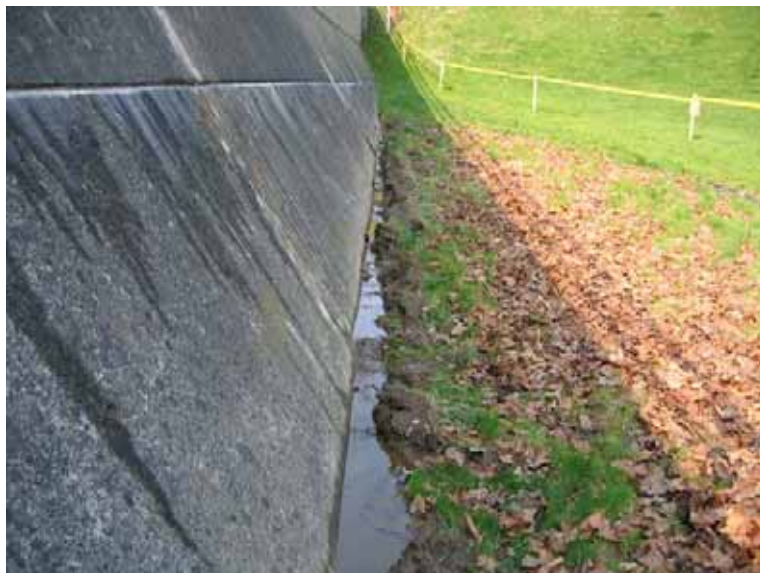
Photo II-12 : DEP photograph, taken April 18, 2005, shows the seepage in this area.

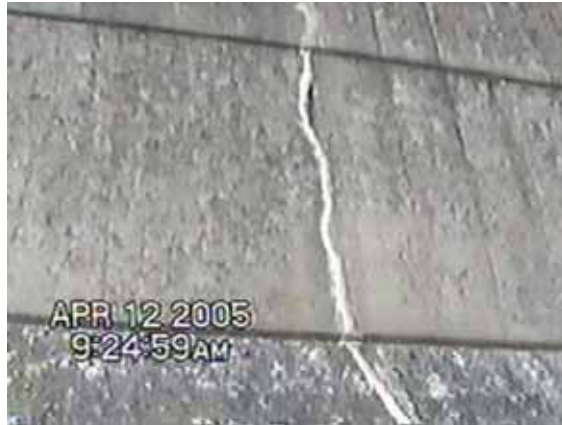
Photo II-13 : CPCC video, taken April 12, 2005.

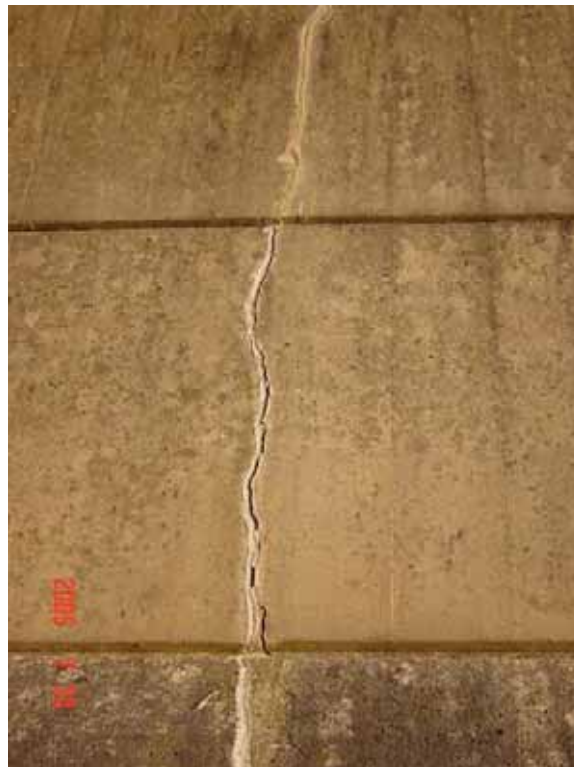
Photo II-14 : DEP photograph, taken July 30, 2005, shows the damage to this area has become more severe.

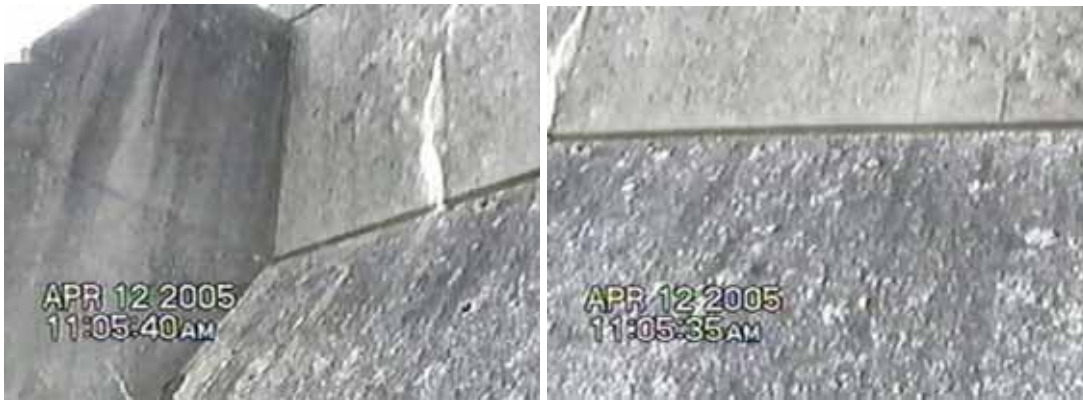
Photo II-15 and II-16 : CPCC video, taken April 12, 2005, shows little to no damage in this area at this time.

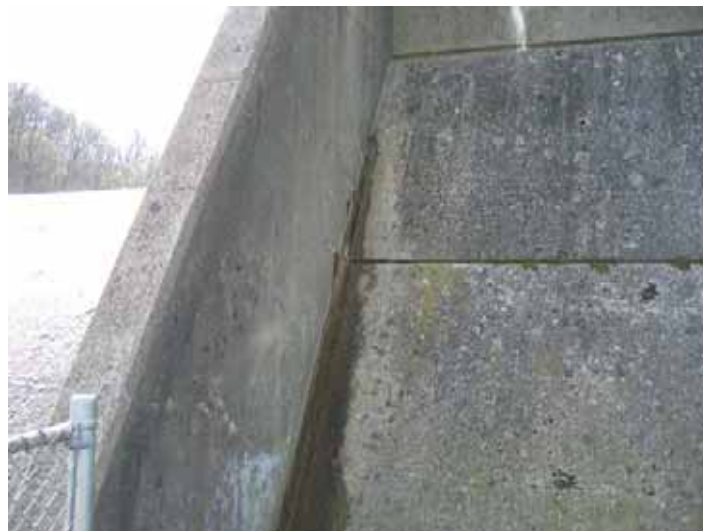
Photo II-17 : DEP photograph, taken April 18, 2005, shows minimal cracking in this area

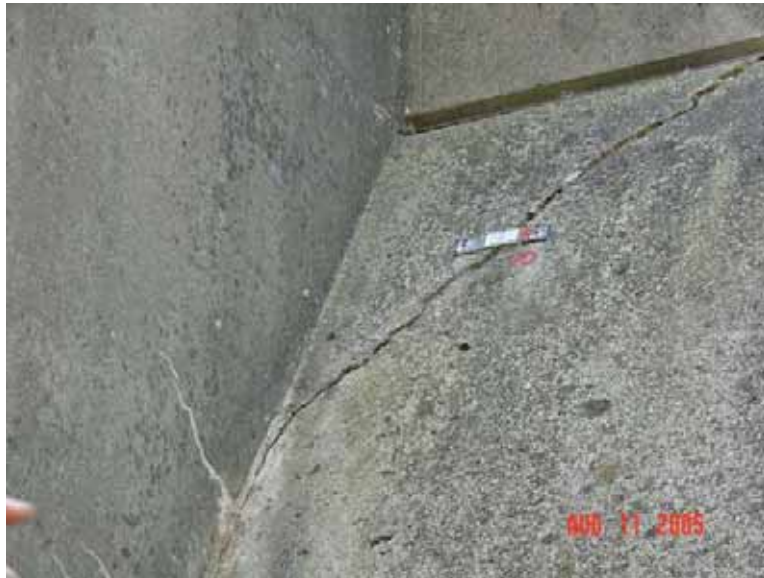
Photo II-18 : DEP photograph, taken August 11, 2005, shows the cracking in this area has become more severe.

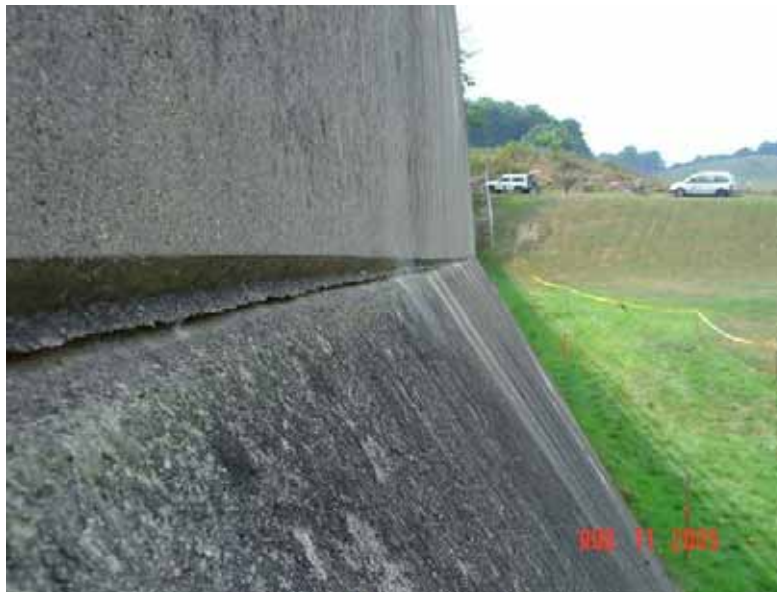
Photo II-19 : DEP photograph, taken August 11, 2005, shows separation of the second horizontal joint from the crest of the dam.

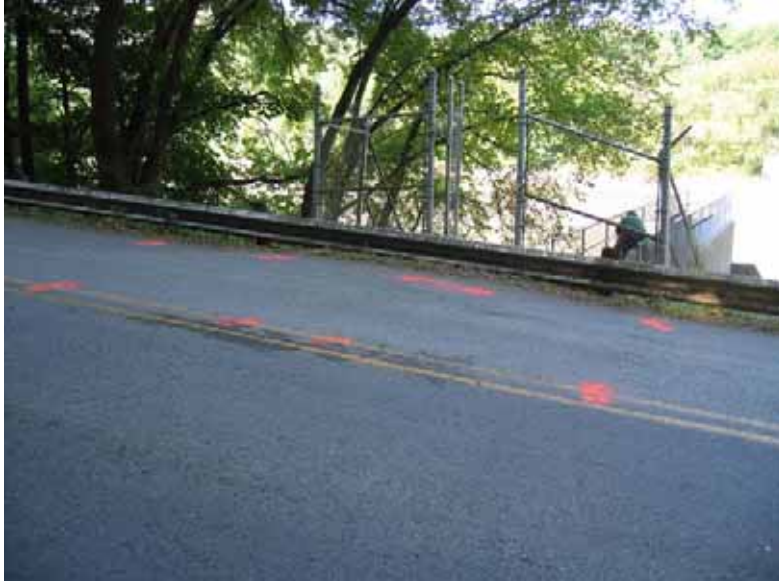
Photo II-35 : DEP photograph, taken August 16, 2005, shows the heaving of Bristoria Road.

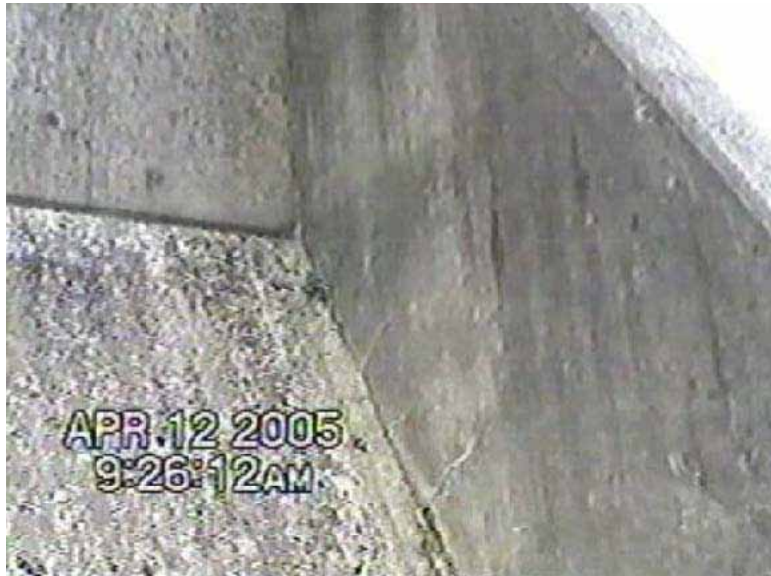
Photo II-36 : CPCC video taken April 12, 2005 shows little to no cracking in this area at the time of the video.

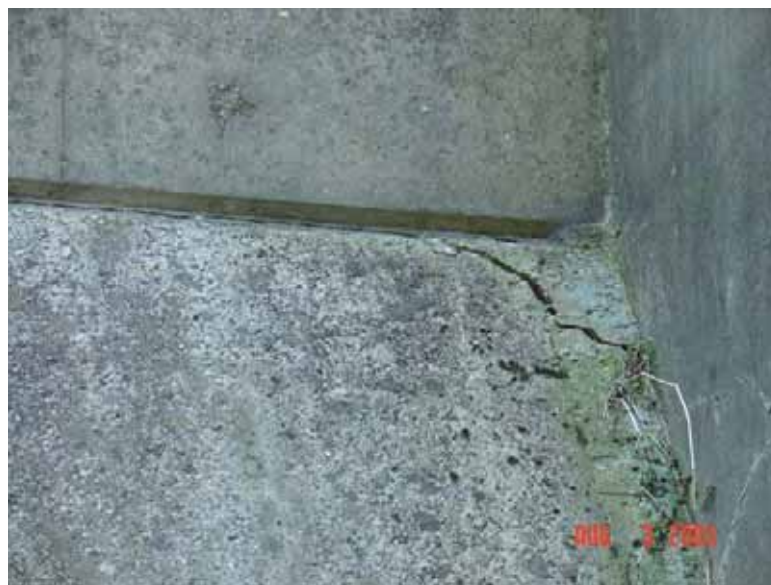
Photo II-37 : DEP photograph taken August 3, 2005 shows the damage in this area has become much more severe.

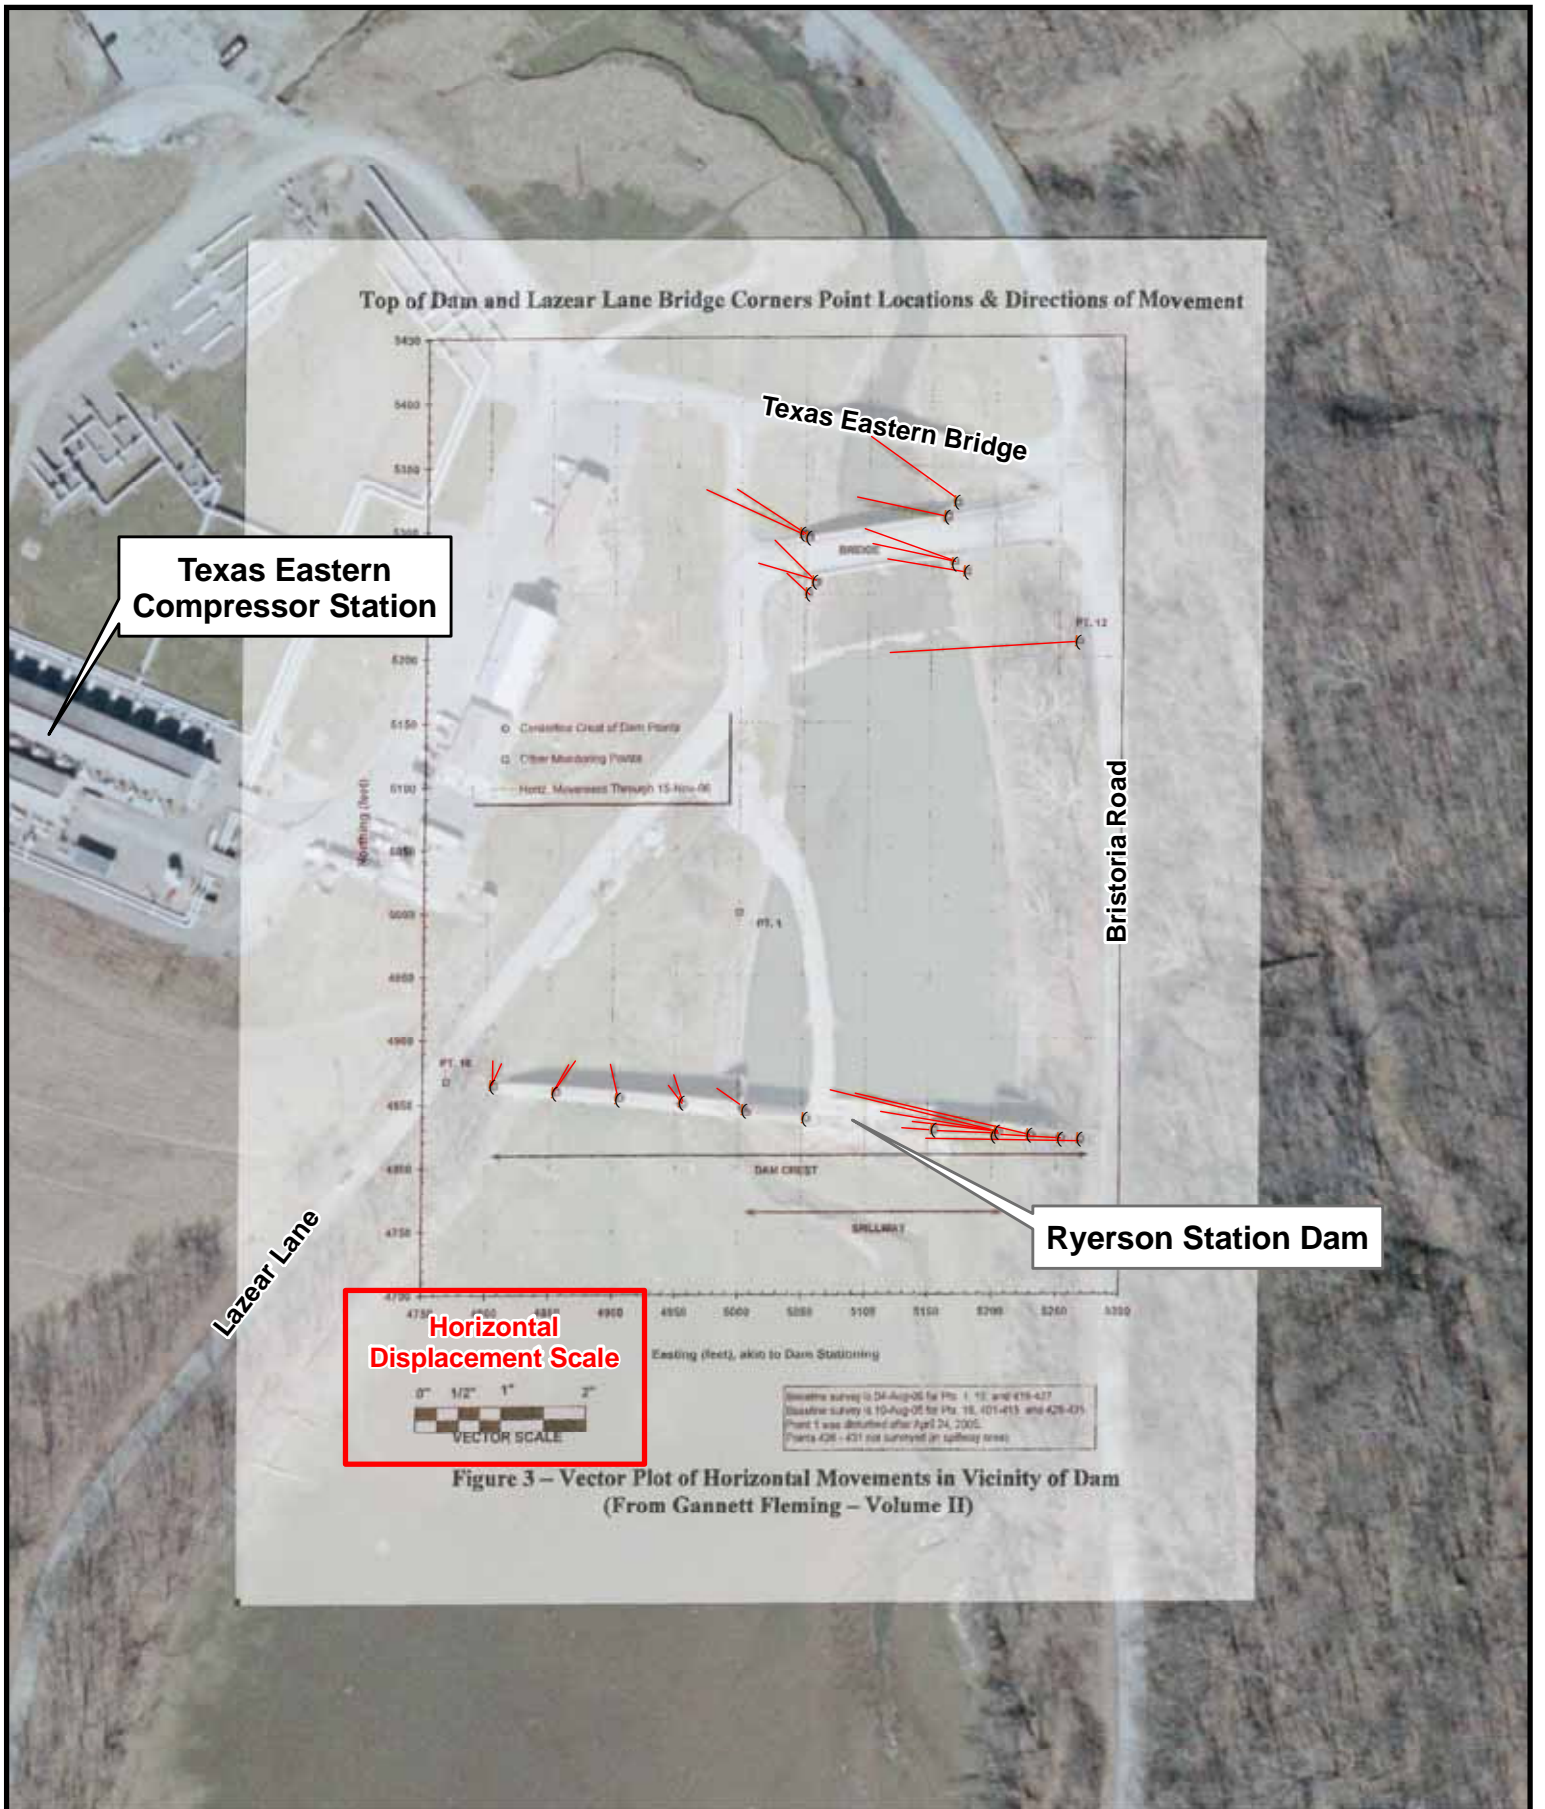
Crack gauges 1 and 2 are located across the vertical structural crack. Gauge 1 is located approximately one-half the distance from the ground to the crest. It indicated the crack opened approximately 1/4 inch from August until September of 2005, then was stable until opening slightly more between July and September of 2006. Gauge 2, located on the crest, indicated that the crack opened 1/4 inch from August through October 2005 and then was stable until opening another 1/8 inch between July and September of 2006.

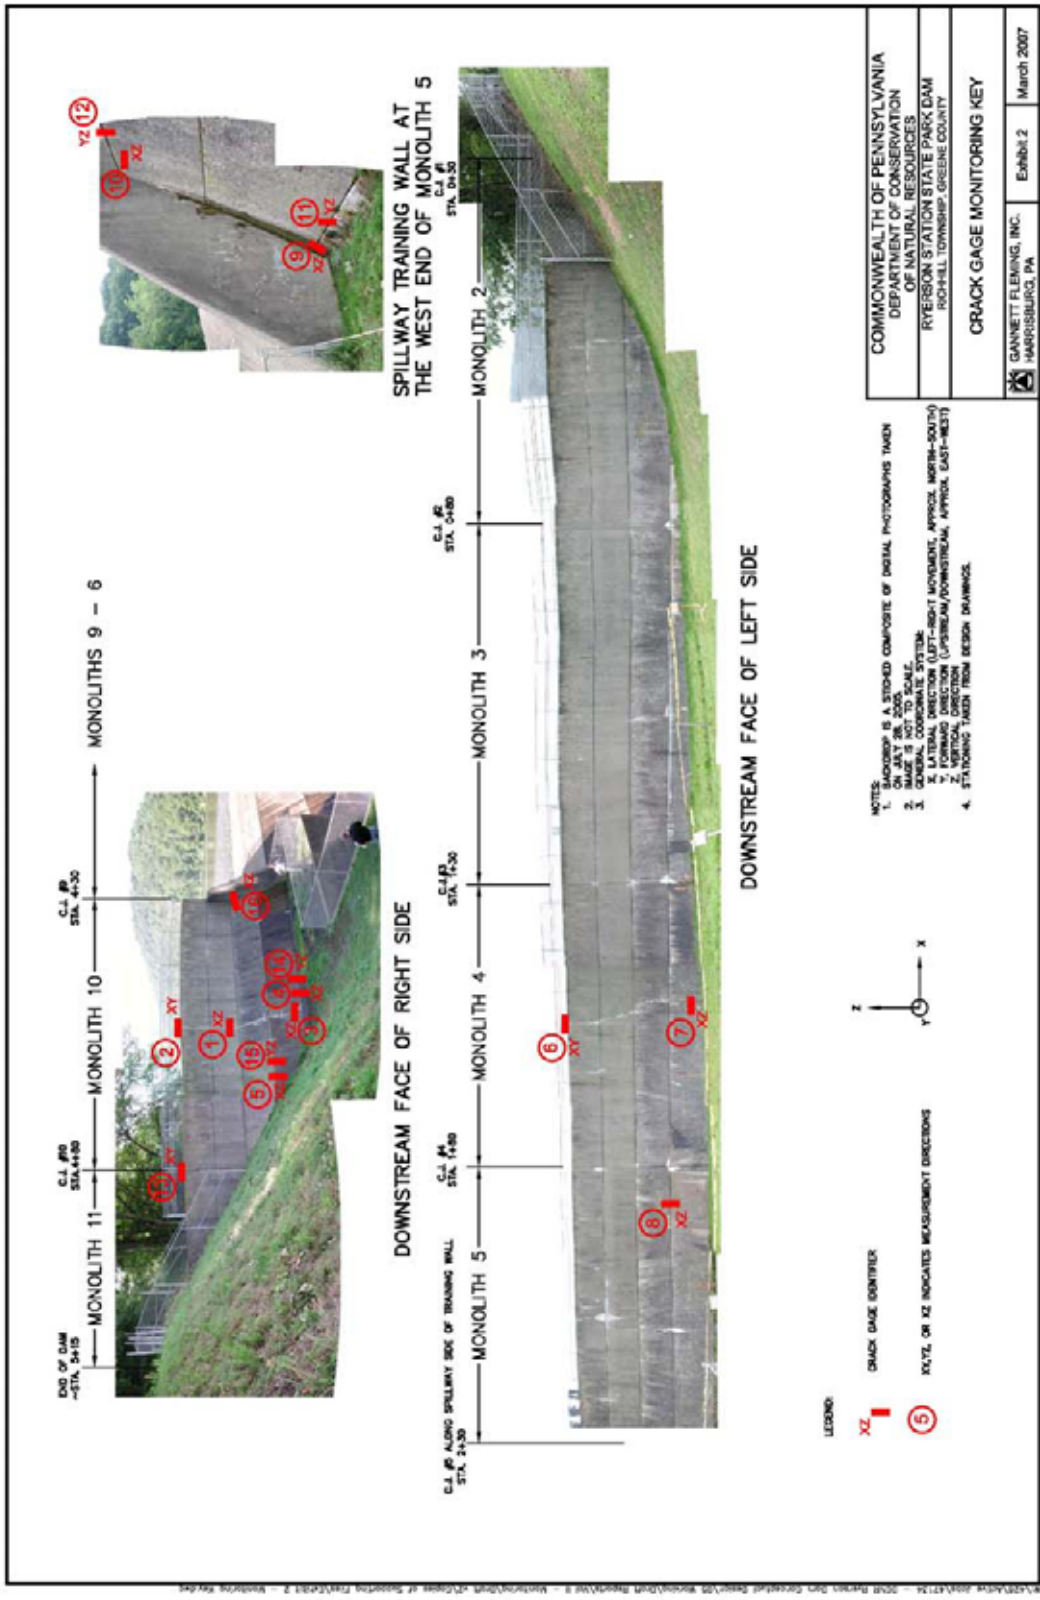
Figure IV-2: Crack Gage Locations (Gannett Fleming Volume II).

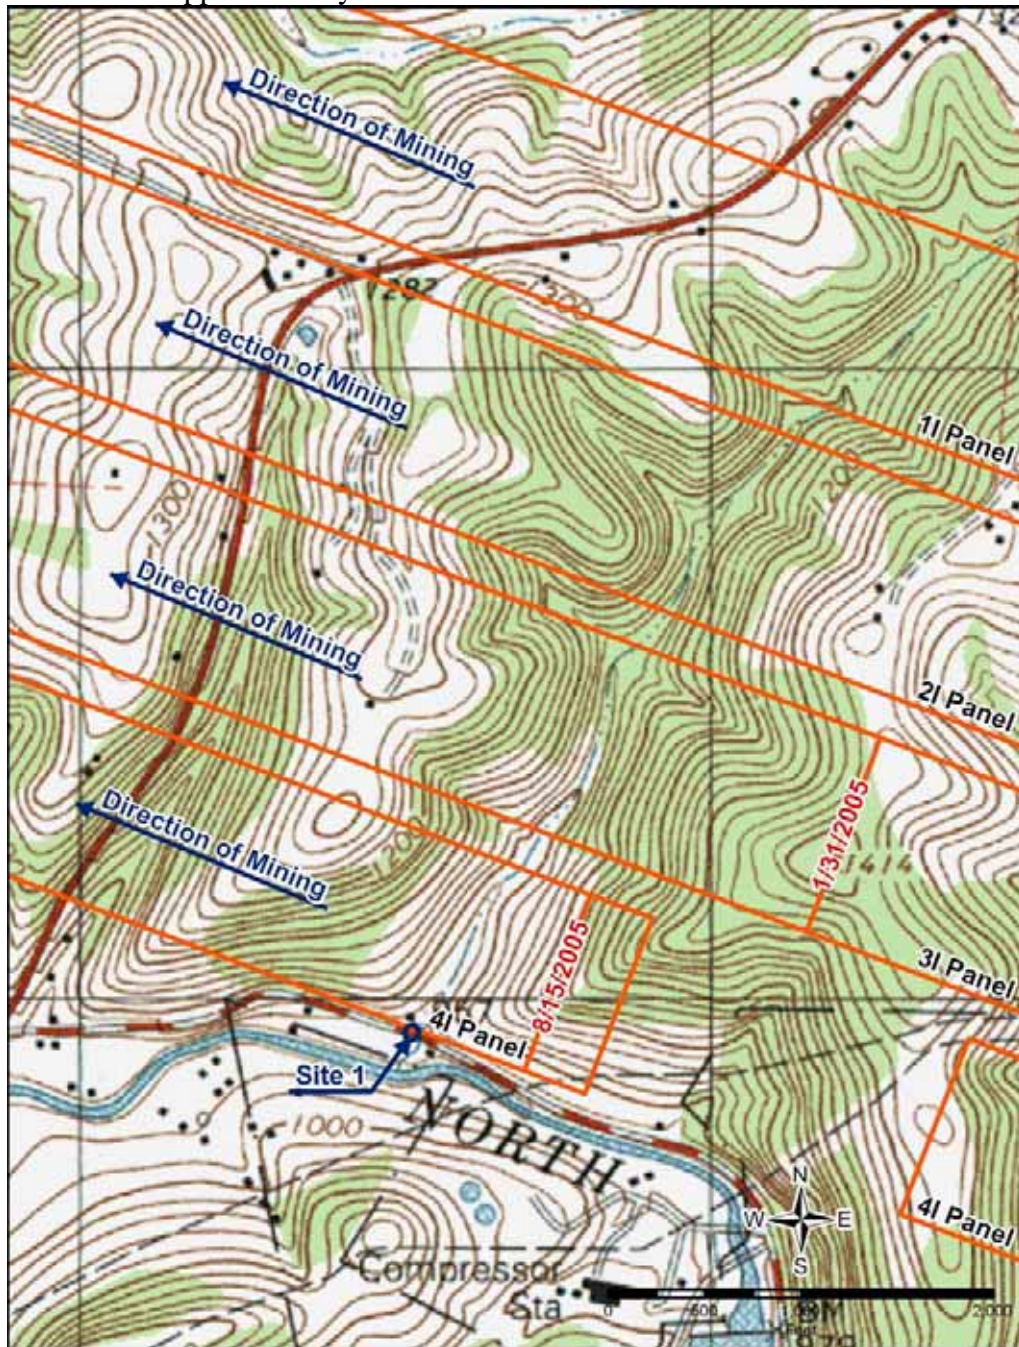
Figure IV-8: Location of Site 1, Bristoria Road Bumps.

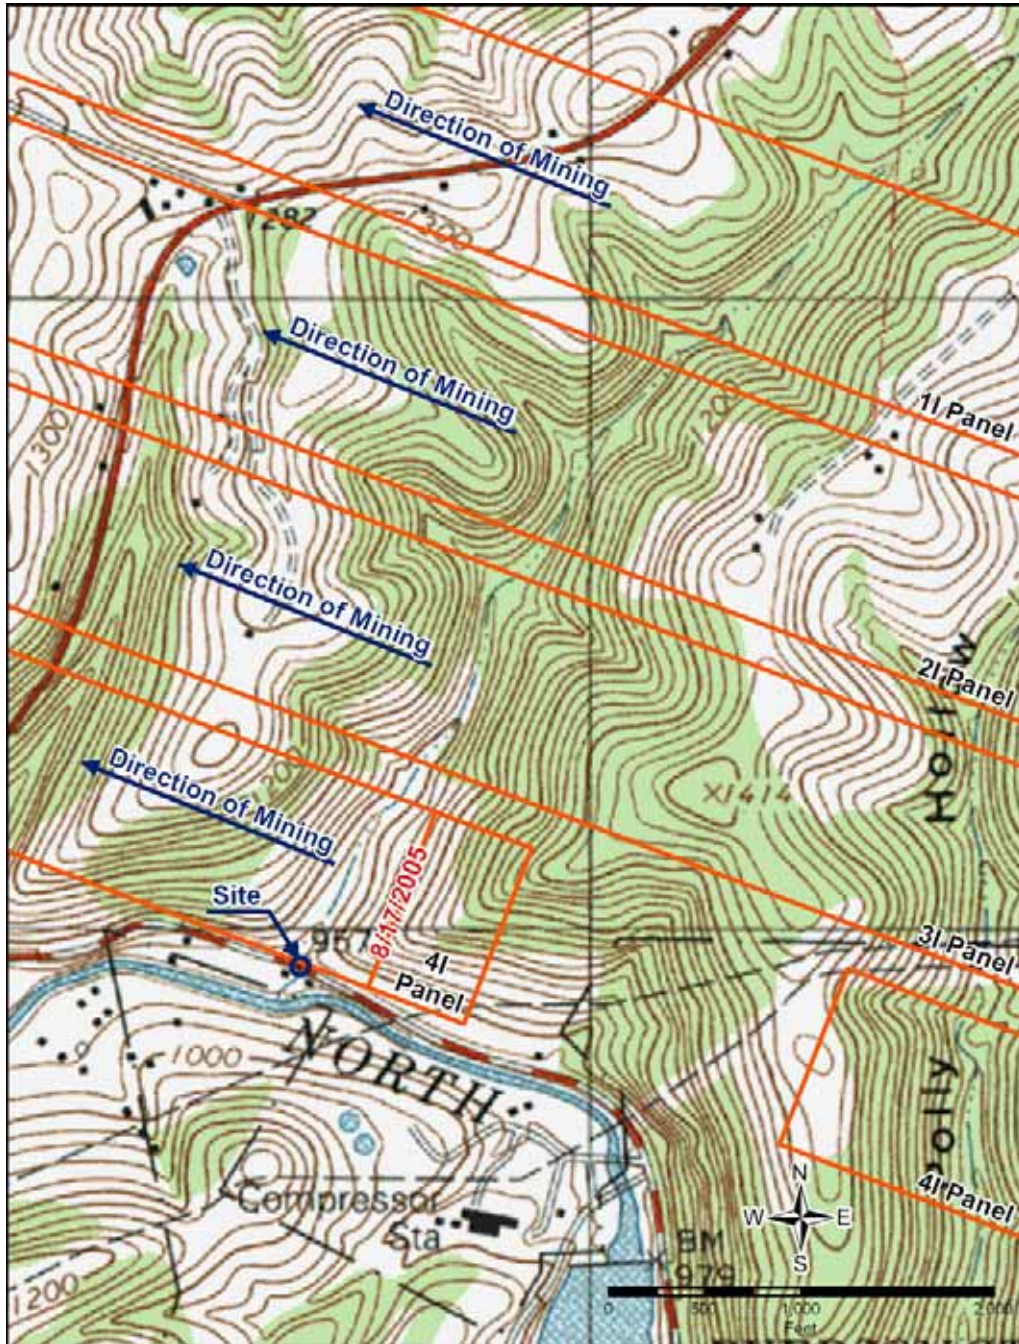
Figure IV-9: Location of Site 2, Bristoria Road Bridge.

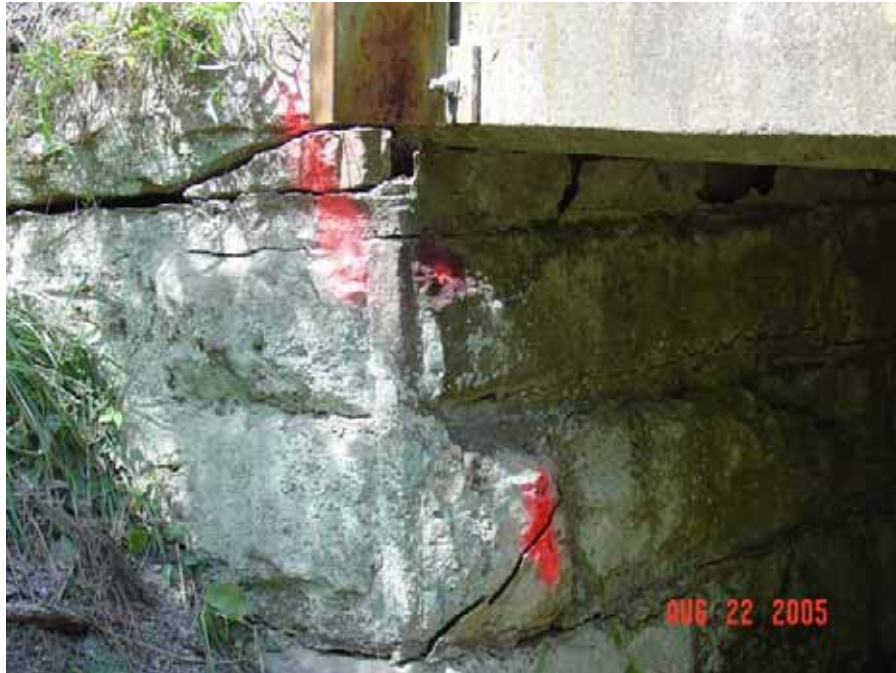
Photo IV-2c: DEP Photograph taken on August 22, 2005 showing cracks in southwest corner of Bristoria Road Bridge.

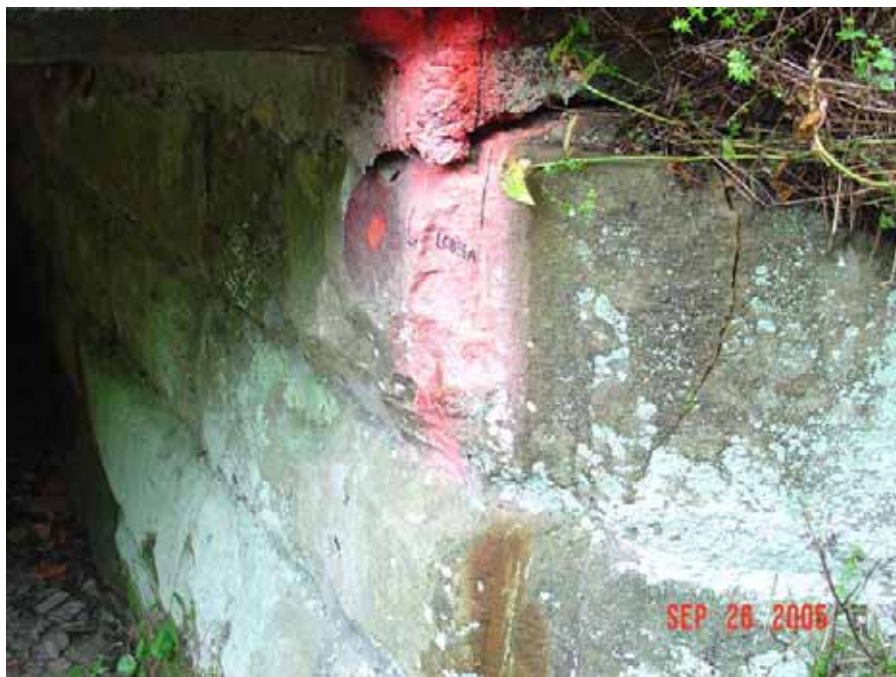
Photo IV-2d: DEP Photograph taken on September 26, 2005 showing movement within southeast corner of Bristoria Road Bridge.

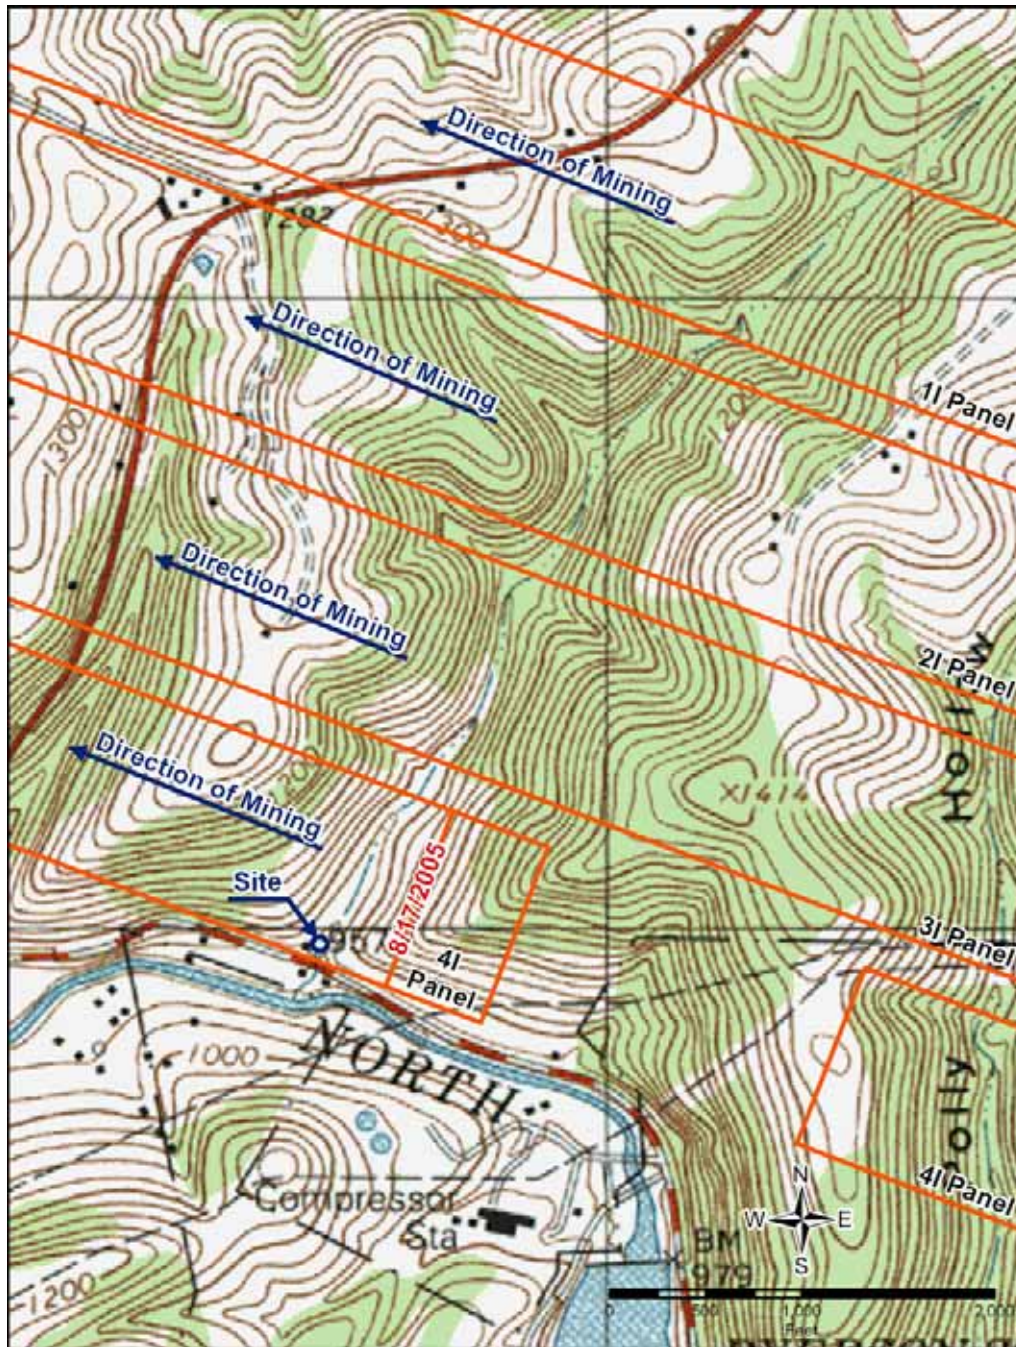
Figure IV-10: Location of Site 3, gas line heave.

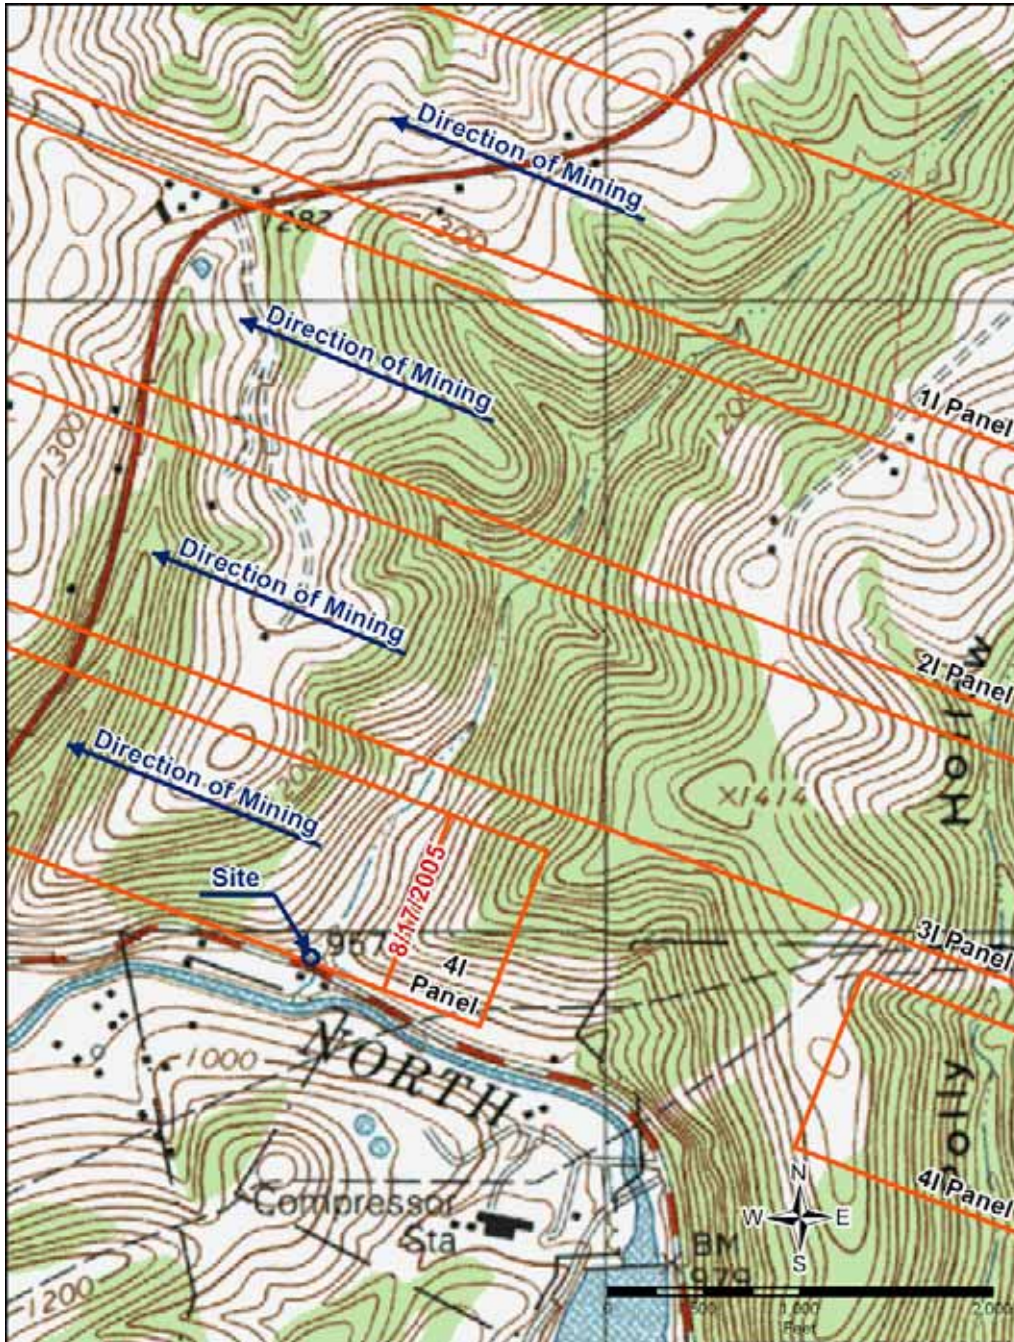
Figure IV-11: Location of Site 4, ground heave.

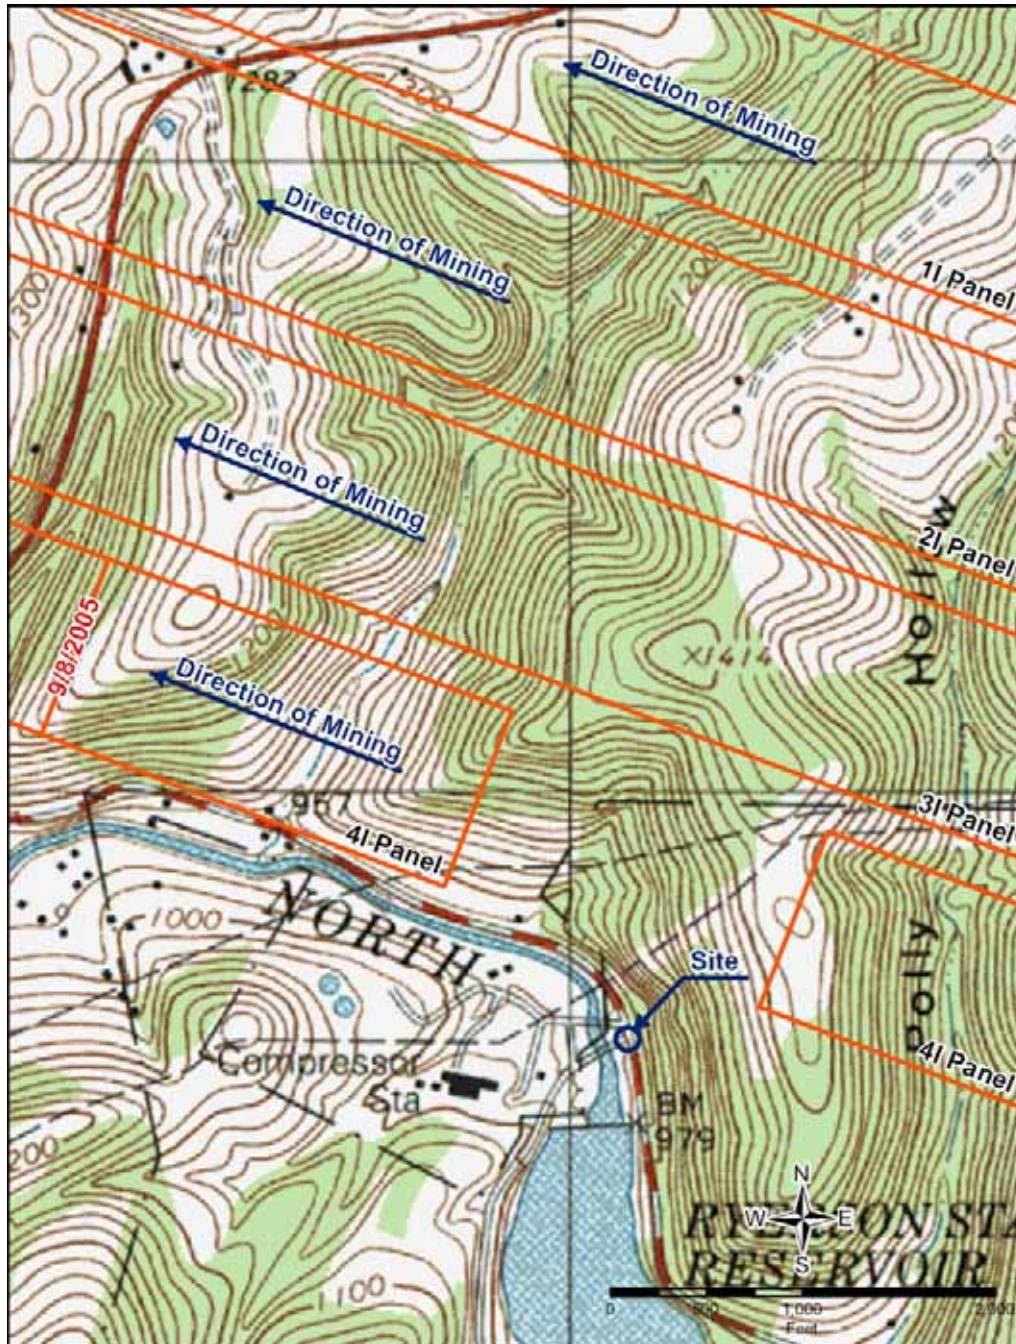
Figure IV-12: Location of Site 5, guide rail moorings on Lazear Lane Bridge.

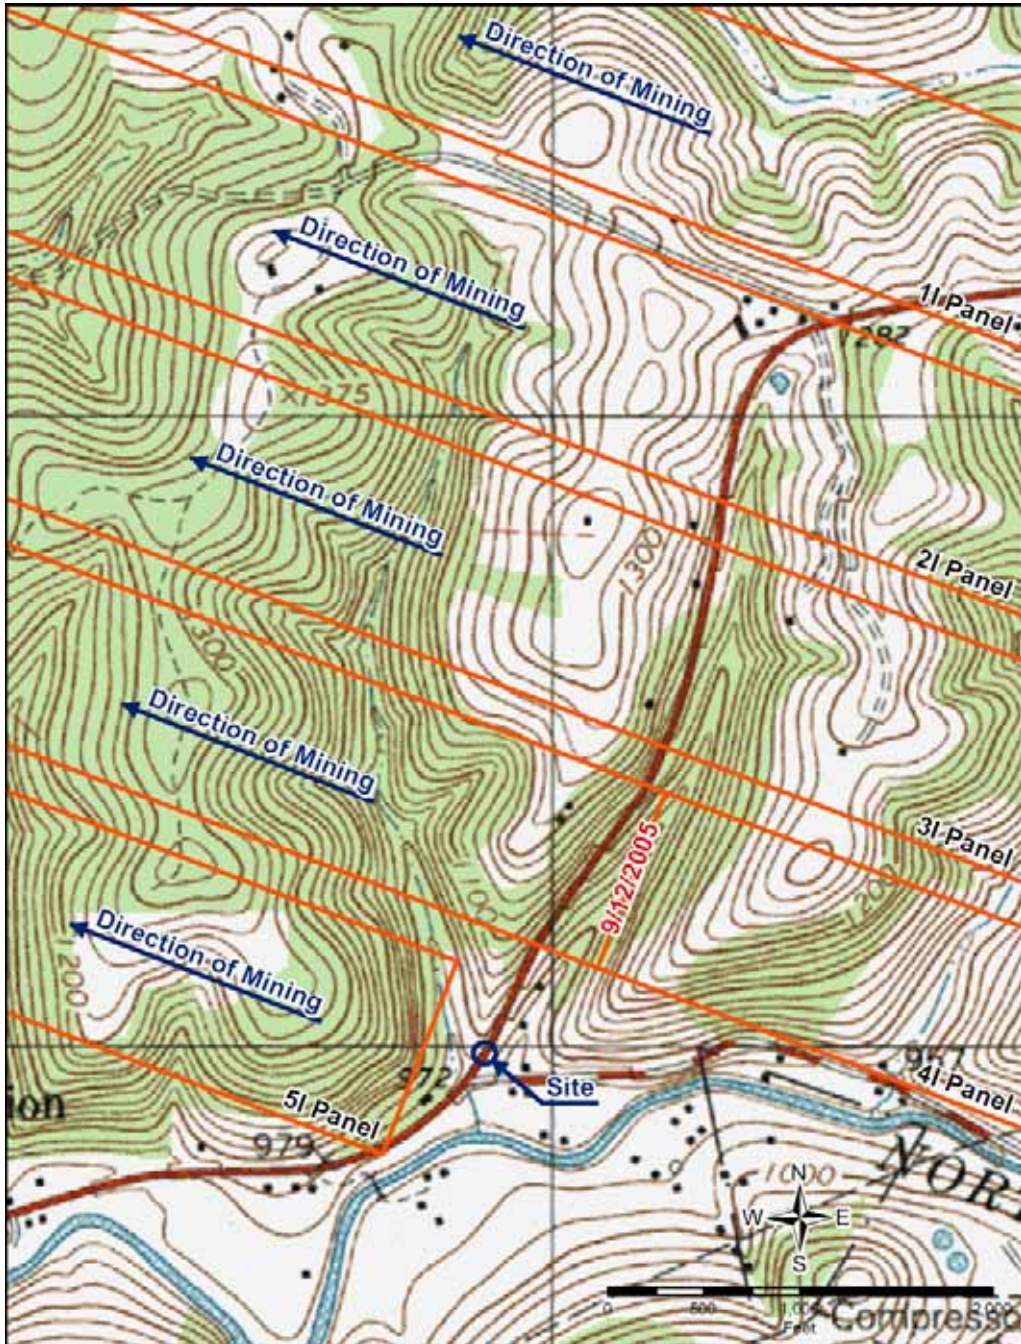
Figure IV-13: Location of Site 6, road bump near Route 21 and Bristoria Road intersection.

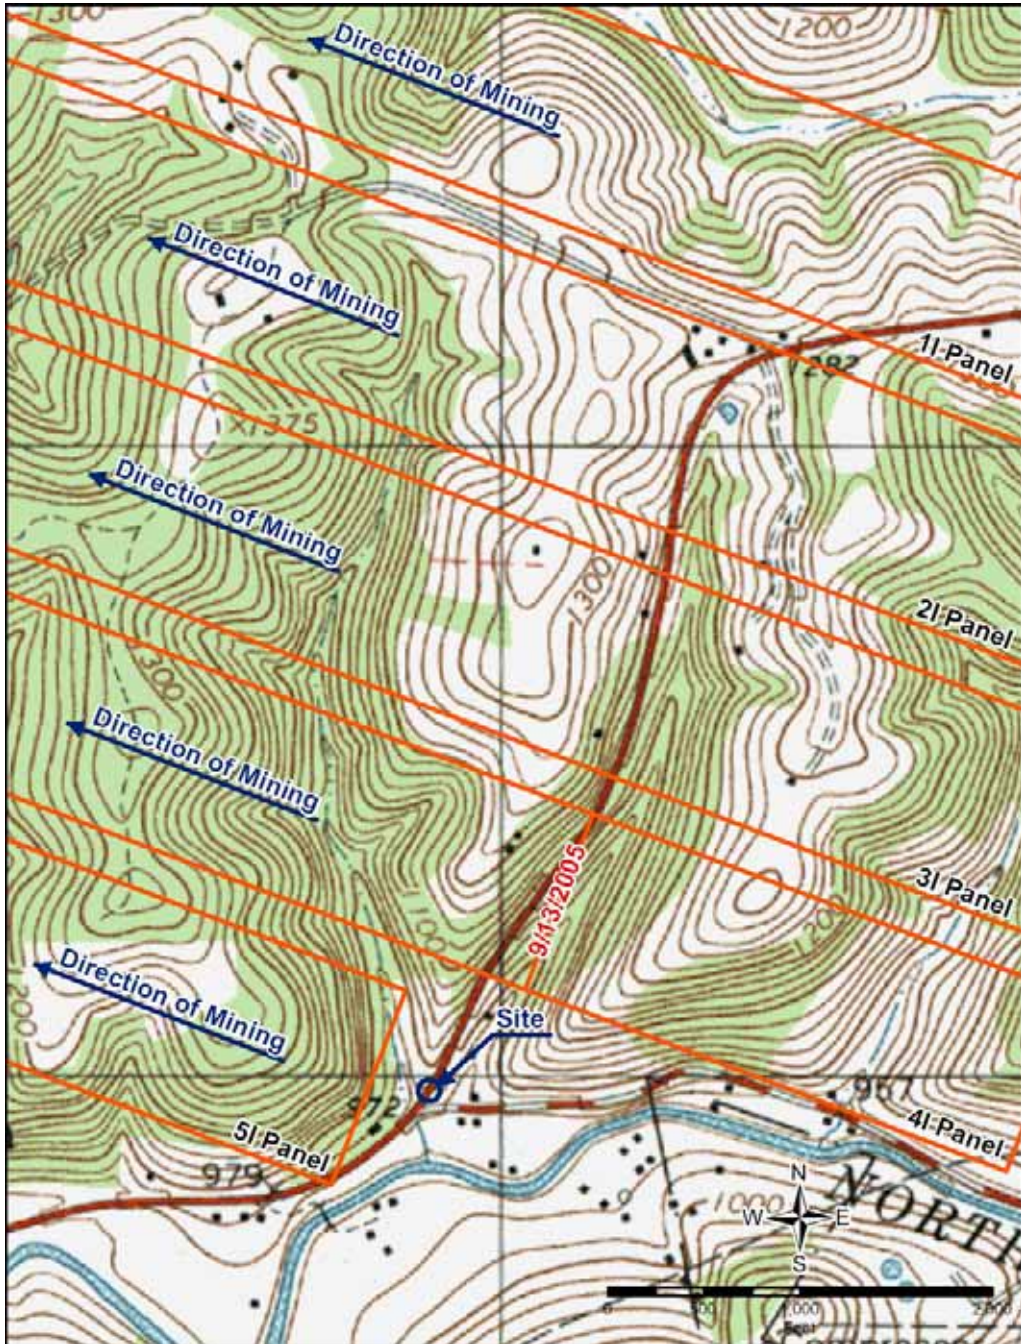
Figure IV-14: Location of Site 7, road bump near Route 21 and Bristoria Road intersection.

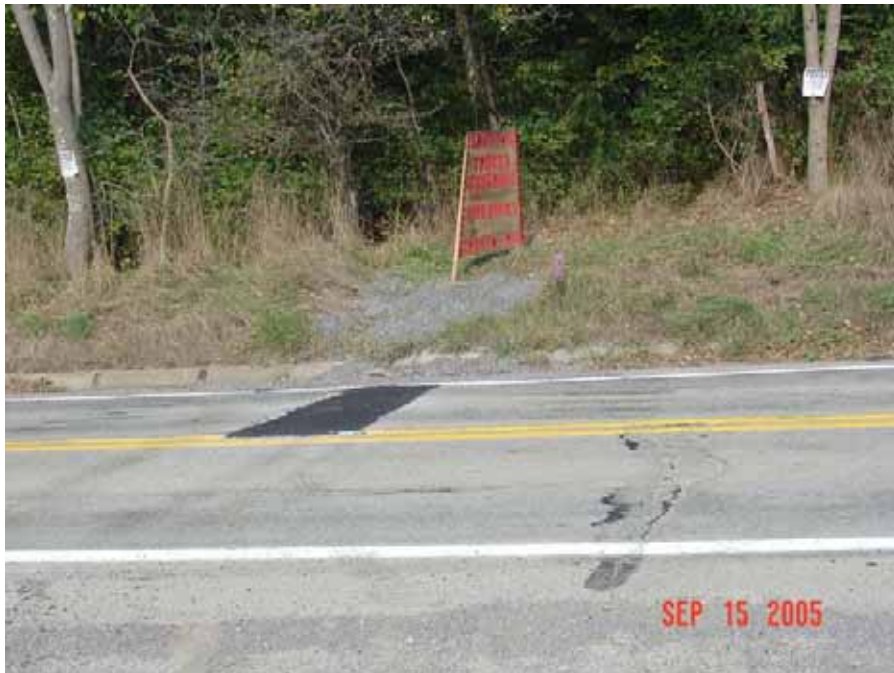
Photo IV-7b: DEP Photograph taken on September 15, 2005 showing side view of milled and patched road bump in westbound lane of Route 21.

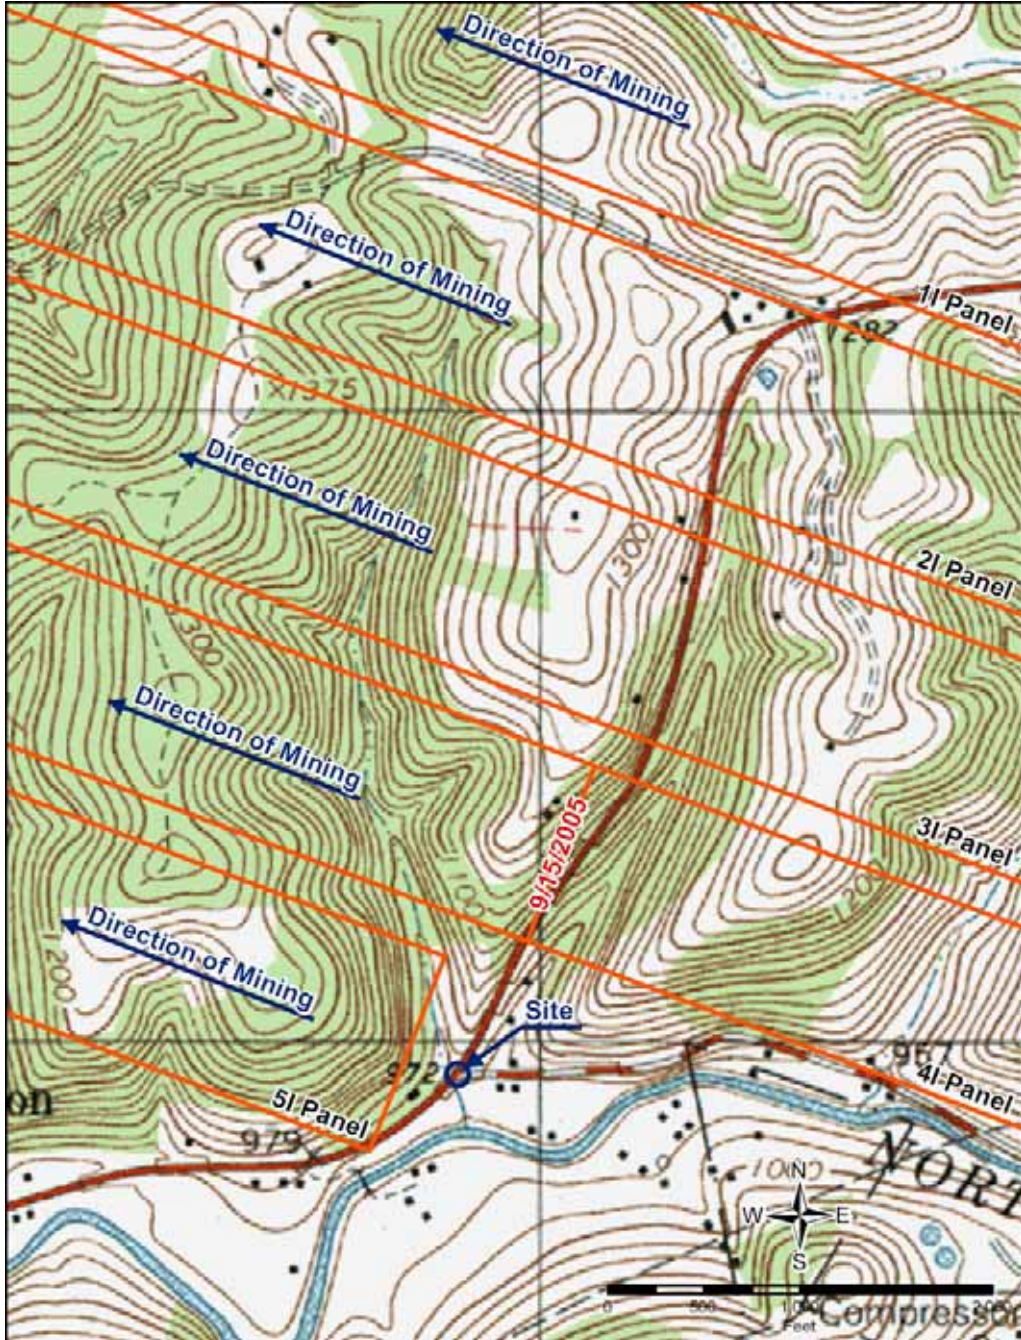
Figure IV-15: Location of Site 8, road cracks near Route 21/Bristoria Road intersection Area.
