RYERSON STATION STATE PARK

RYERSON STATION DAM

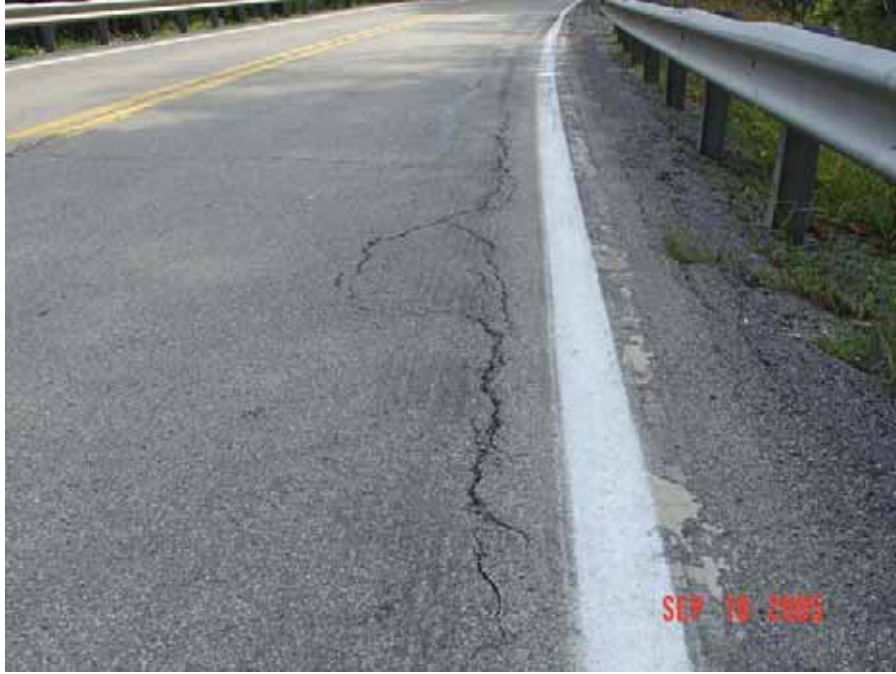
Photo IV-8a: DEP Photograph taken on September 19, 2005 showing cracks within westbound lane of Route 21.

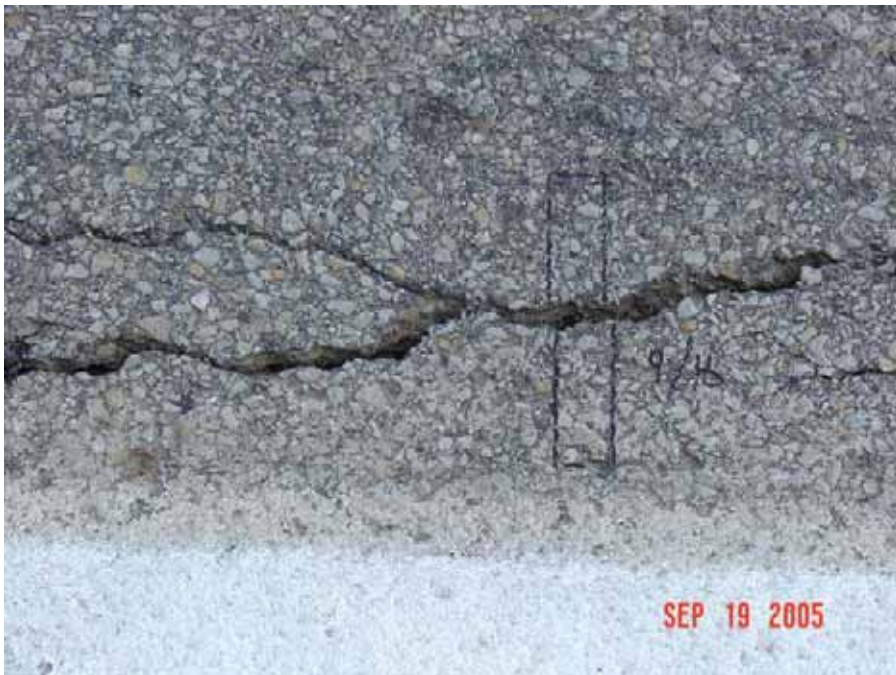
Photo IV-8b: DEP Photograph taken on September 19, 2005 showing close-up of cracks and movement in westbound lane of Route 21.

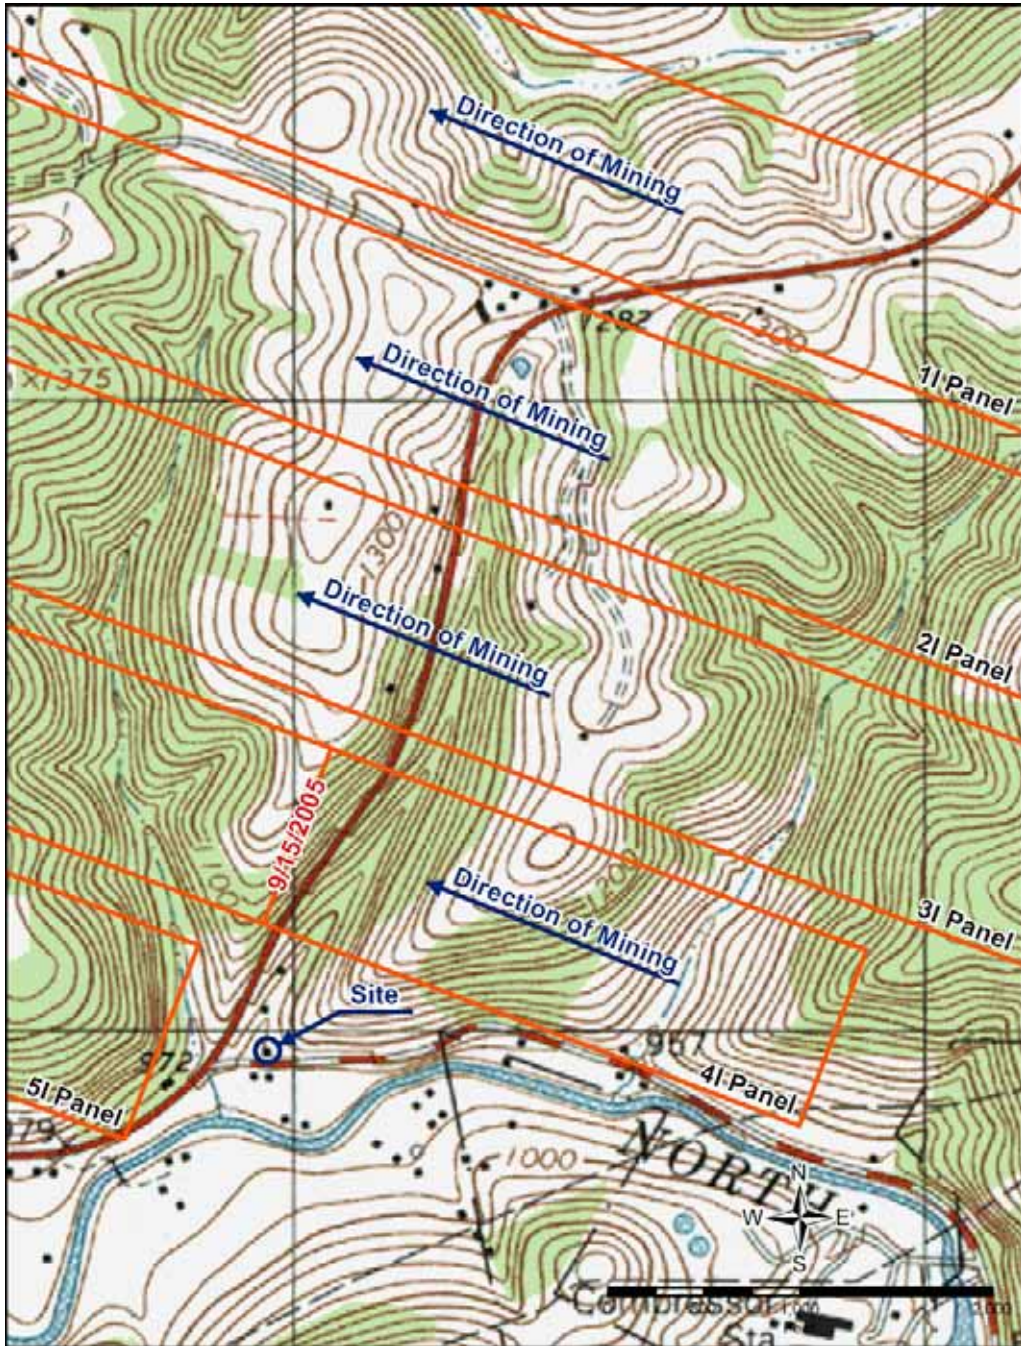
Figure IV-16: Location of Site 9, Bottinelli Residence near Route 21/Bristoria Road Intersection Area.

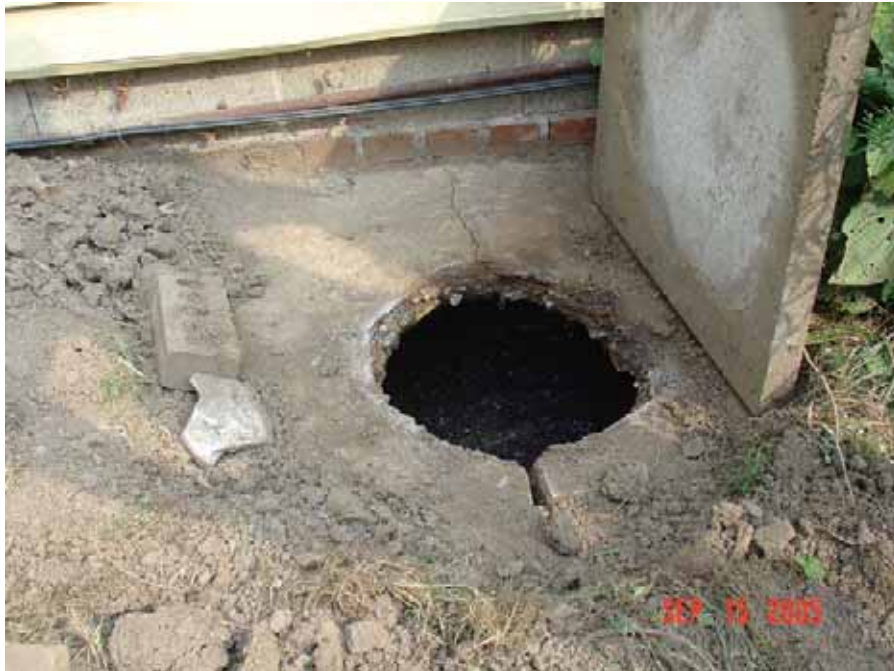
Photo IV-9a: DEP Photograph taken on September 15, 2005 showing minor cracks in Bottinelli Residence.

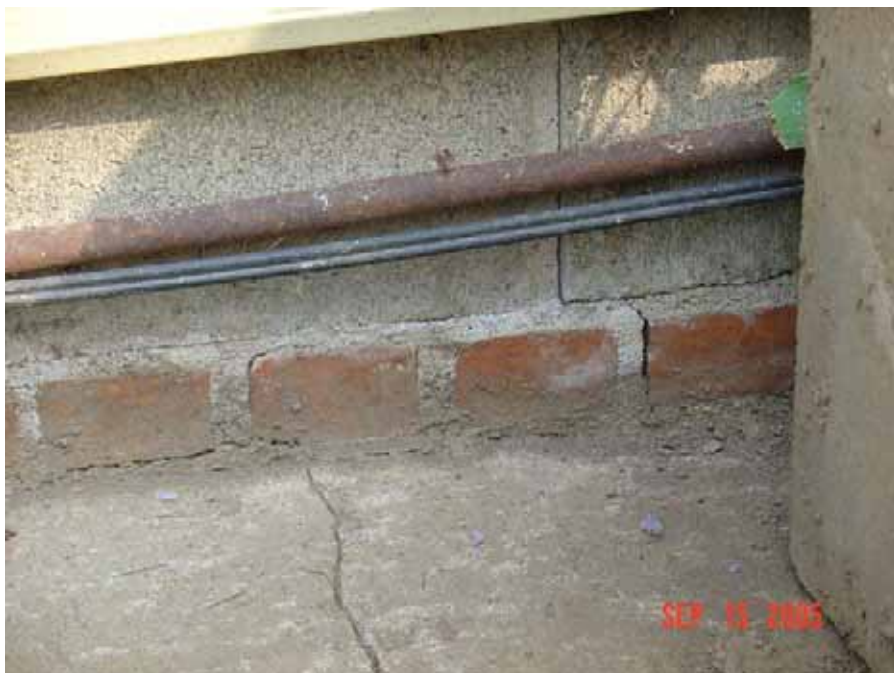
Photo IV-9b: DEP Photograph taken on September 15, 2005 showing close-up of minor cracks in Bottinelli Residence.

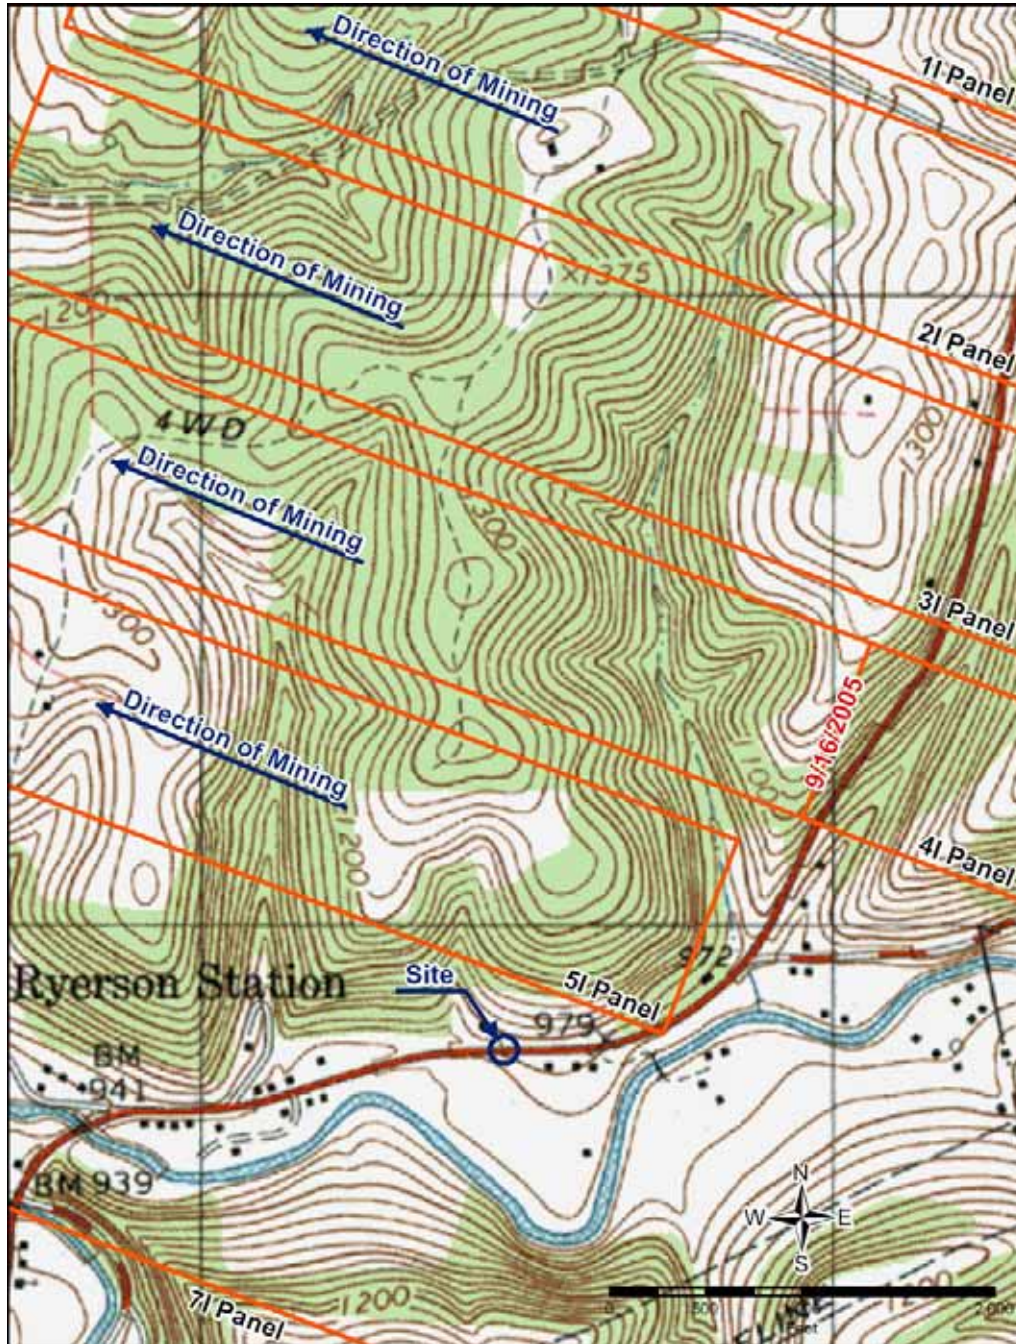
Figure IV-17: Location of Site 10, Route 21 guide rail mooring site.

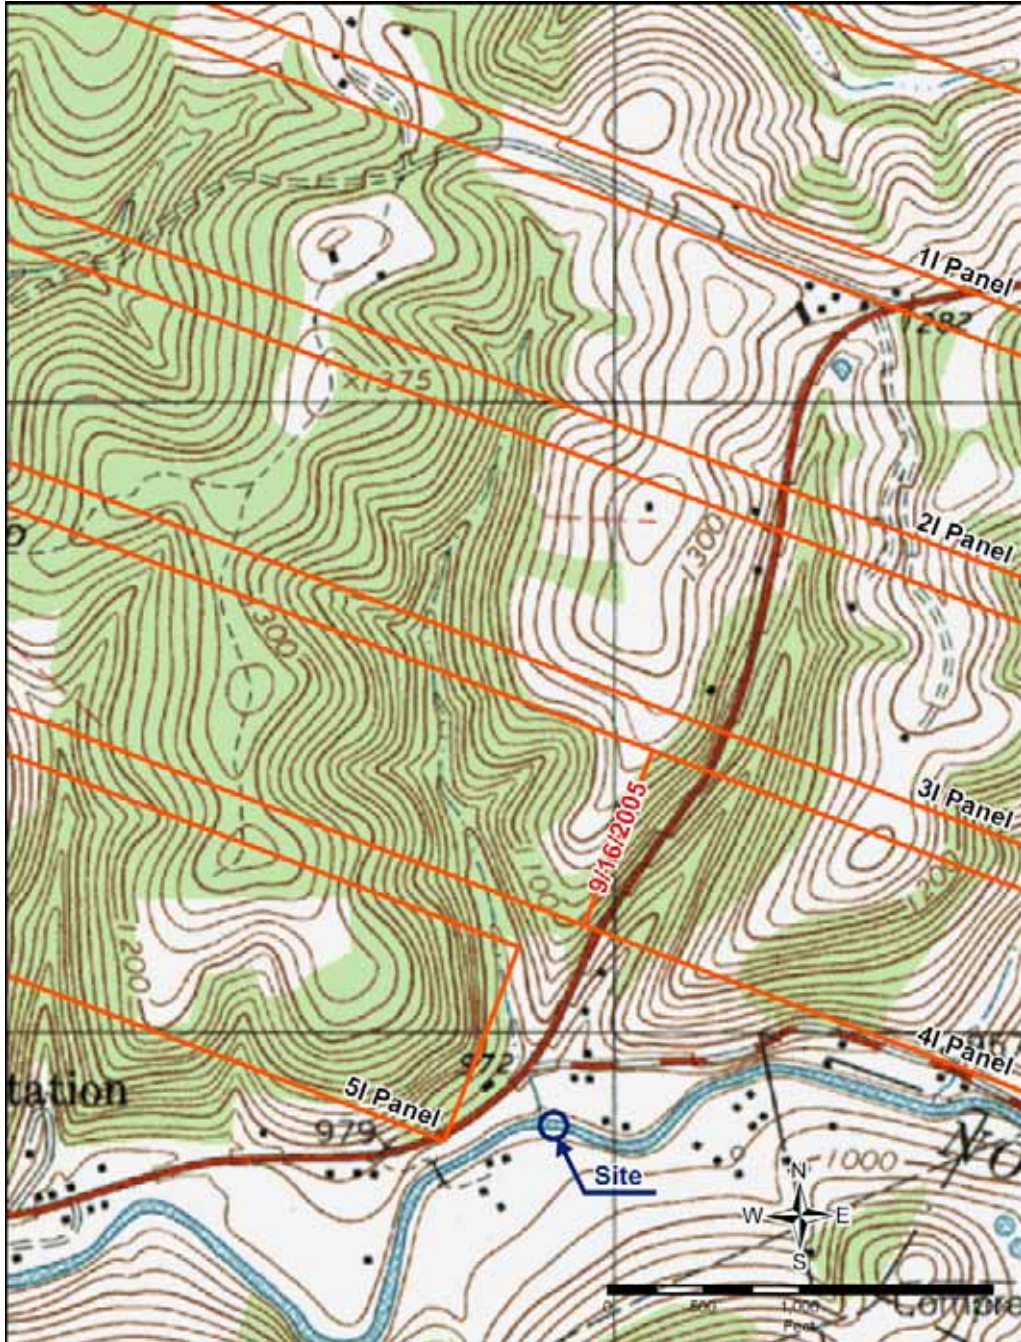
Figure IV-18: Location of Site 11, streambed heave observed in the North Fork of Dunkard Fork.

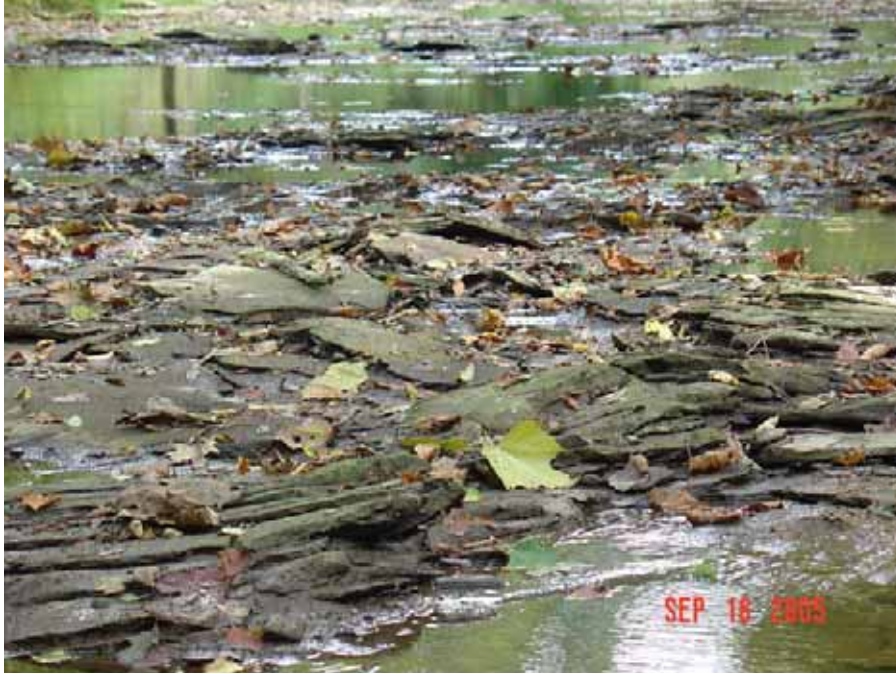
Photo IV-11a: DEP Photograph taken on September 16, 2005 showing streambed heave looking upstream.

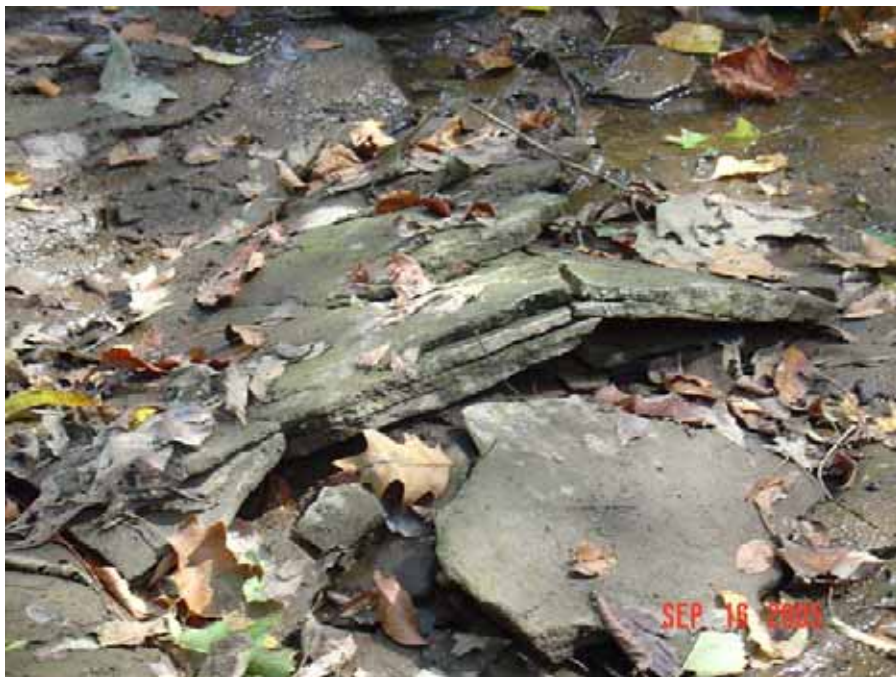
Photo IV-11b: DEP Photograph taken on September 16, 2005 showing heaved and cracked rocks within streambed.

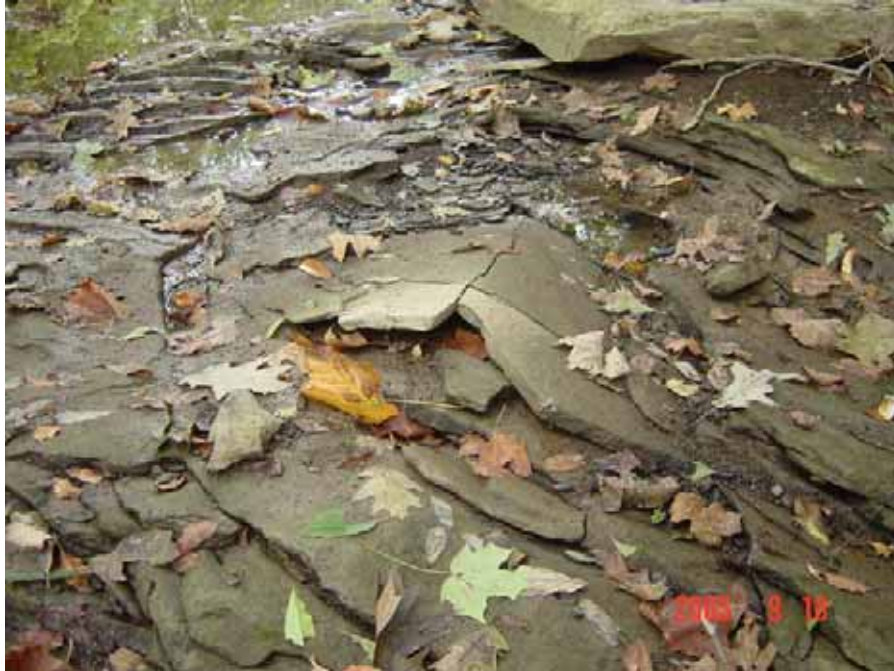
Photo IV-11c: DEP Photograph taken on September 18, 2005 showing heaved and cracked rocks within streambed.

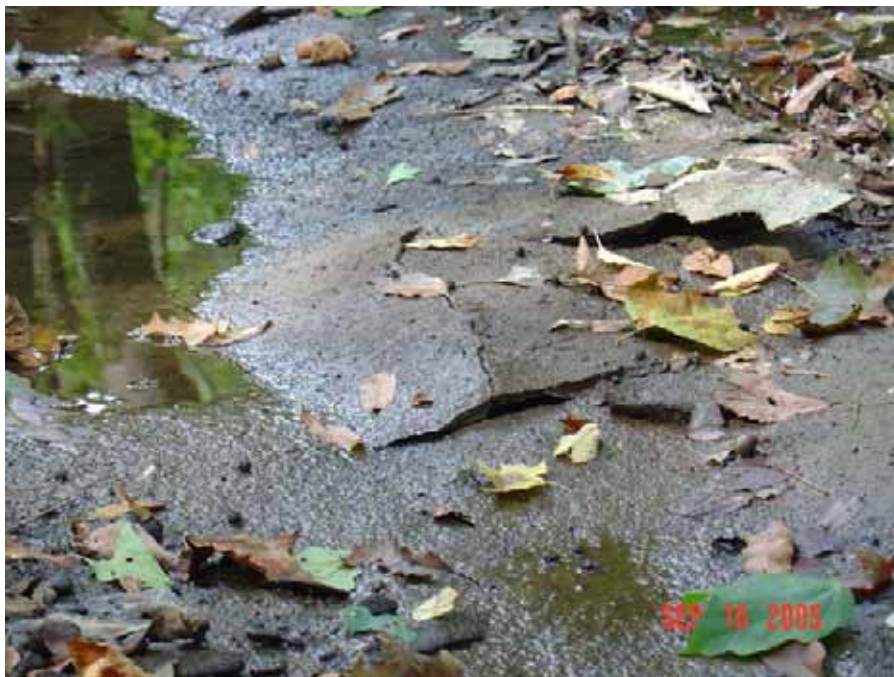
Photo IV-11d: DEP Photograph taken September 16, 2005 showing heaved and cracked rocks within streambed.

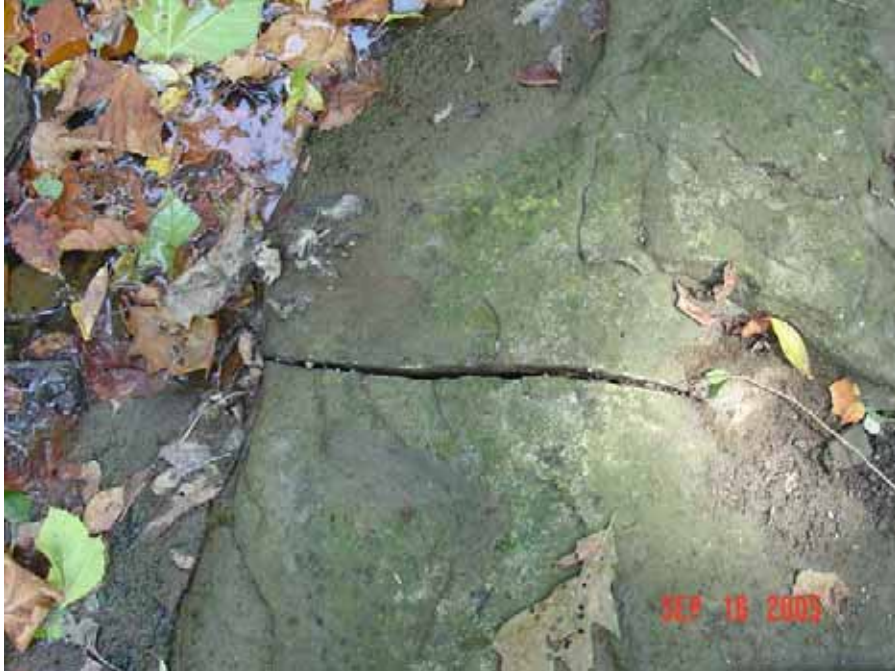
Photo IV-11e: DEP Photograph taken September 16, 2005 showing crack in bedrock within streambed.

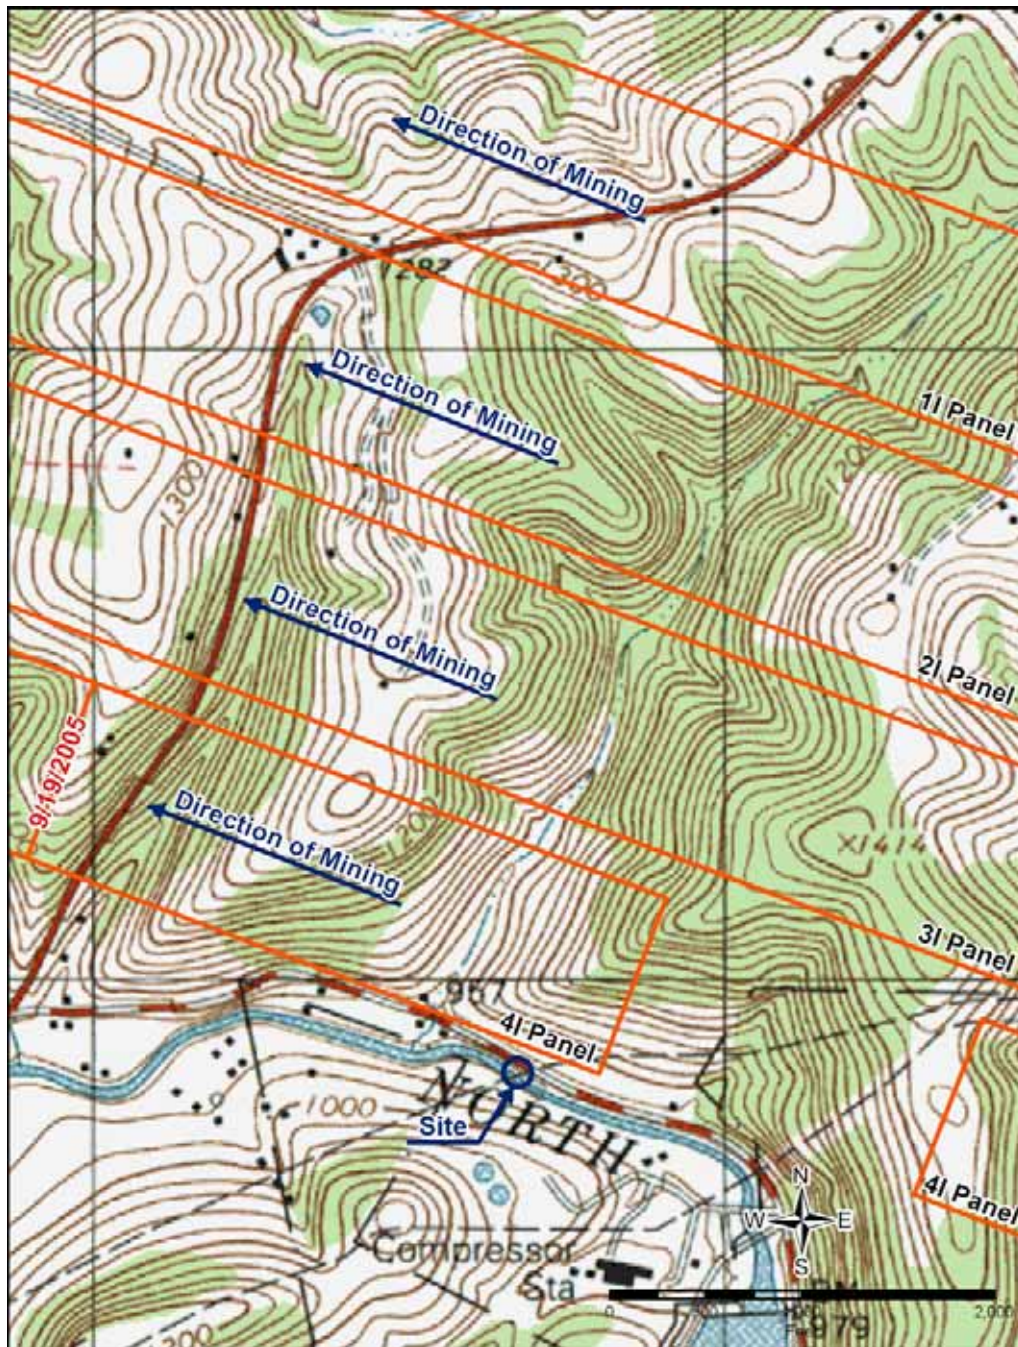
Figure IV-19: Location of Site 12, Texas Eastern pipeline heave crossing North Fork of Dunkard Fork.

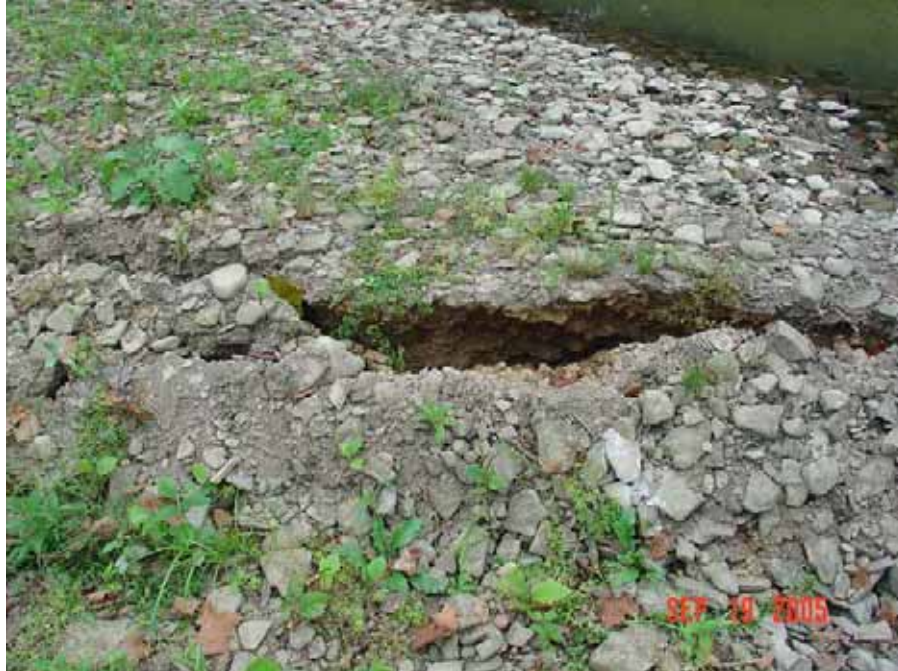
Photo IV-12e: DEP Photograph taken on September 19 2005 showing ground crack associated with pipeline heave.

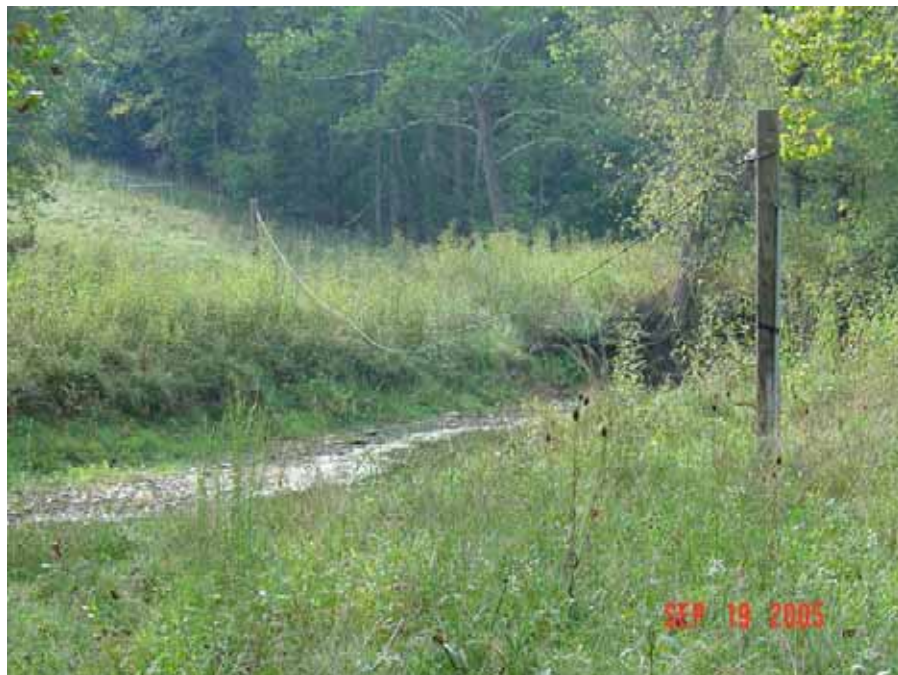
Photo IV-12f: DEP Photograph taken on September 19 2005 showing sag in pipeline marker cable crossing streambed.

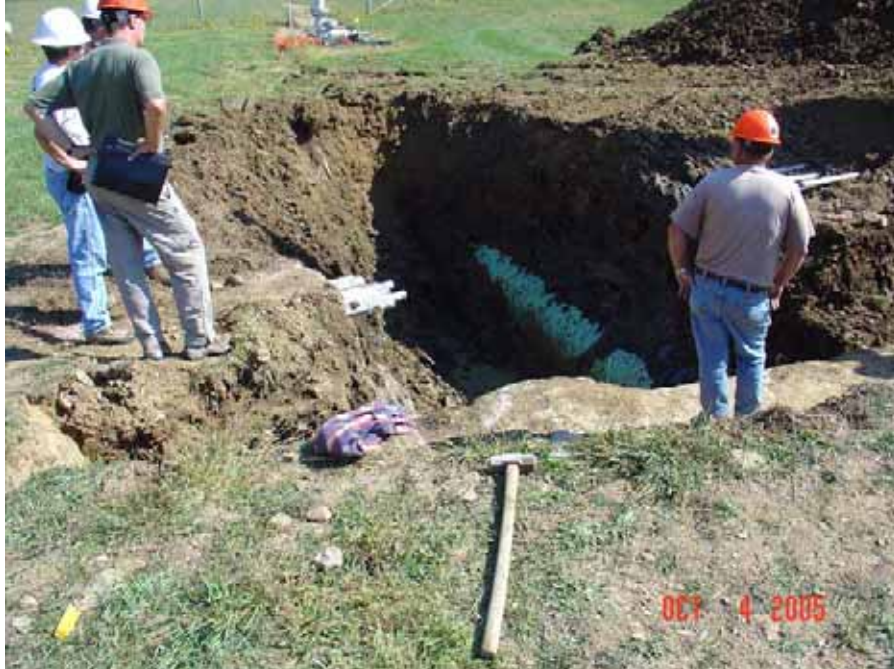
Photo IV-13e: DEP Photograph taken on October 4, 2005 showing a Texas Eastern pipeline being exposed for repairs.

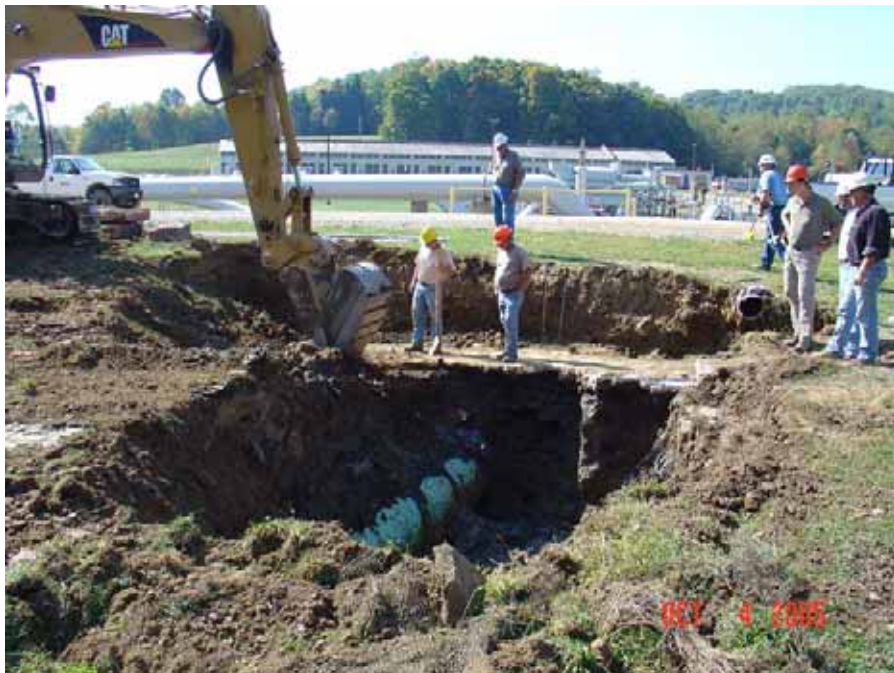
Photo IV-13f: DEP Photograph taken on October 4, 2005 showing a Texas Eastern pipeline being exposed for repairs.

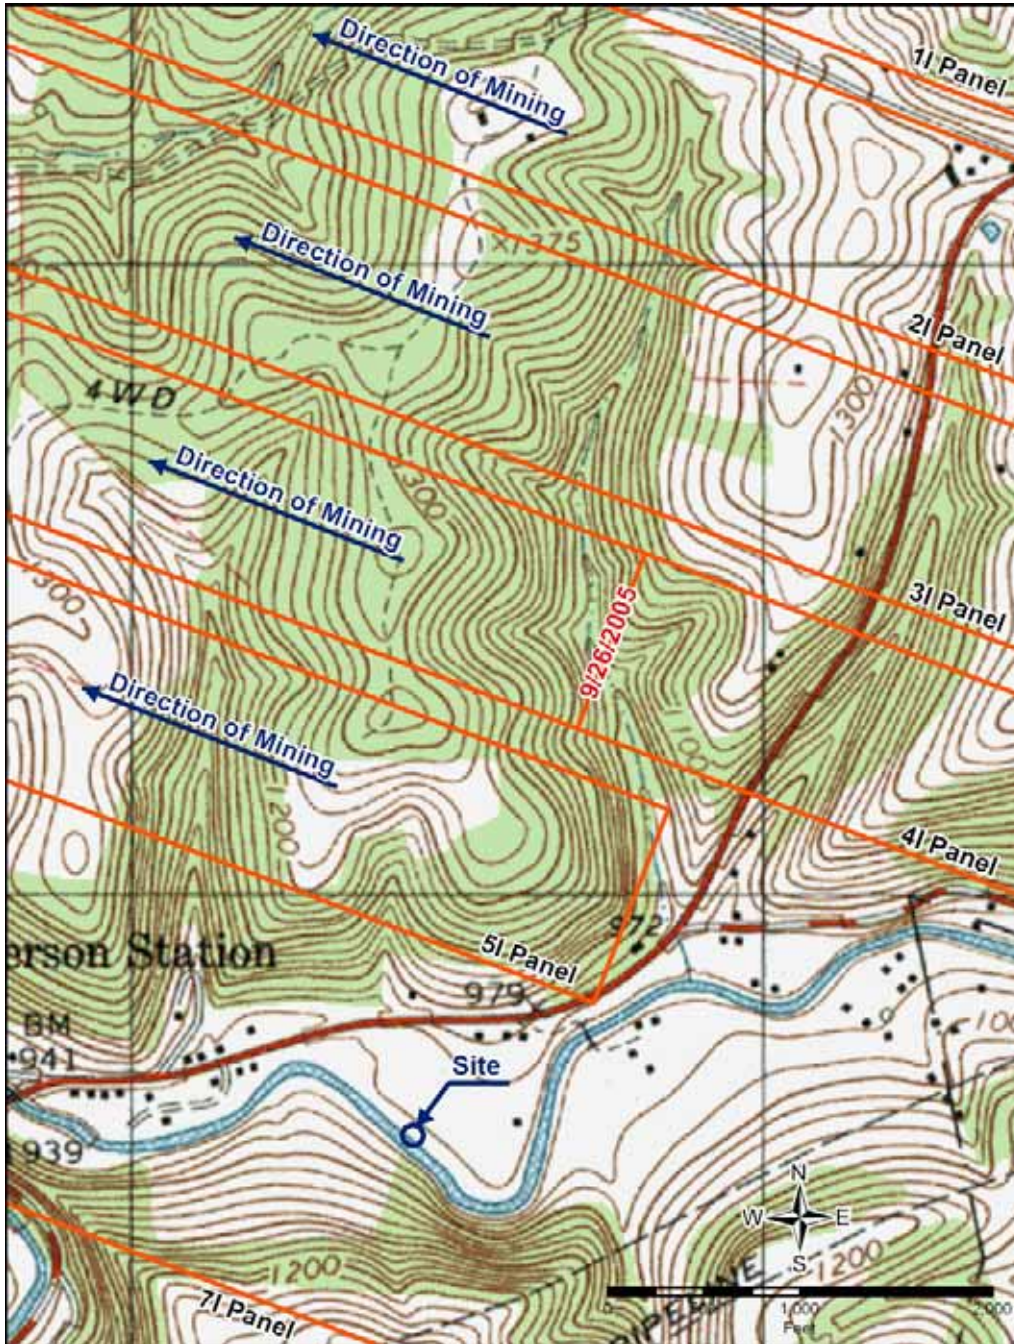
Figure IV-21: Location of Site 14, Equitrans Pipeline PDB92 heave.

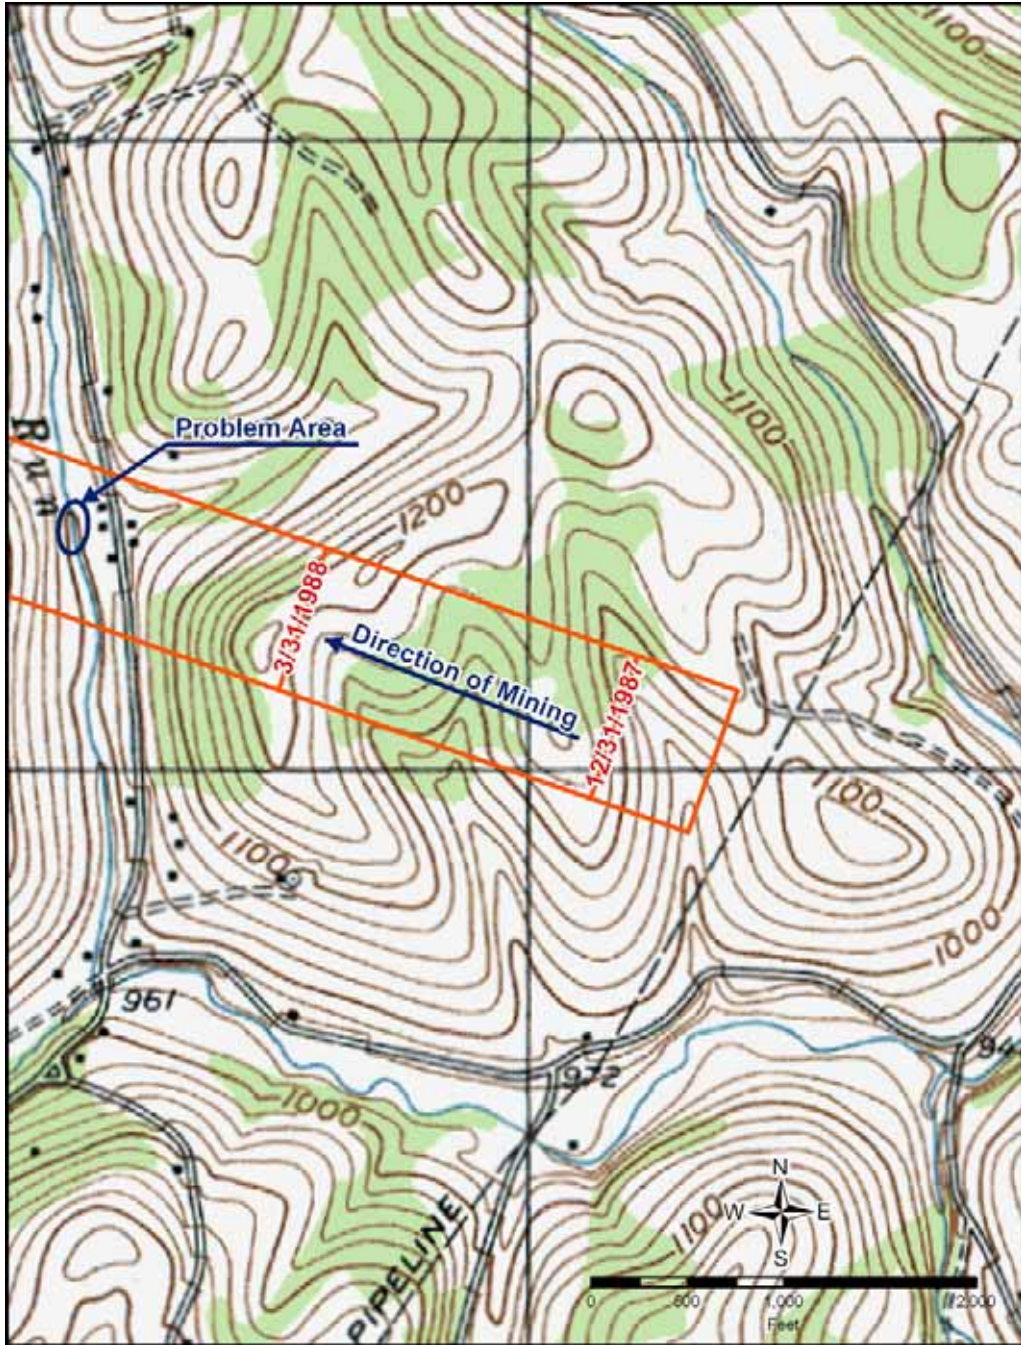
Figure IV-22: Location of Sugar Run Problem Area.

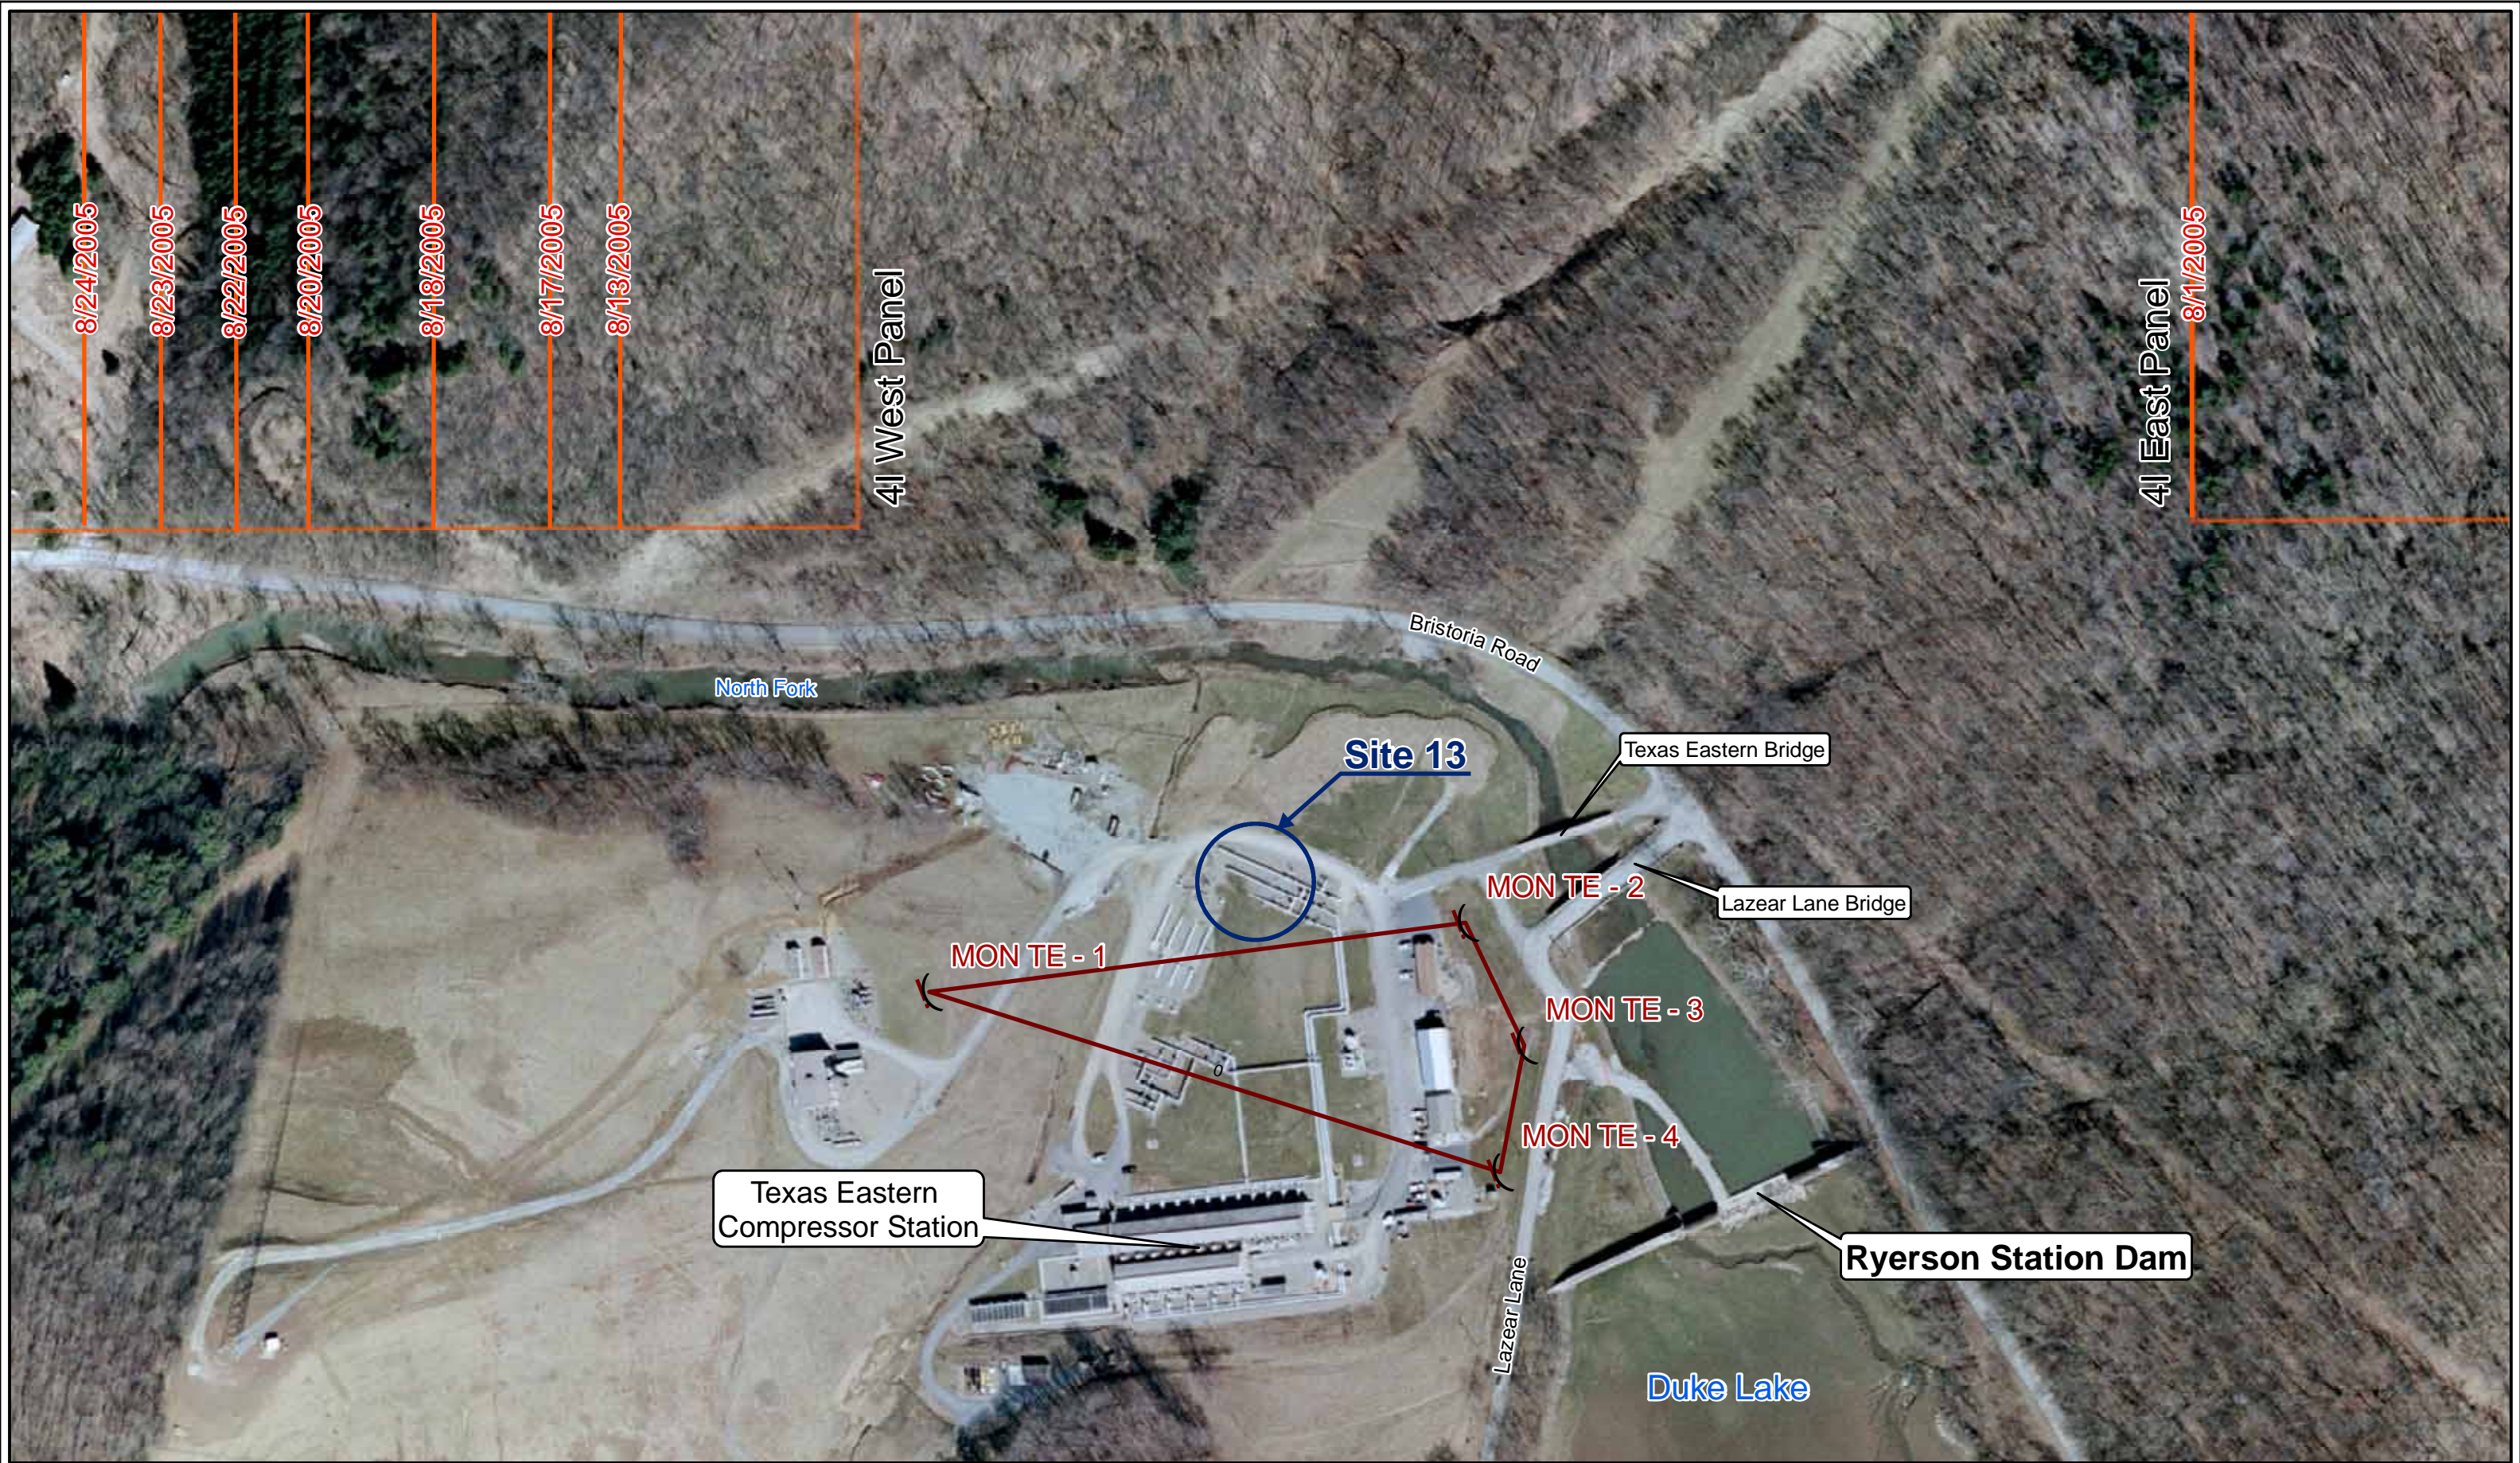
Data Sources: Base Mapping - PAMAP Project Aerial Photography.
 "Mined Longwall Panel" - Digitized from Bailey Mine 6-month mine maps provided by CPCC.
 "Longwall Face Location" - Digitized from plus readings provided by CPCC.
 "CPCC Monitoring Area" and "CPCC Monitoring Points" - Digitized from "Monuments At Texas Eastern Compressor Station" map provided by CPCC.
