Fixing A Broken Trout Stream

Donegal Creek Restoration Project
Written by Mark A. Metzler

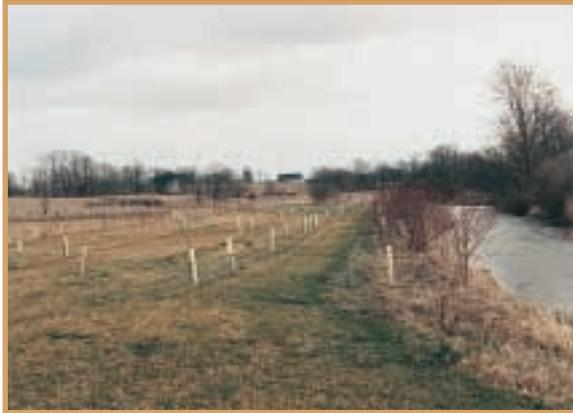
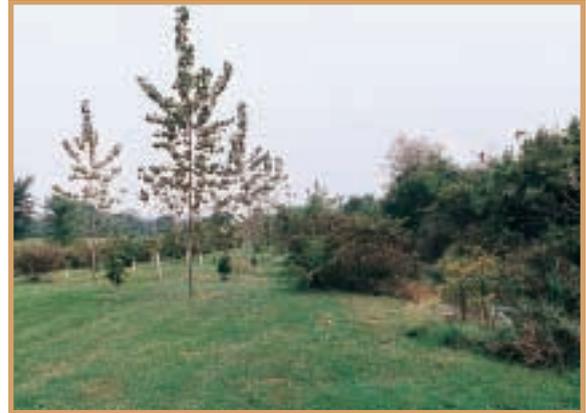
Before & After
Forrest buffer
planting on
Donegal's west
branch. The
buffer is 50' wide
and includes 2
rows of shrubs.

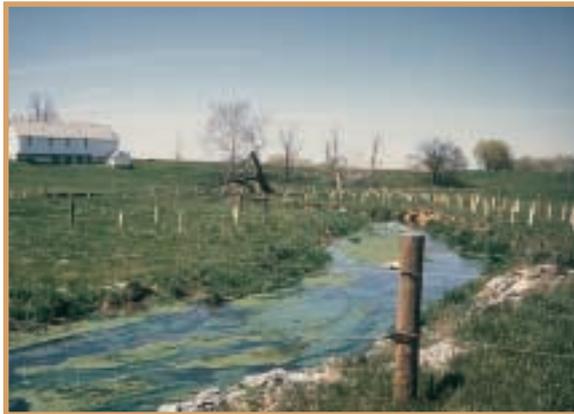
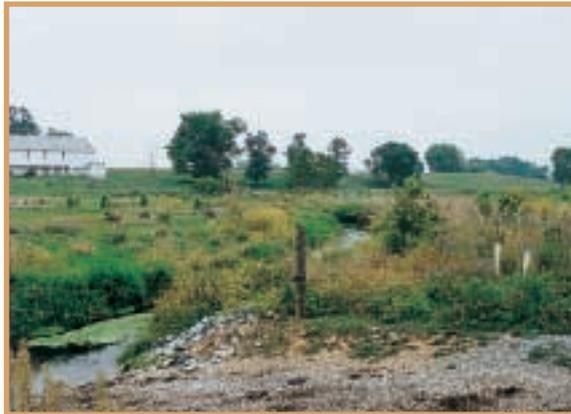
Before & After
Forrest buffer
planting on
Donegal's east
branch. The
buffer in some
locations exceeds
100' in width.
Notice the use
of tree protector
tubes.

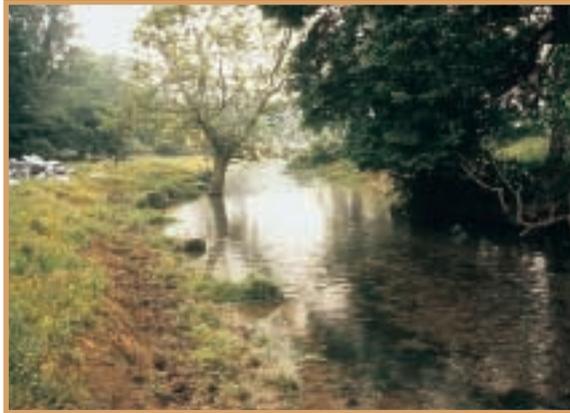
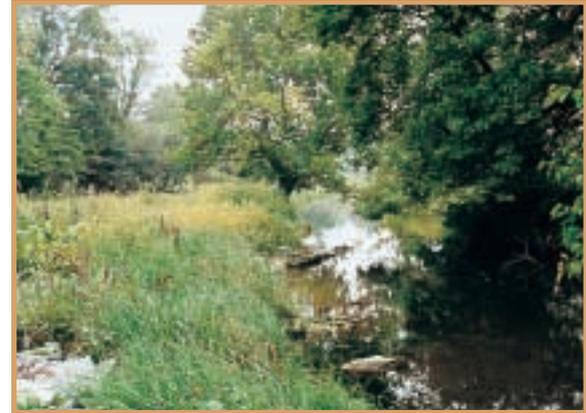
Before & After
The installation of 2 rock deflectors and streambank fencing repaired this badly eroded streambank on Donegal's east branch. This all took place within one year.

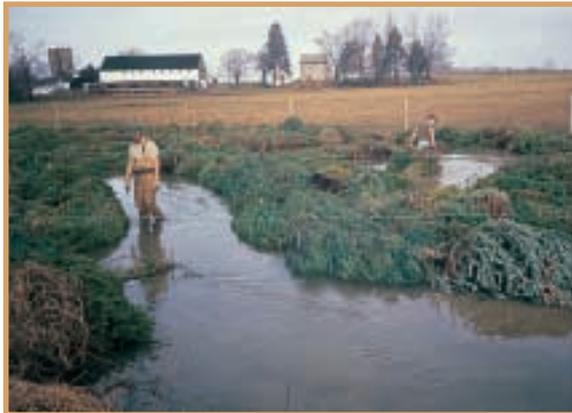
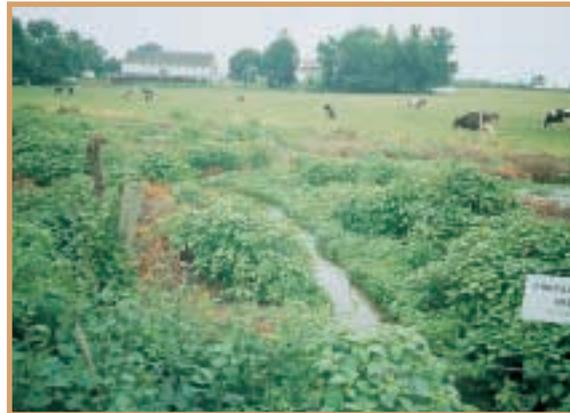
Before & After
Used Christmas trees were utilized to build this "porcupine deflector." Notice the extremely wide and shallow stream channel in the first photo compared to the second photo.

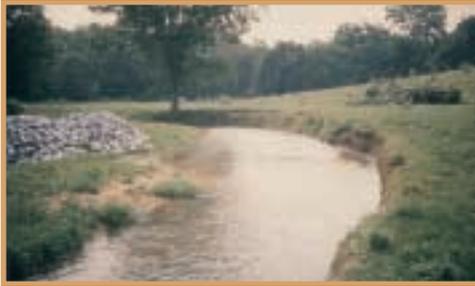
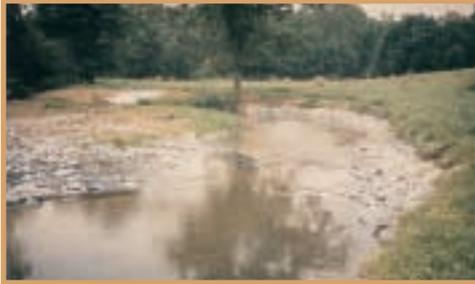
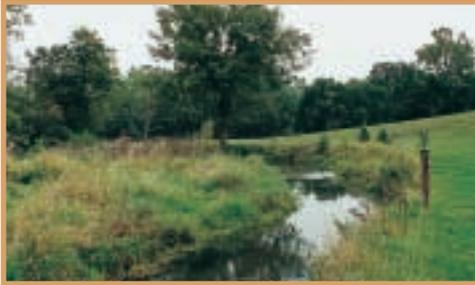
This photo series shows, from top to bottom, stream improvement work that took place in the Donegal's main stem. Improvements consisted of installing 2 log deflectors, 1 inverted "V" dam, 1 cattle crossing, 2 fence stiles, streambank fencing and a forest buffer planting.

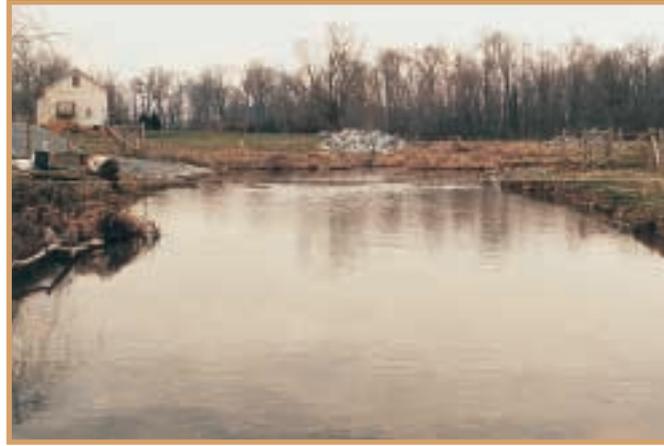
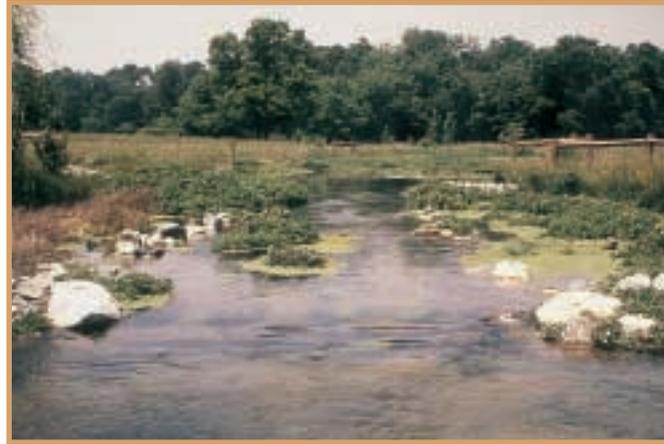
This is a view of Monitoring Station #2 on the Donegal's west branch. In 1997, there were no trout in this pasture. After improvements such as re-fencing plus the installation of deflectors and log "bumps", trout could again be seen sipping blue-winged olive mayflies from the surface in 1998.

Monitoring station #2 is located in a pasture setting approximately 500 feet downstream from station #1. Prior to restoration activities, station #2 was severely impacted by a free ranging dairy herd. The stream channel was extremely wide and shallow. Little in-stream cover and plant life existed. Since the introduction of stream-bank fencing and structural habitat, station #2 is coming alive. Prior to improvements, bloodworms (*Chironomus* species) dominated the invertebrate population, but now sowbugs and scuds are becoming the more dominating species as the muddy substrate is replaced with clean gravel and rock outcroppings. Various dace and mottled sculpin are the dominant fish species.
