# **Cove Run Sediment and Phosphorus TMDLs**

Fulton County, Pennsylvania

**Final Draft Submitted for EPA Approval, July 2021**

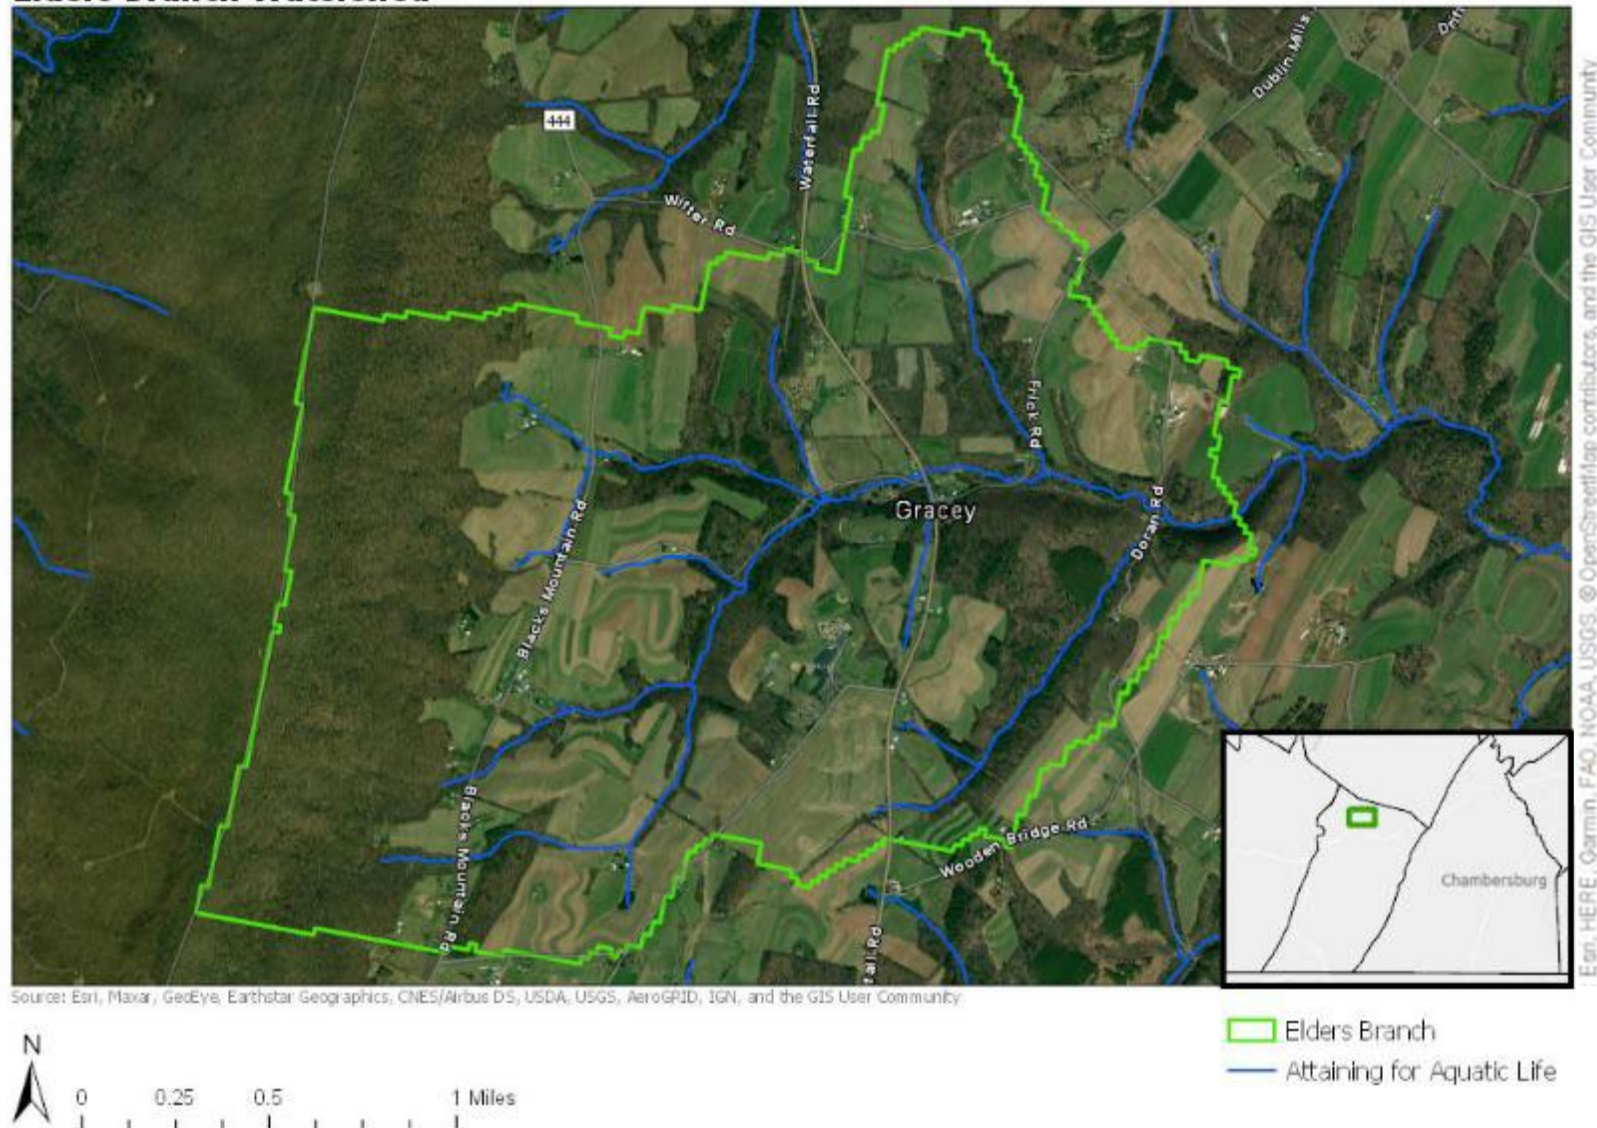
Figure 2. Elders Branch Subwatershed, Fulton County. All stream segments were listed as attaining for aquatic life use per the 2020 Final Pennsylvania Integrated Report (see PA DEP's 2020 Integrated Report Viewer available at: <https://www.depgis.state.pa.us/IRViewer2020/>).

Considering that it was nearby, only about 18 miles to the northeast, within the same section of the same physiographic province, and had similar topographic characteristics as the Cove Run Watershed, the Elders Branch Watershed, also in Fulton County was explored for use as a reference. Since it is required that the reference watershed be +/-30% of the impaired watershed's area, a delineation point was chosen upstream of the mouth to yield a subwatershed of the Elders Branch so that it was of similar size as the study watershed (Figure 2).

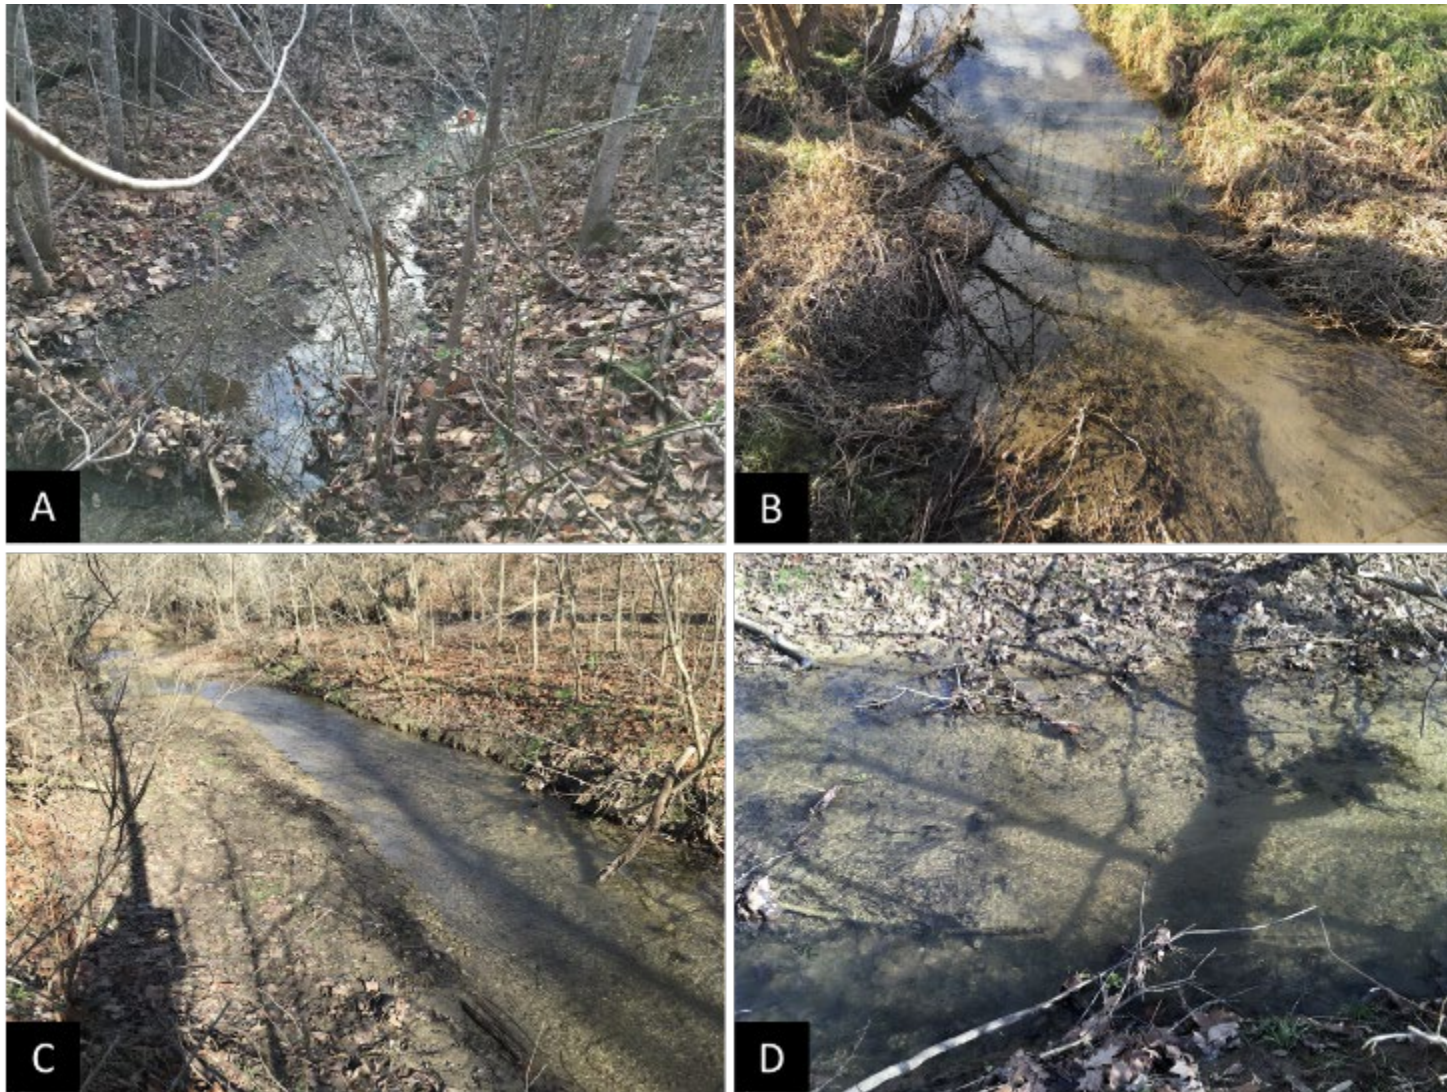
Figure 3. Evidence of siltation impairments in the Cove Run Watershed. High rates of fine sediment deposition were obvious in both a tributary (A) and mainstem (B-D) sites within the watershed.

After selecting the potential reference, the two watersheds were visited during January of 2021 to confirm the suitability of the reference as well as to explore whether there were any obvious land use differences that may help to explain why one watershed was impaired for sediment and nutrients while the other was attaining. The fine sediment impairment was obvious in the Cove Run Watershed. In the few places where stream segments readily accessible, the substrate appeared to be blanketed with fines (Figure 3). Algal blooms or other indicators of eutrophication were not apparent however, perhaps due to the winter visit. Observations of agricultural practices and land uses within the watershed were consistent with an expectation of impairment. While the margins of the watershed typically had naturally vegetated landcover, the central valley area was dominated by intensive agriculture and expansive forested riparian buffers were lacking in most cases (Figure 4). On top of this, croplands were observed on steep slopes (Figure 5) and pasture areas along streams and drainageways were sometimes so heavily used that they were bare (Figure 5). It should also be noted however that some good practices were observed as well, including: areas with forested cover, some stream segments/drainageways having forested or herbaceous buffers, and use of cover crops during the winter (Figure 6).

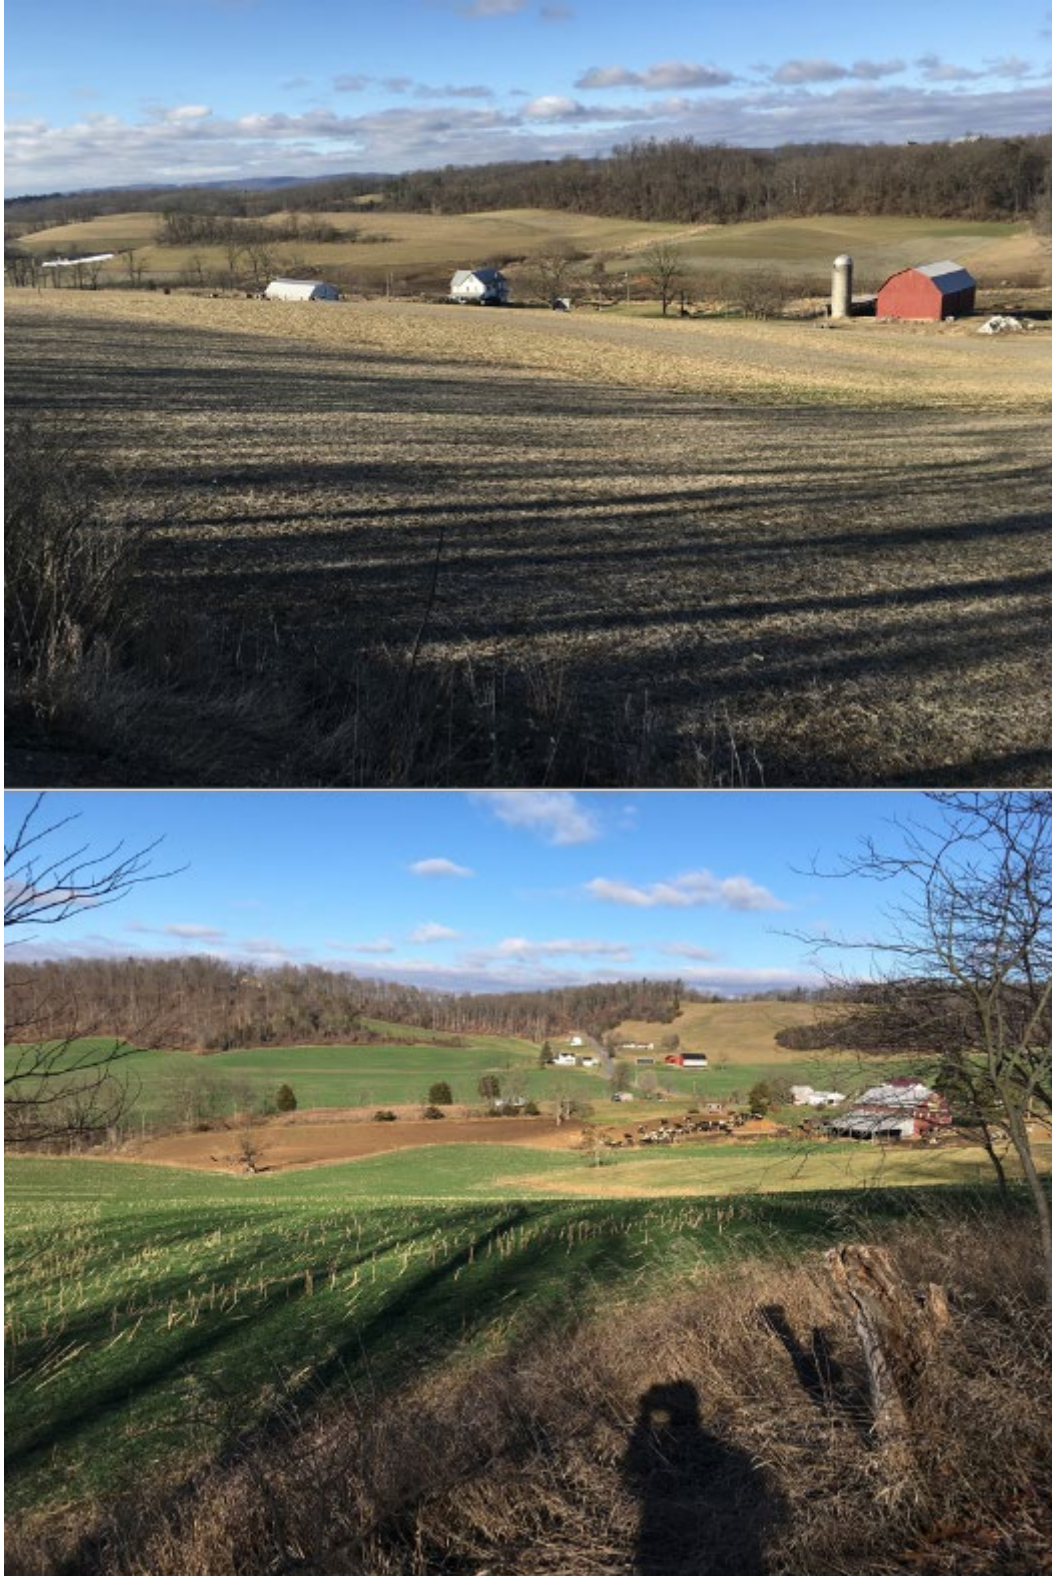
Figure 4. Example landscapes within the Cove Run Watershed. The watershed existed as a narrow valley with rolling farmlands bracketed by forested uplands. Agricultural landcover was heavy in the valley area and stream segments often lacked expansive riparian buffers.

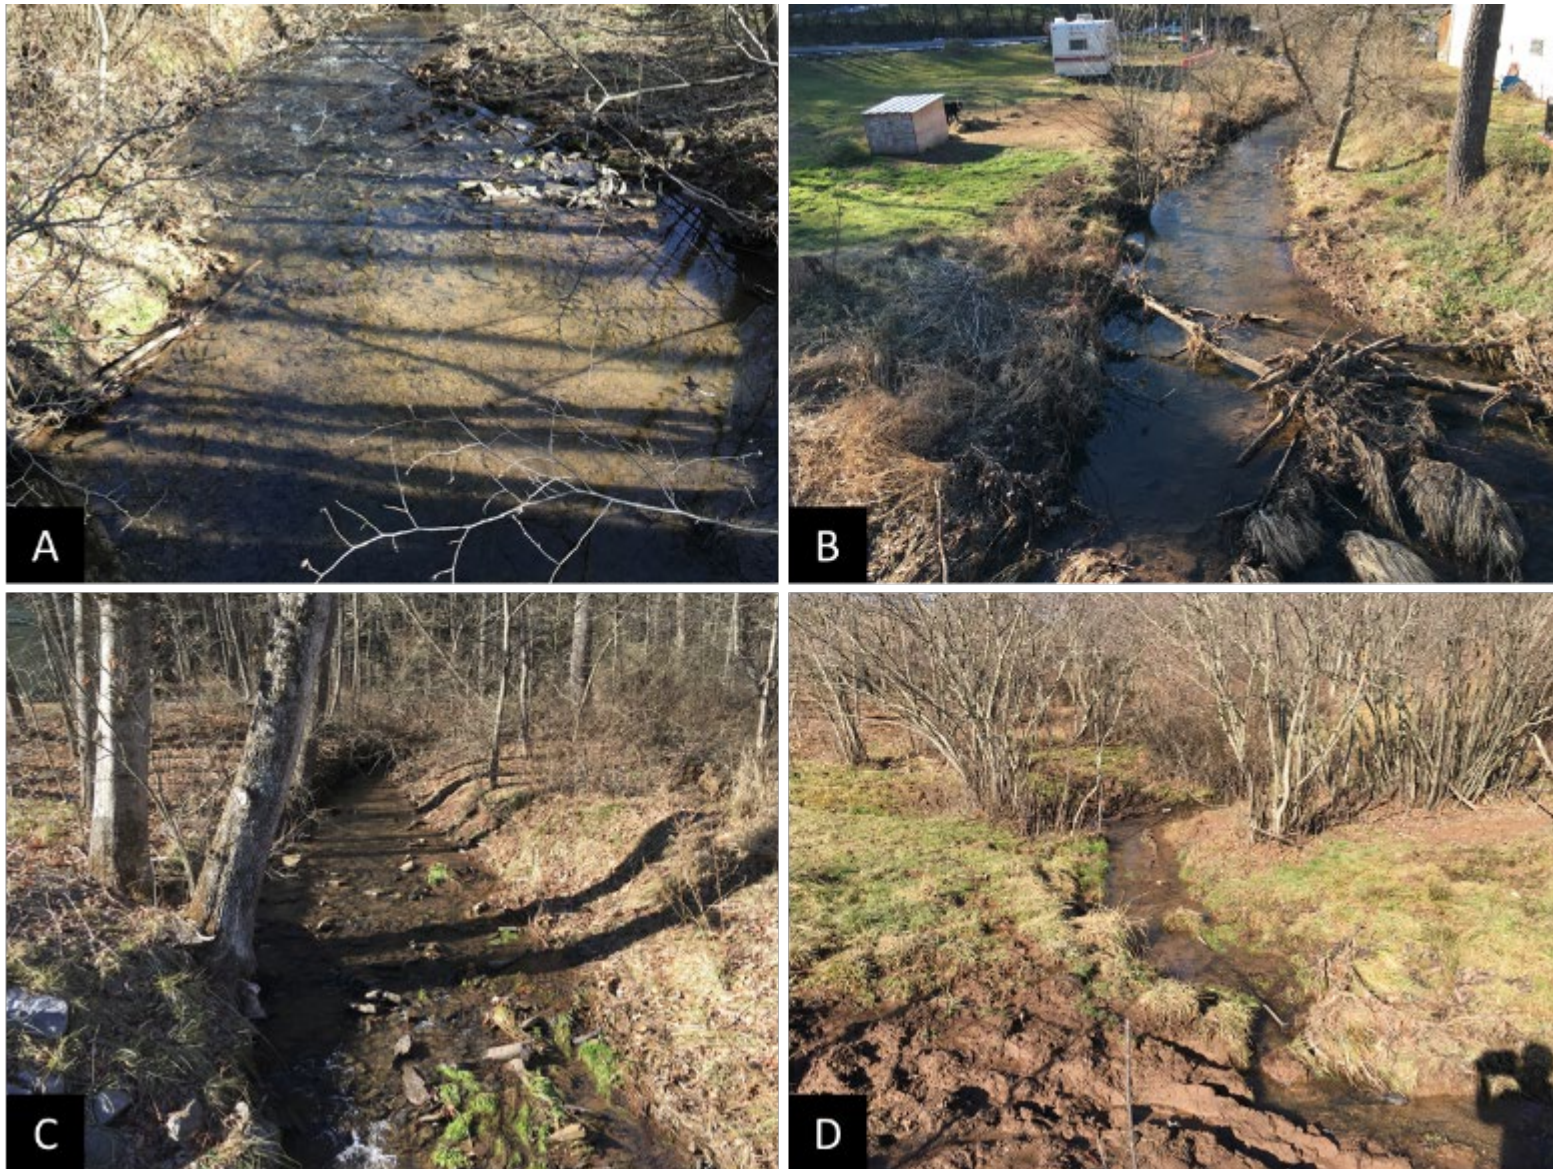
Figure 7. Substrate conditions within the Elders Branch reference subwatershed. Mainstem and tributary substrate was typically primarily rocky, as in A through C, though some apparently localized anthropogenic fines deposition could be observed as well (D).

In contrast, stream conditions within the attaining Elders Branch reference subwatershed appeared to be far better. Stream segments were typically rocky with fairly minor fine sediment deposition. In cases where fine sediment deposition was substantial, it appeared to be relatively localized (Figure 7). Obvious symptoms of eutrophication were not observed.

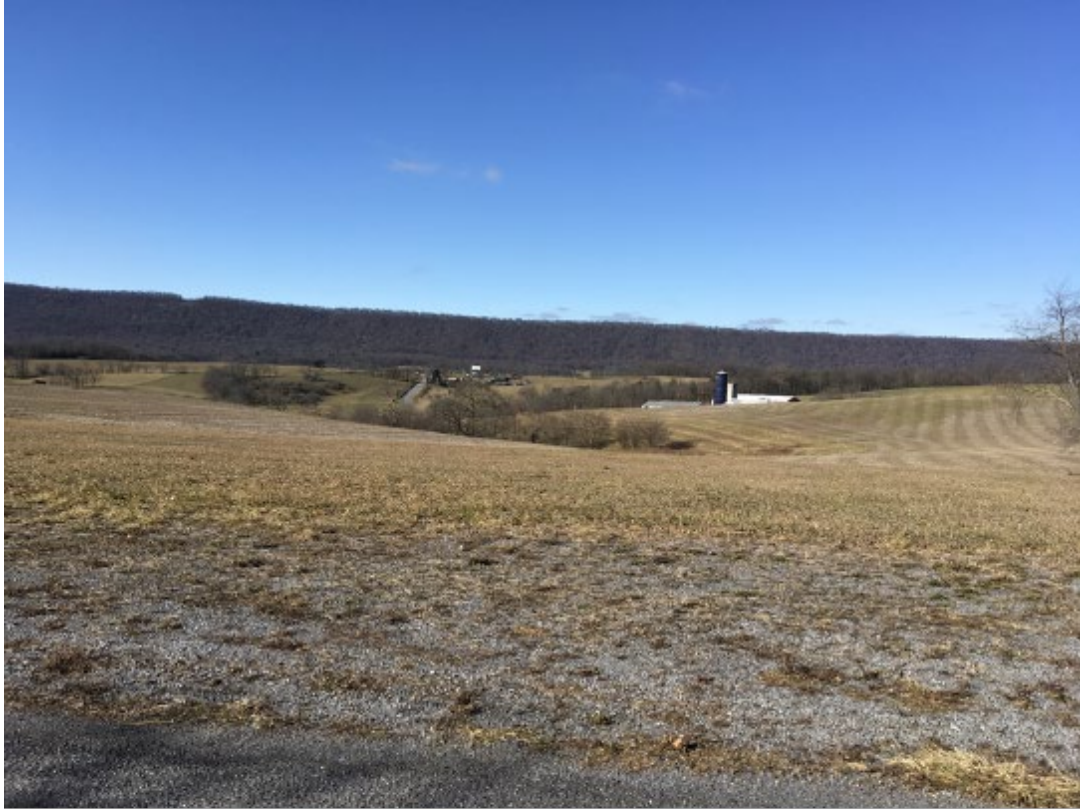
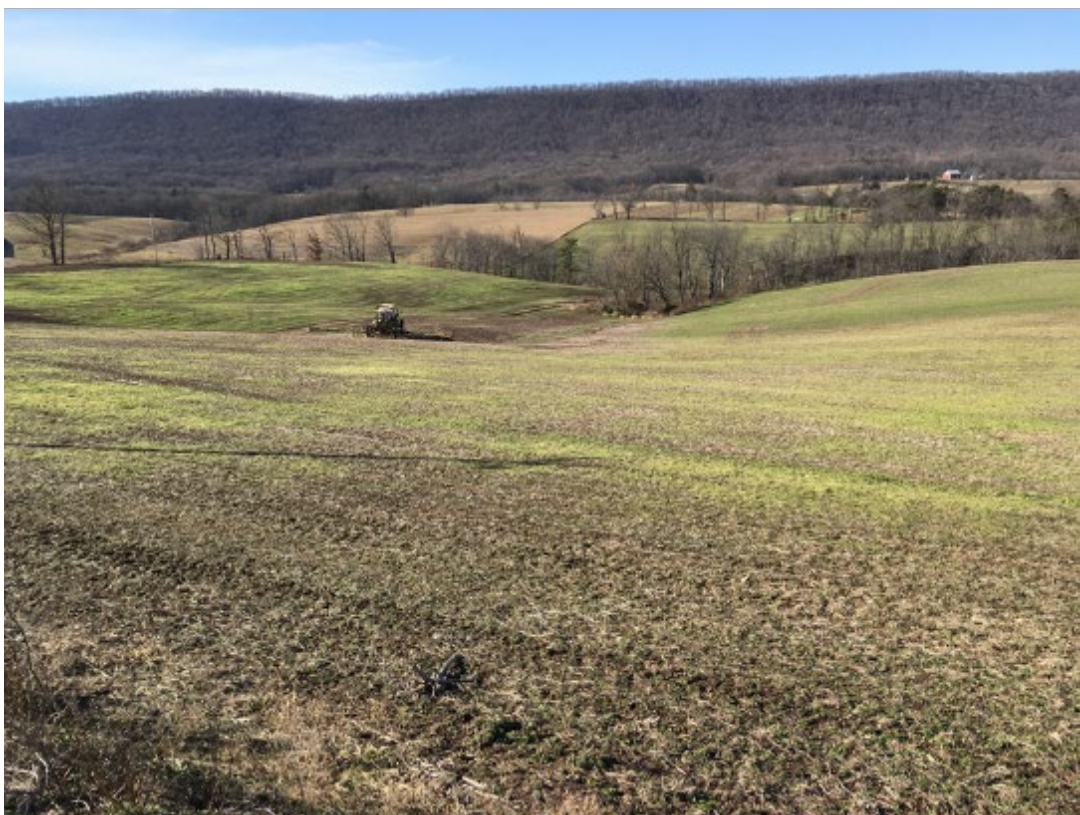
Figure 8. Landscapes within the Elders Branch Subwatershed. Like the Cove Run Watershed, the watershed had forested uplands and a valley dominated by rolling hills with agriculture.

Like the Cove Run Watershed, uplands within the Elders Branch Subwatershed were typically forested whereas valley areas were dominated by hilly agriculture (Figure 8). However, unlike the Cove Run Watershed, expansive forested riparian buffers were common (Figure 9). In addition, drainageway protection was observed in some (Figure 9), though not all (Figure 10) cases. While some problematic pasture lands were observed in the Elders Branch Subwatershed, the highly problematic areas appeared to be far less common and typically less severe (Figure 10). These factors, in addition to the fact that there were less overall croplands in the Elders Branch Subwatershed, may help explain why the Elders Branch was comparatively healthy relative to the Cove Run Watershed.

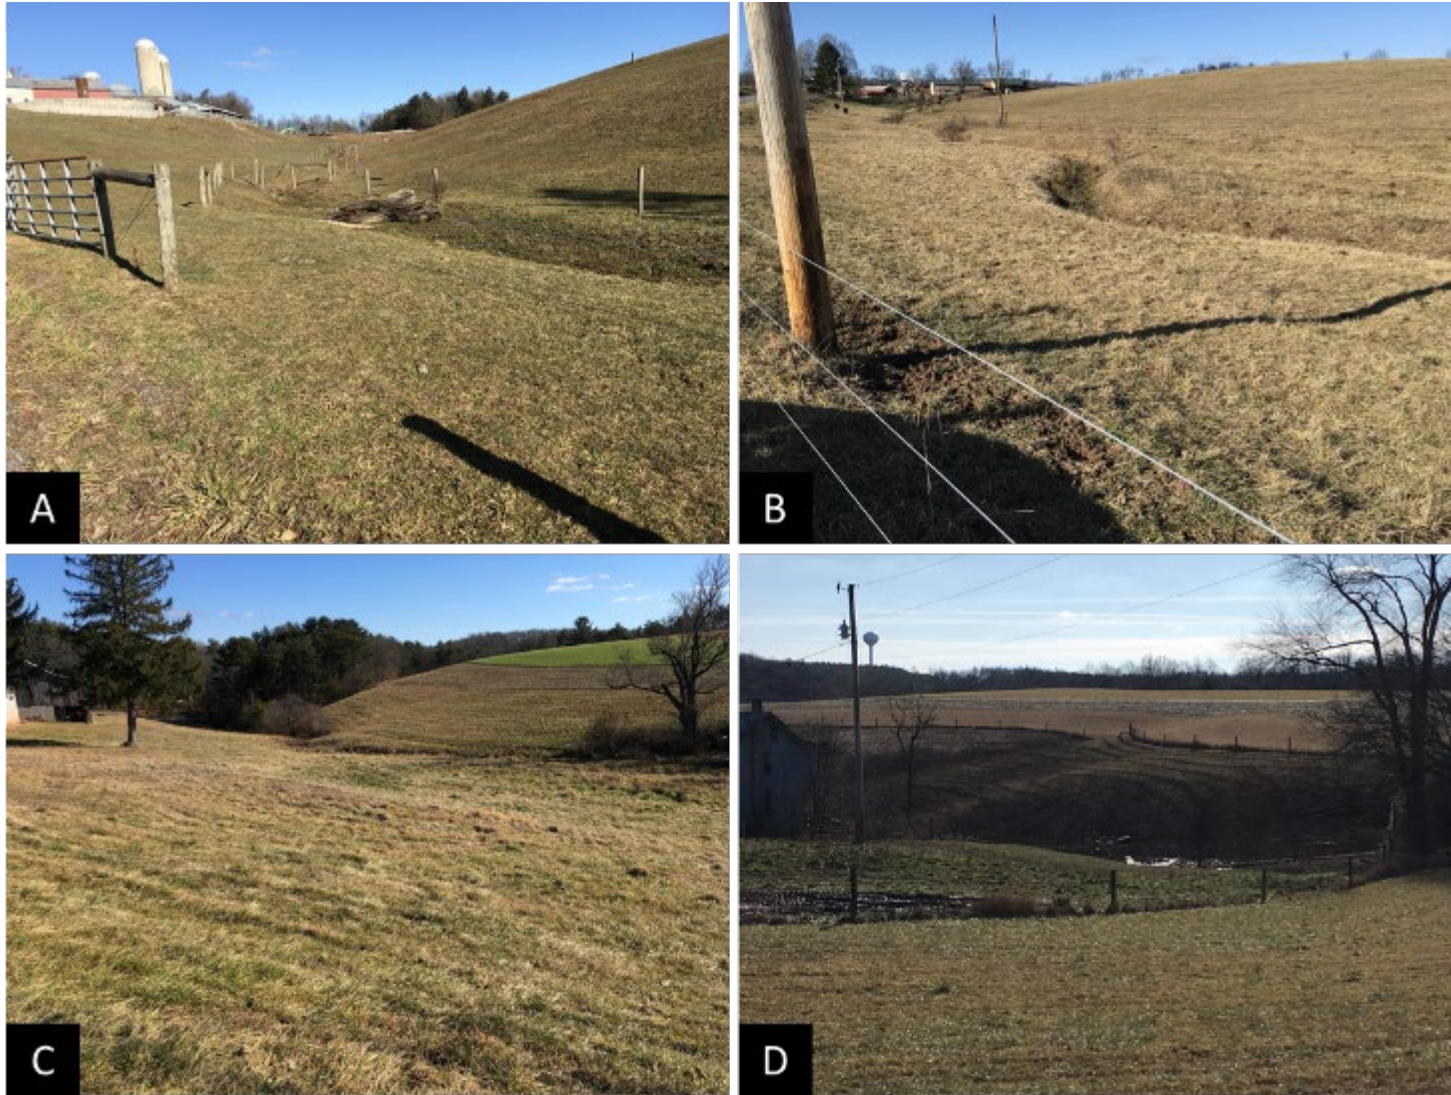
Figure 10. Practices within the Elders Branch Subwatershed that may exacerbate pollutant loading. Sections of drainageways and low order tributaries sometimes flowed through pastures and hay lands without adequate riparian buffers. However, with an occasional exception, as in D, heavy use pastures tended to be less problematic relative to those observed in the Cove Run Watershed.
