Little Trough Creek Sediment TMDL

Huntingdon County, Pennsylvania

Submission for EPA approval, April 27, 2021

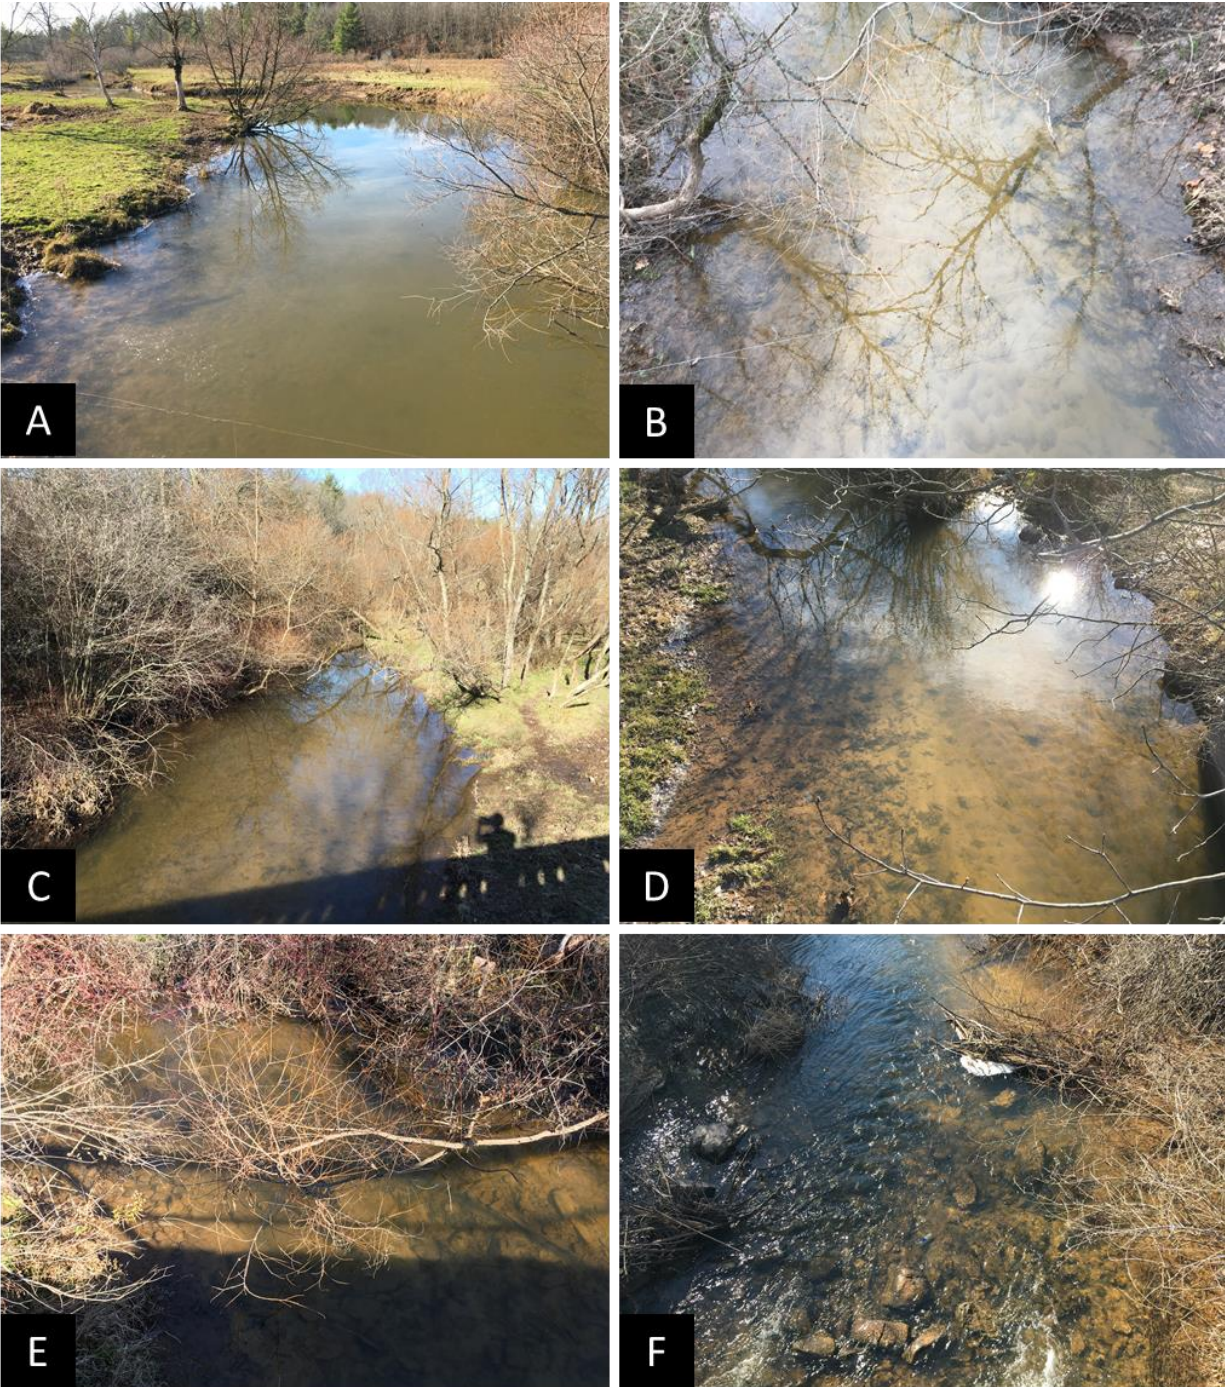
Figure 4. Photographs of stream substrate within the lower and middle reaches (Calvin area and downstream) of the Little Trough Creek mainstem. The upper row (A and B) shows the downstream most reaches while the lower photos (E and F) show more upstream reaches near Calvin. In most cases, the streambed was dominated by fine sediment. However, this was in part due to natural sandy conditions. Finer fractions and high turbidity in some cases suggested agricultural pollution as well. Some rockiness was observed in higher gradient areas (E and F).

Site observations in the Little Trough Creek Subwatershed indicated that the streambed was dominated by fine sediment, in part due to agricultural pollution but also due to natural sandy conditions (Figures 4 and 5). Indeed, some sites, particularly in the lower mainstem but also some tributaries, had high turbidity and deposits of finer fractions often associated with agriculture. However, the presence of sandy substrate in headwater areas where substantial agricultural pollution was not suspected along with sandstone bedrock suggested that sandy substrate was natural for this watershed, especially in the very low gradient reaches.

It is hypothesized that the noted impairments may be attributable to poor agricultural practices in a watershed that was especially vulnerable to sediment deposition. While there were substantial agricultural lands in the valley (Figure 6), the overall amount of agriculture in the watershed was modest (Table 5) and dominated by hay/pasture lands (Table B1) which tend to be lesser sediment sources than croplands. However, areas were observed where: pasture lands were trampled to the point of creating bare patches, cattle had direct access to the stream resulting in enhanced bank erosion and lack of riparian buffering, and barnyard areas drained towards streams (Figure 7). It should also be noted though that natural conditions, including an abundance of forest and wetlands (Figure 8) as well as good management practices such as allowances for riparian buffers and the use of cattle exclusion fencing (Figure 9) likely protected water quality in this watershed. Overall, conditions within the watershed did not appear to be particularly bad and perhaps would not have even resulted in impairments in many other watersheds. However, the middle and lower mainstem of the Little Trough Creek Subwatershed was so low gradient (Figures 4 and 10) that sediment deposition rather than export may be favored.

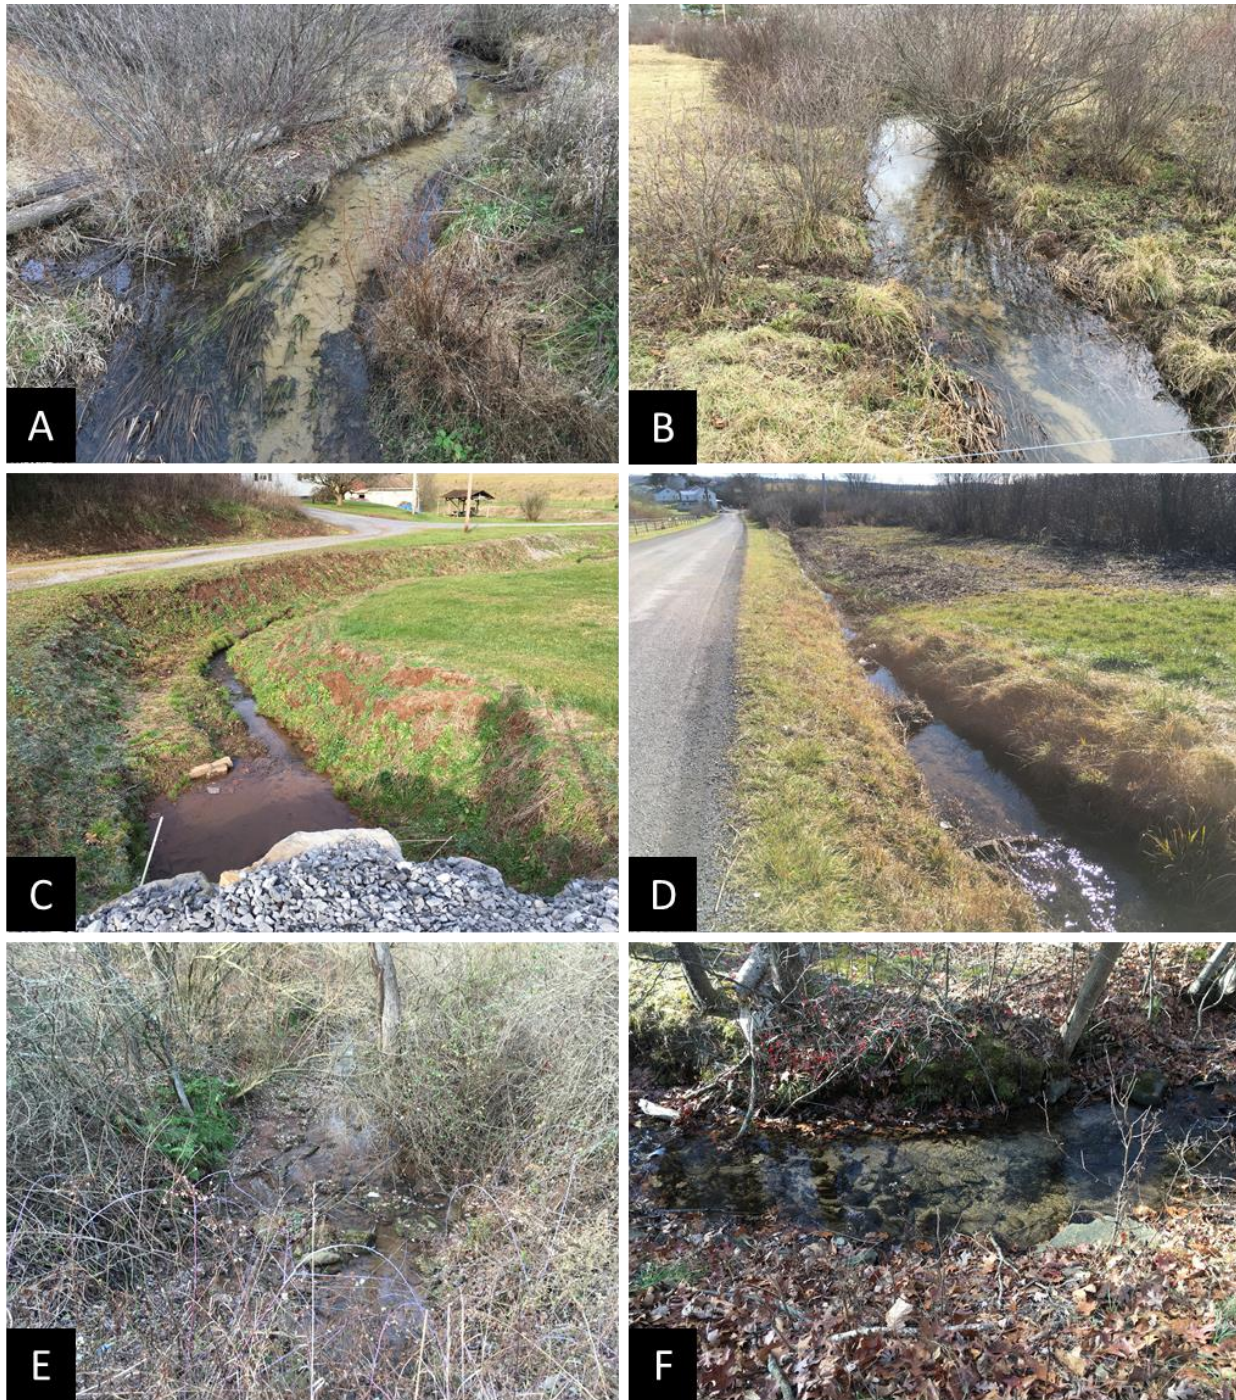
Figure 5. Photographs of substrate conditions in the upper mainstem (upstream of Colfax) and tributaries in the Little Trough Creek Subwatershed. The upper mainstem occurring above the most intensive agricultural area was very sandy (photos A and B) which, along with the presence of sandstone bedrock, suggests this is a natural condition. Some tributaries had deposits of finer fractions suggesting anthropogenic pollution however (C and D). Photographs E and F show that other tributaries had rockier, healthier appearing substrate, though in many cases with natural sand deposits (F).

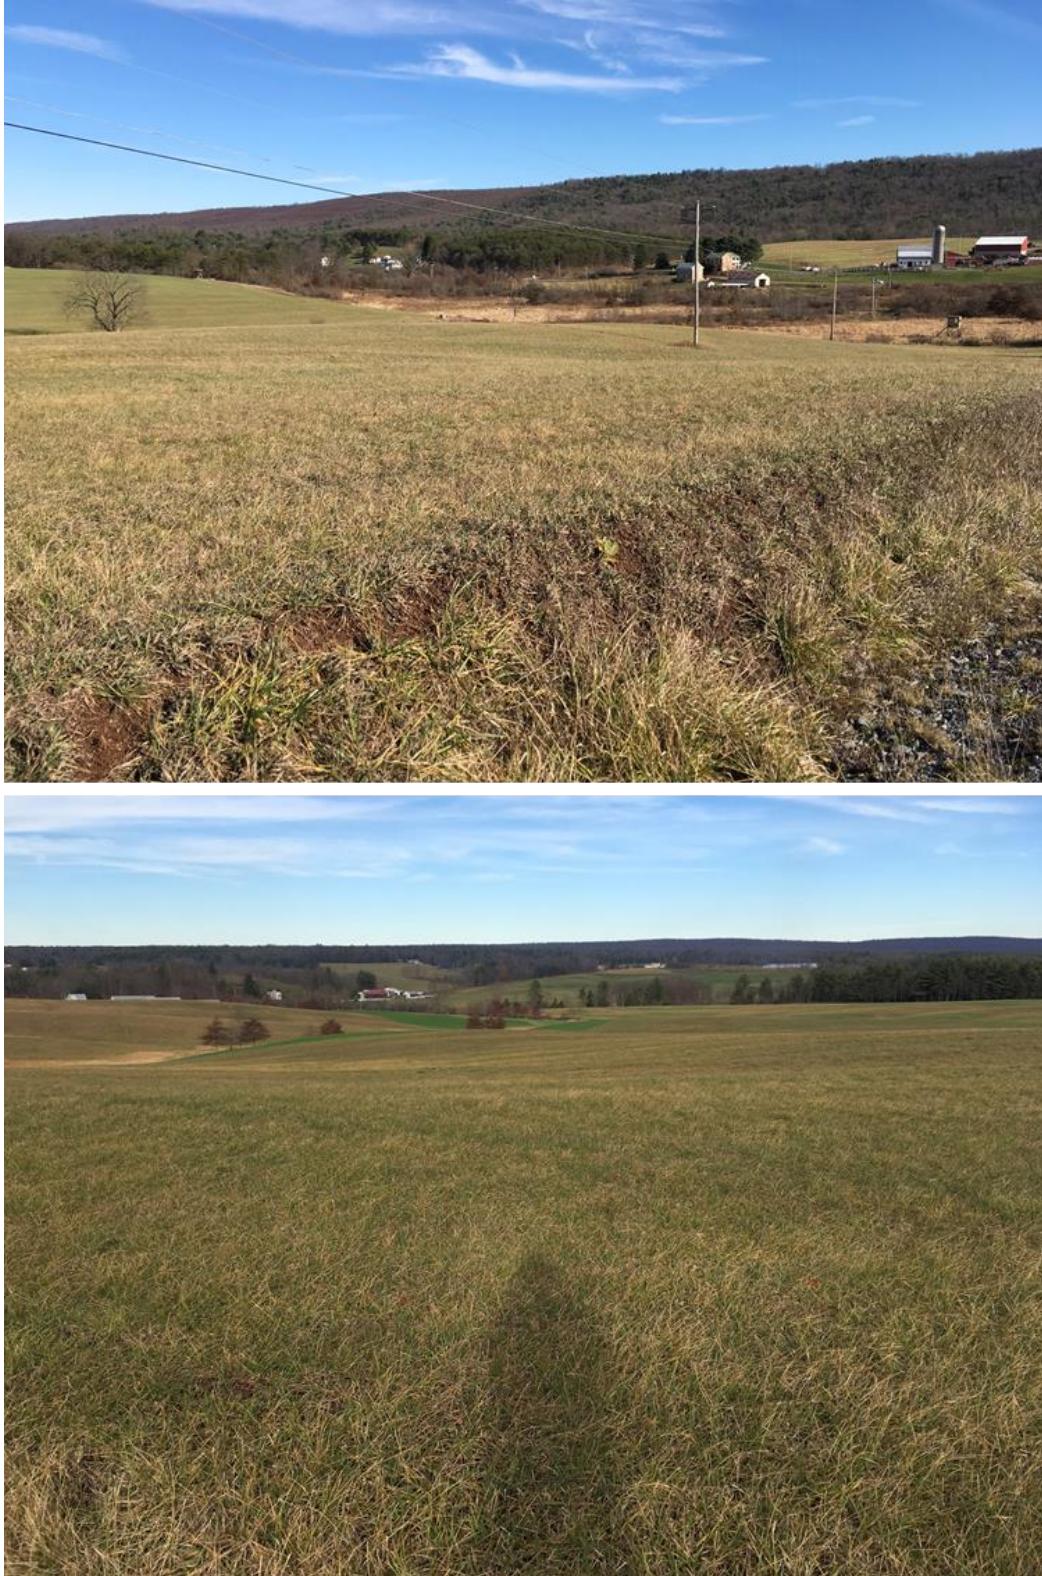
Figure 6. Example landscapes within the Little Trough Creek Subwatershed. Note the dominance of hay and pasture lands within the valleys and forested uplands along the margins of the watershed. Shrubby wetlands commonly occurred along valley stream segments.

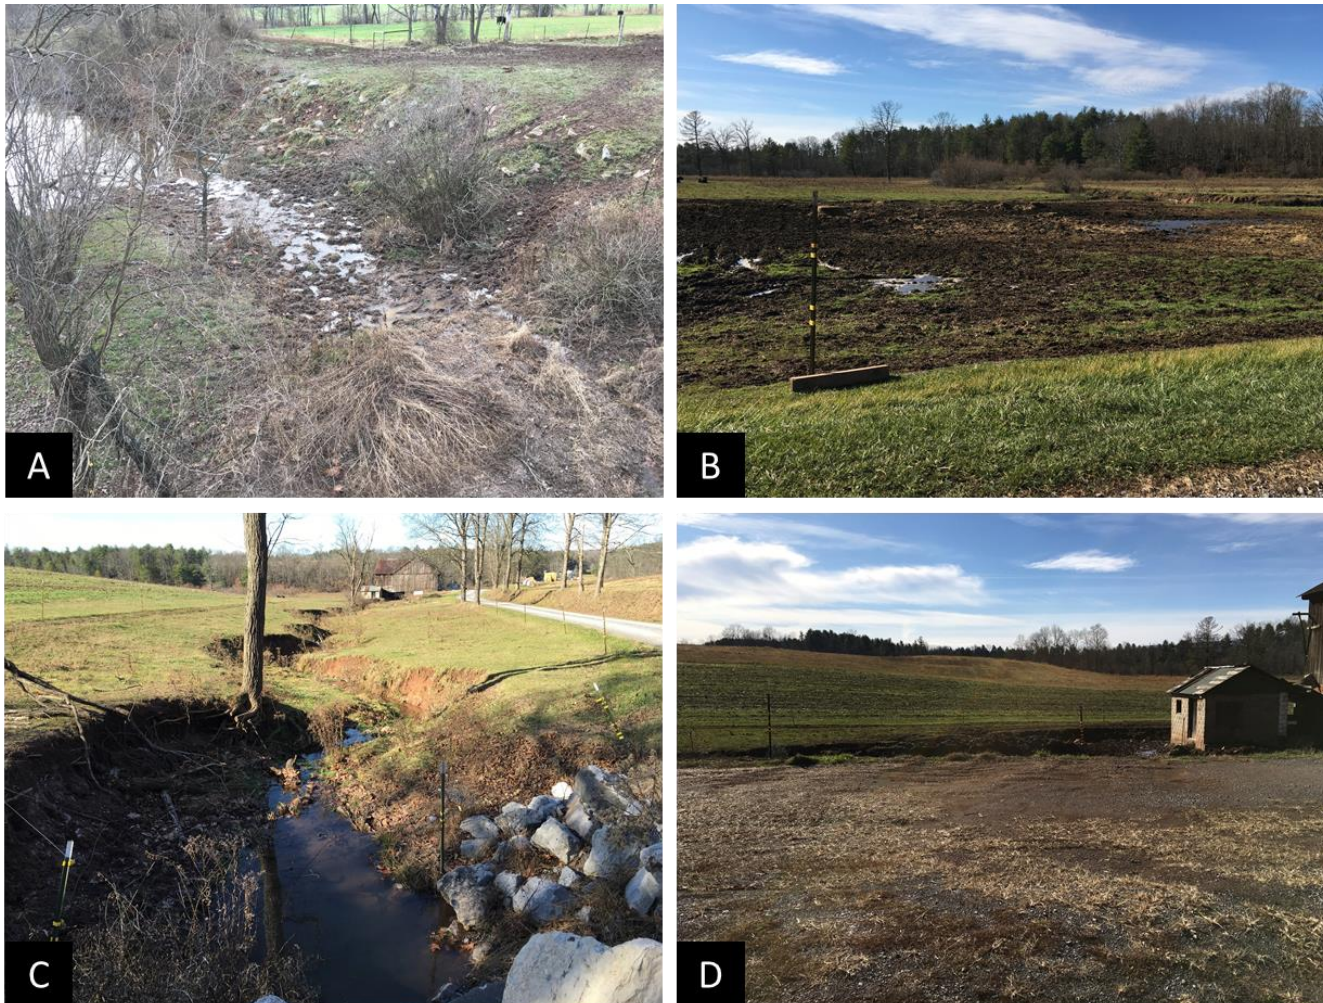
Figure 7. In addition to the overall amount of agriculture, the most obvious reasons for impairment in the Little Trough Creek Subwatershed were cattle access to the stream and lack of riparian buffers. This resulted in bare areas and eroding banks, which leads to increased sediment and nutrient loading. Croplands, which appear to be in the background in photograph D comprised a small percentage of the overall land area in the watershed. However, they can be particularly important sediment sources when unbuffered and on slopes as in D.

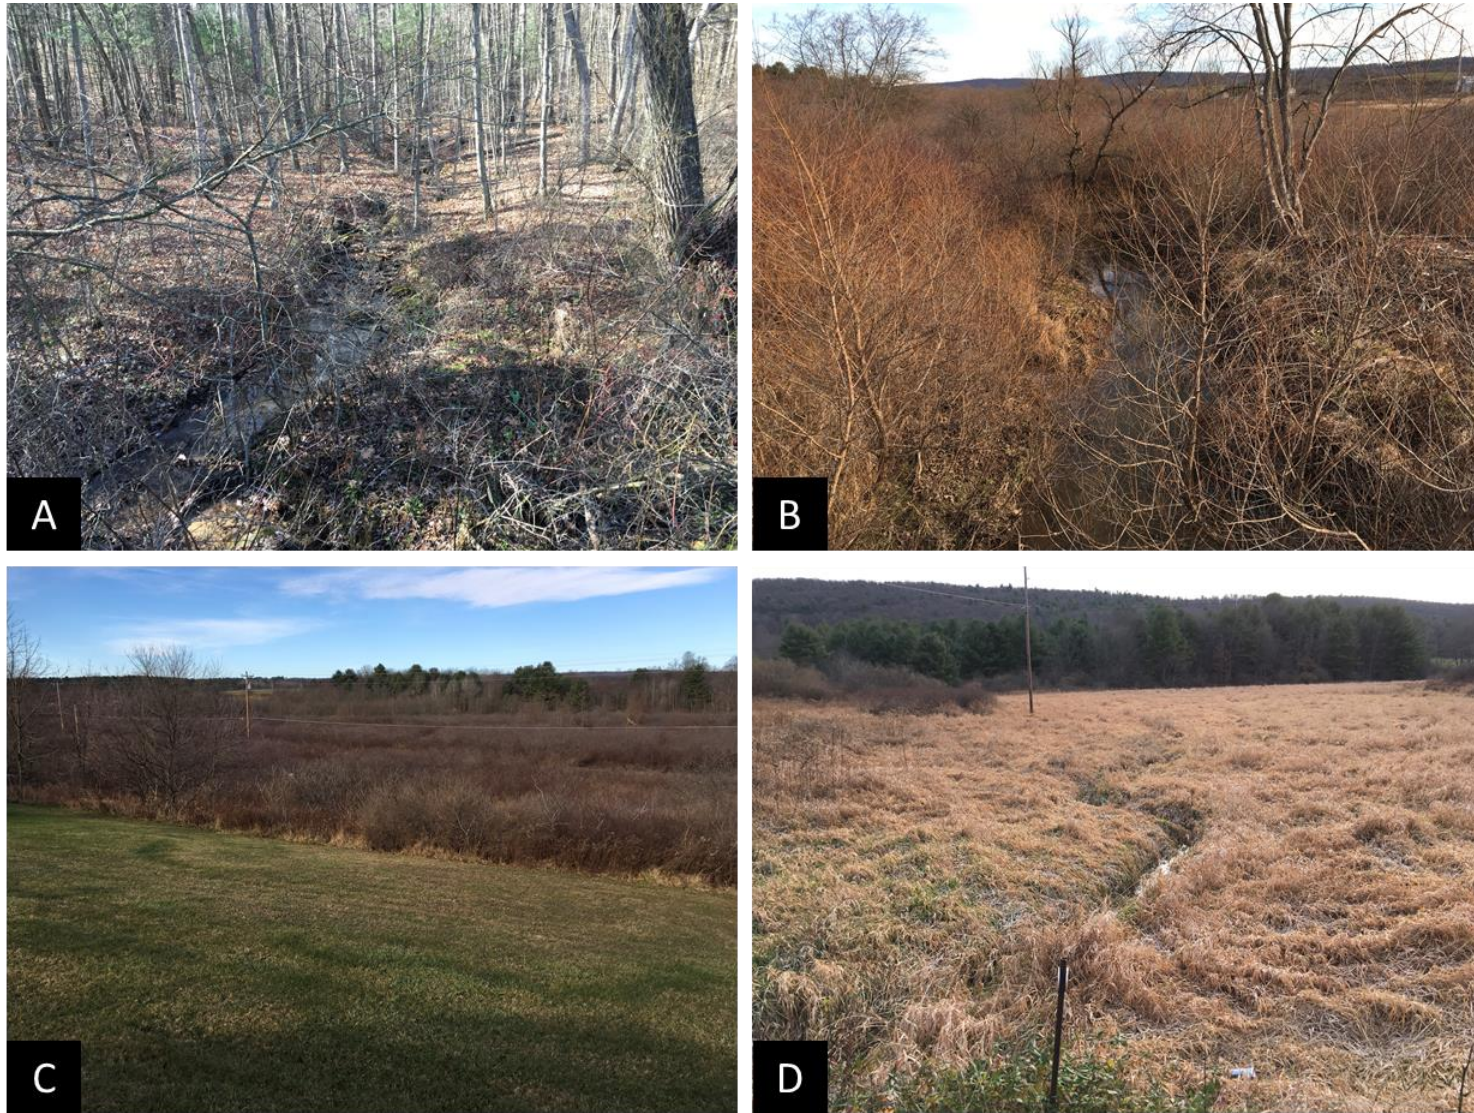
Figure 8. Natural factors protecting water quality in the Little Trough Creek Subwatershed. Many upland tributaries were forested (A) and wetlands were common along much of the mainstem (B and C) and some tributaries (D).

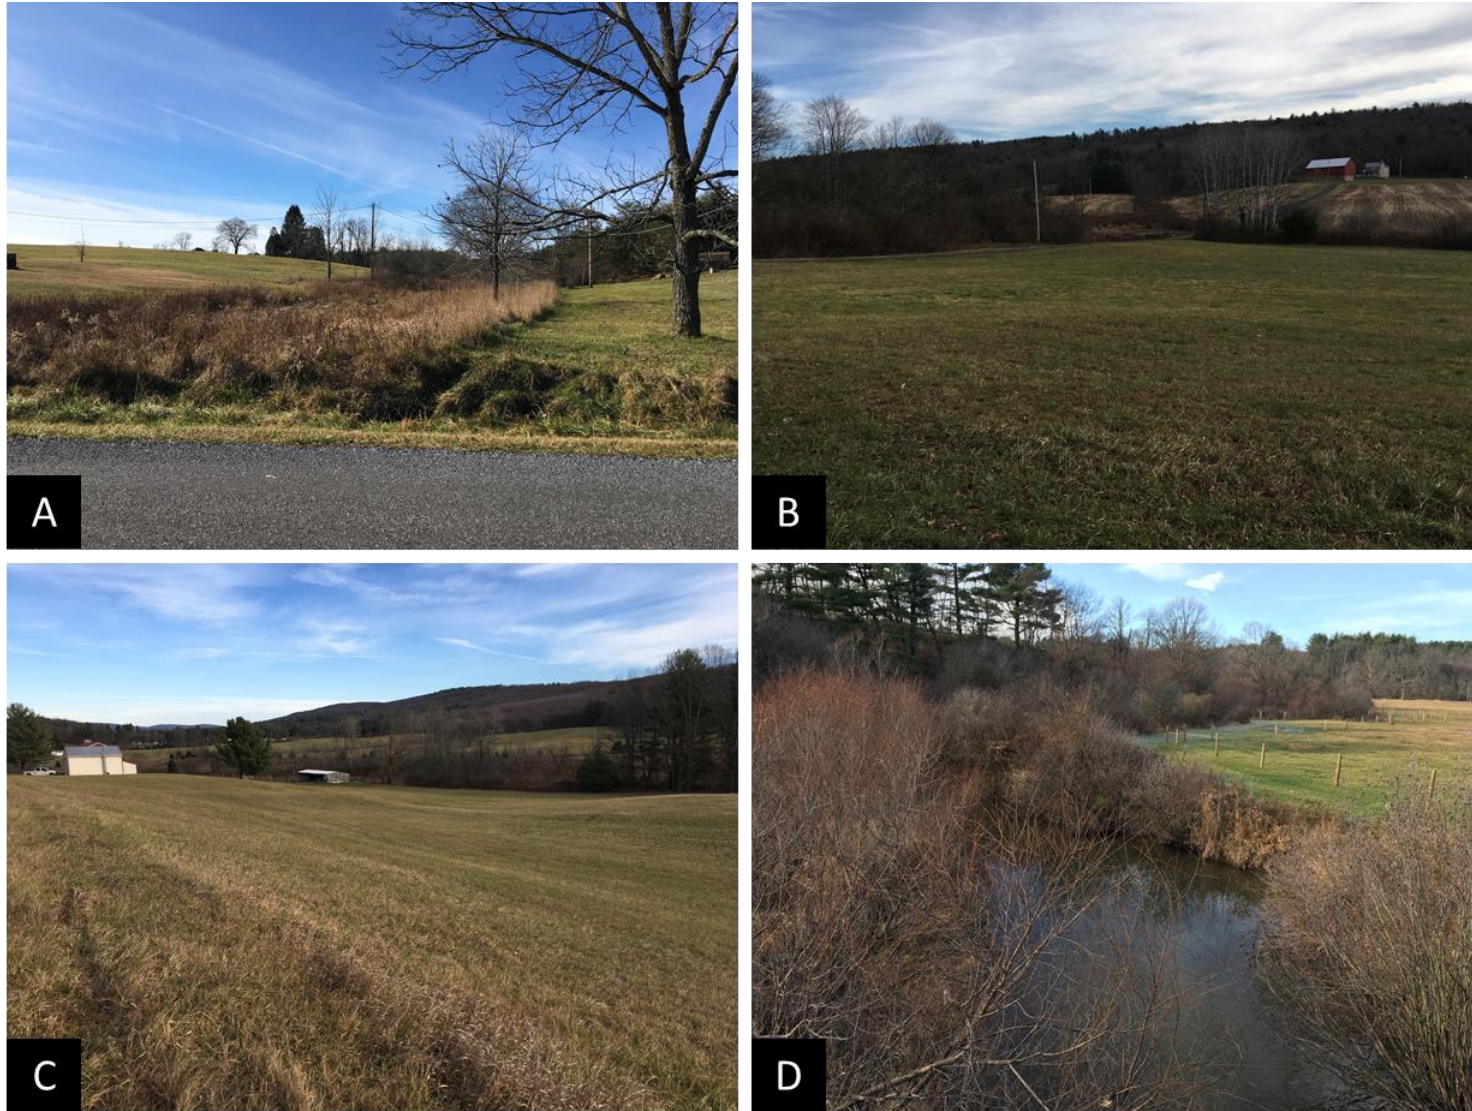
Figure 9. Anthropogenic factors protecting the Little Trough Creek Subwatershed. Some stream segments had riparian buffers (A through C) and/or livestock exclusion fencing (D).

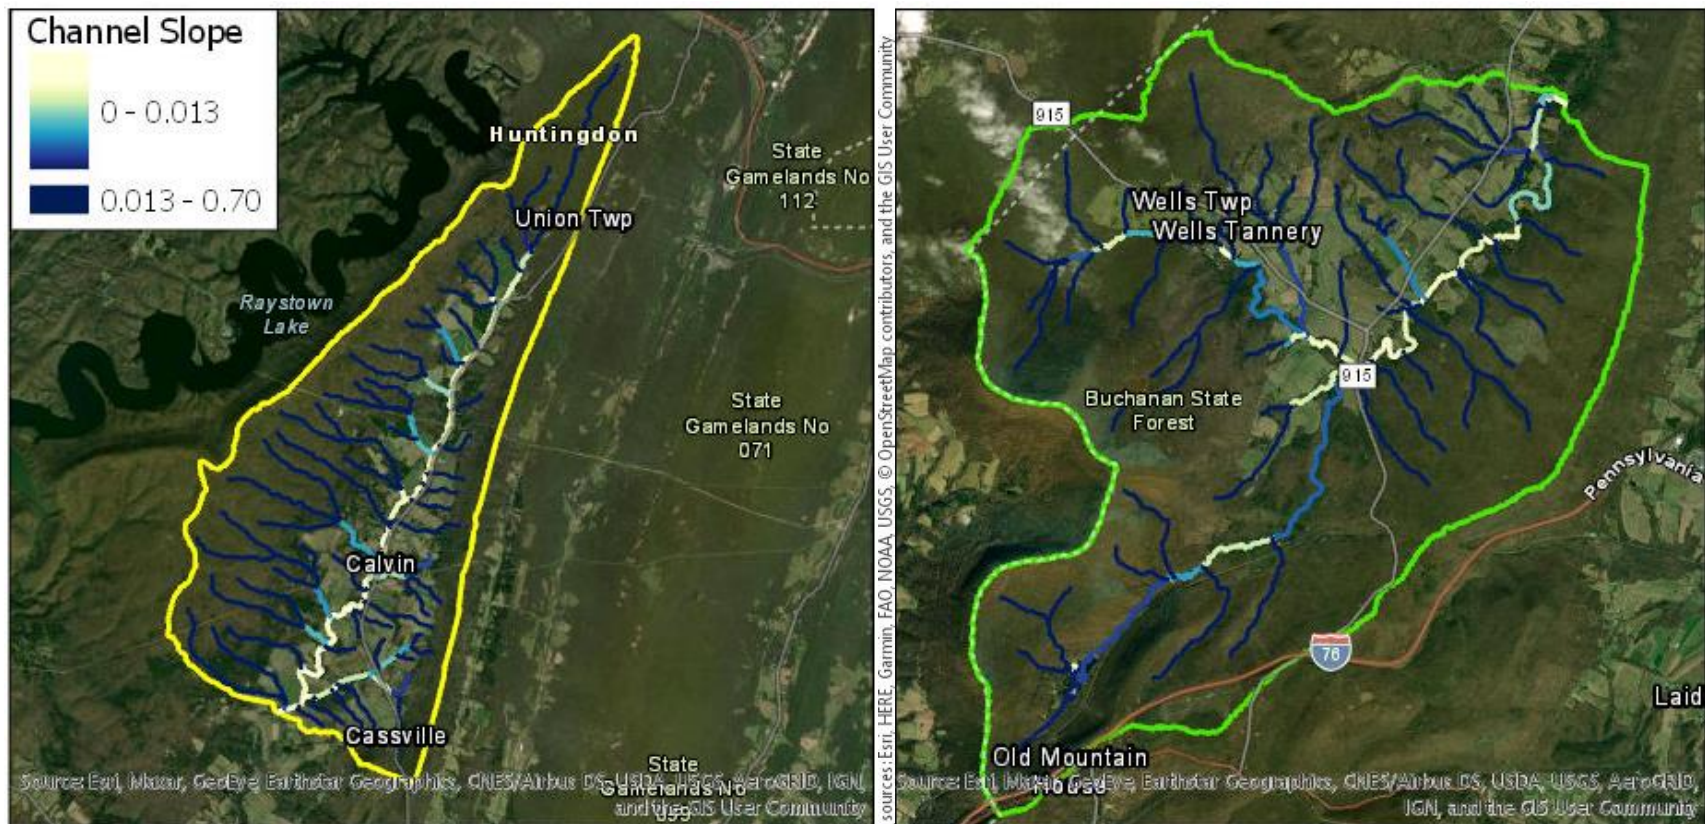
Figure 10. Map of channel slopes in the Little Trough Creek (left) and Sideling Hill Creek (right) watersheds. Slopes were reported as drop:length per USGS FACET output (see Hopkins et al. 2020)

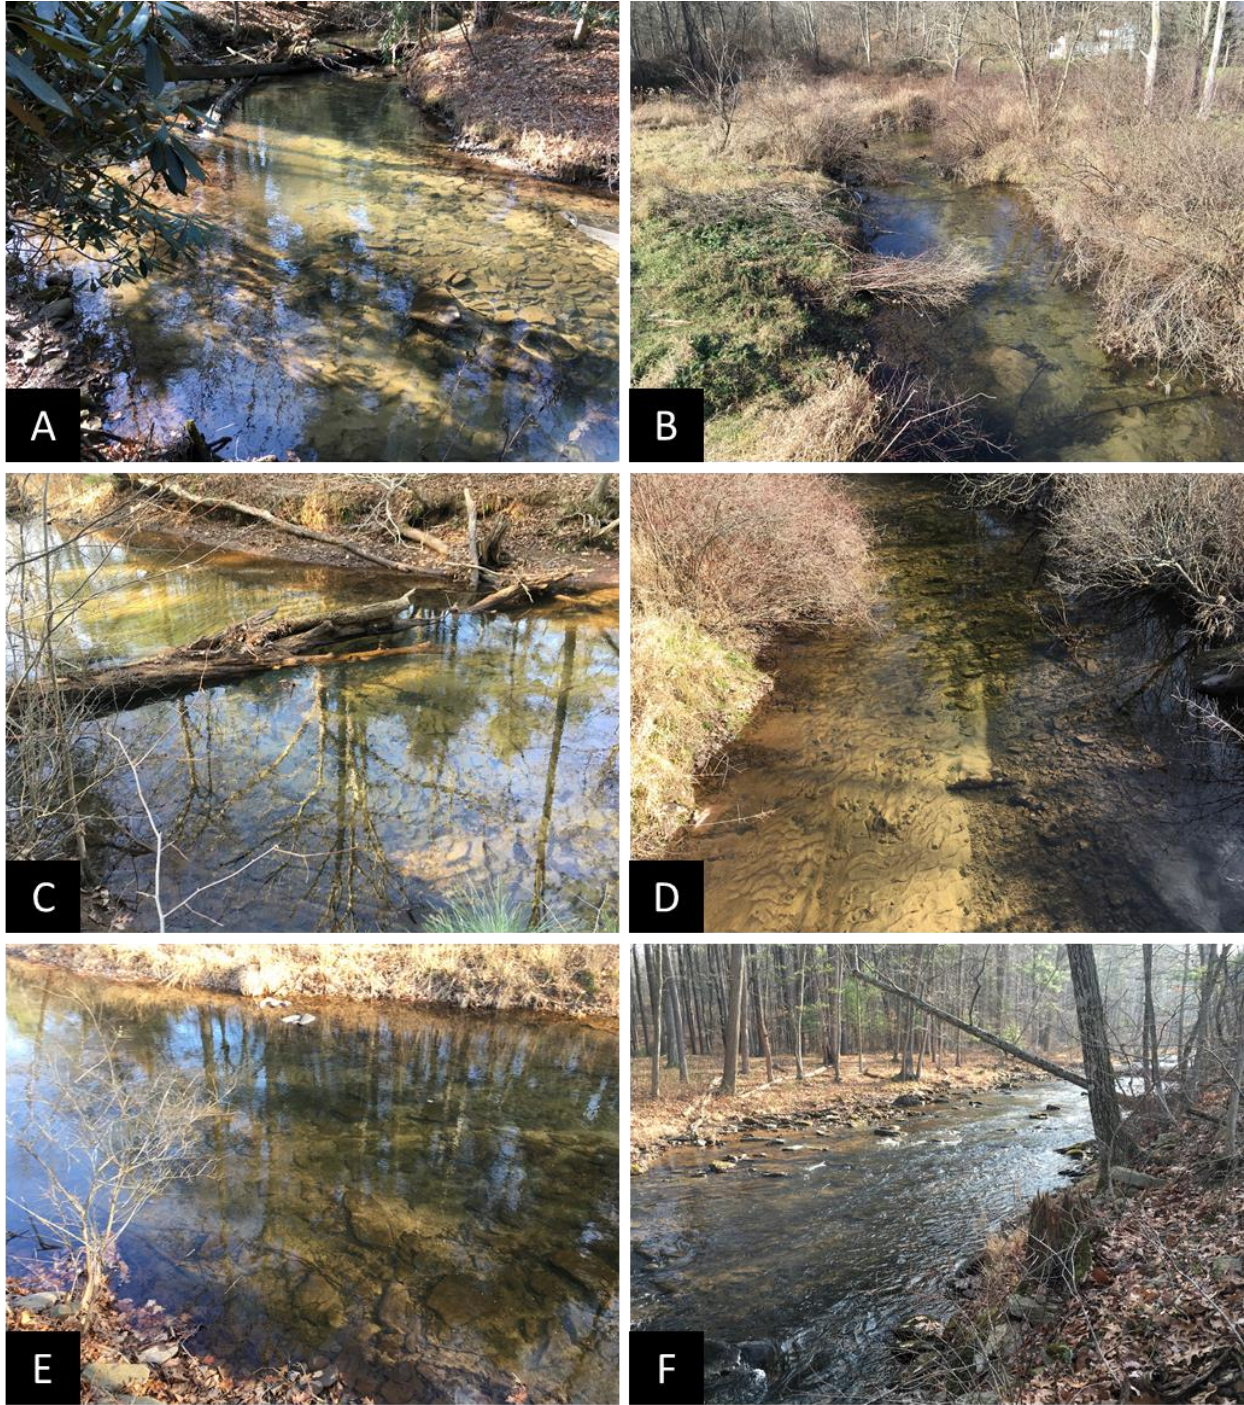
Figure 11. Photographs of larger mainstem reaches within the Sideling Hill Creek Subwatershed. Note the abundance of sand, especially in lower gradient reaches of the watershed's mid section (B-D). The downstream most observed reach however was primarily rocky and higher gradient (E and F). Note the exceptional water clarity throughout.

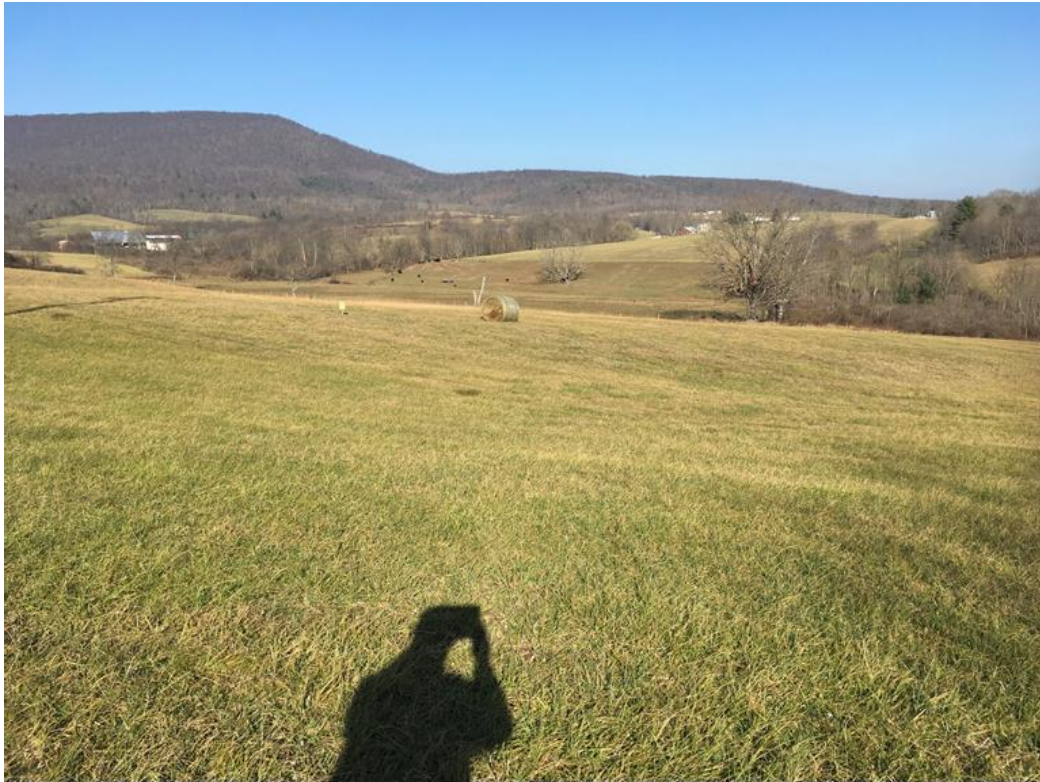
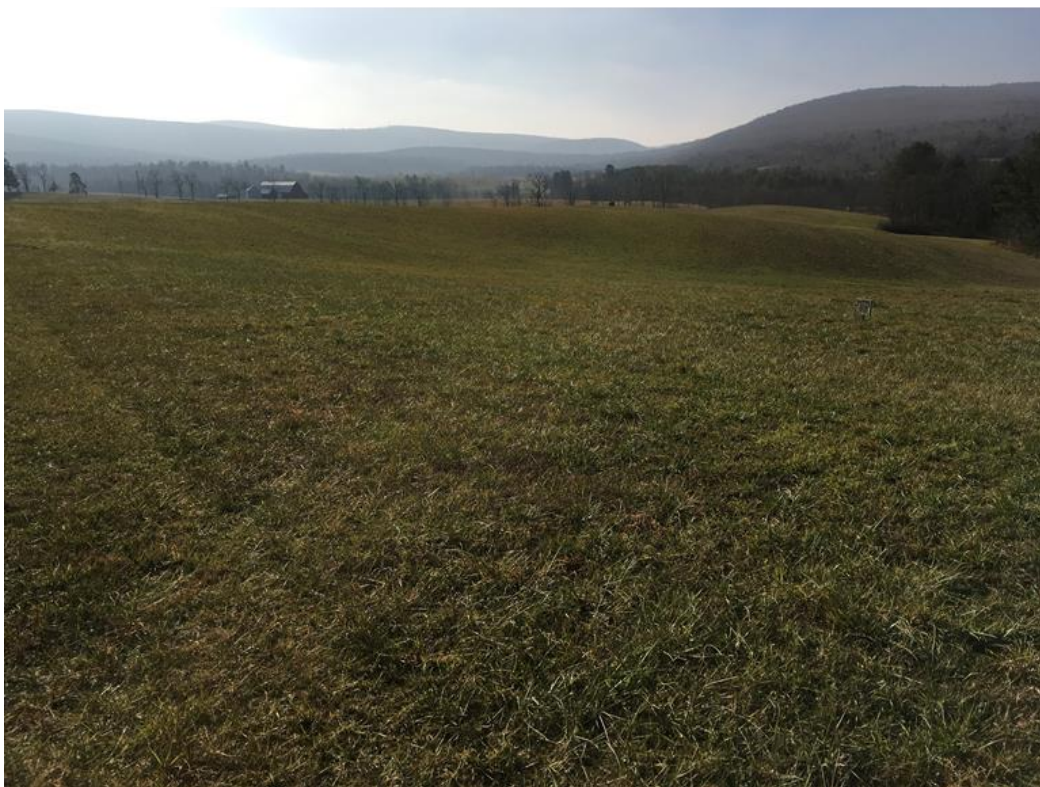
Figure 13. Photographs of landscapes within the Sideling Hill Creek Subwatershed. Note the forested mountainous margins of the watershed and valley area dominated by hay/pasture lands.

Like the Little Trough Creek Subwatershed, uplands within the Sideling Hill Creek Subwatershed were primarily forested whereas valleys had substantial hay and pasture lands but little croplands (Figure 13). The overall amount of agriculture within the Sideling Hill Creek Subwatershed was substantially less however, about half as what occurred within the Little Trough Creek Subwatershed. In addition to its lesser amount of agriculture, conditions that promoted stream health within the Sideling Hill Creek Subwatershed included that so many of its stream segments occurred within forested areas or had forested buffers (Figures 3 and 14). Other practices such as the use of herbaceous buffers and cattle exclusion fencing were observed as well (Figure 14). It should also be noted though that there were also areas where conditions clearly could have been improved in the Sideling Hill Creek Subwatershed, particularly through the use of riparian buffers.

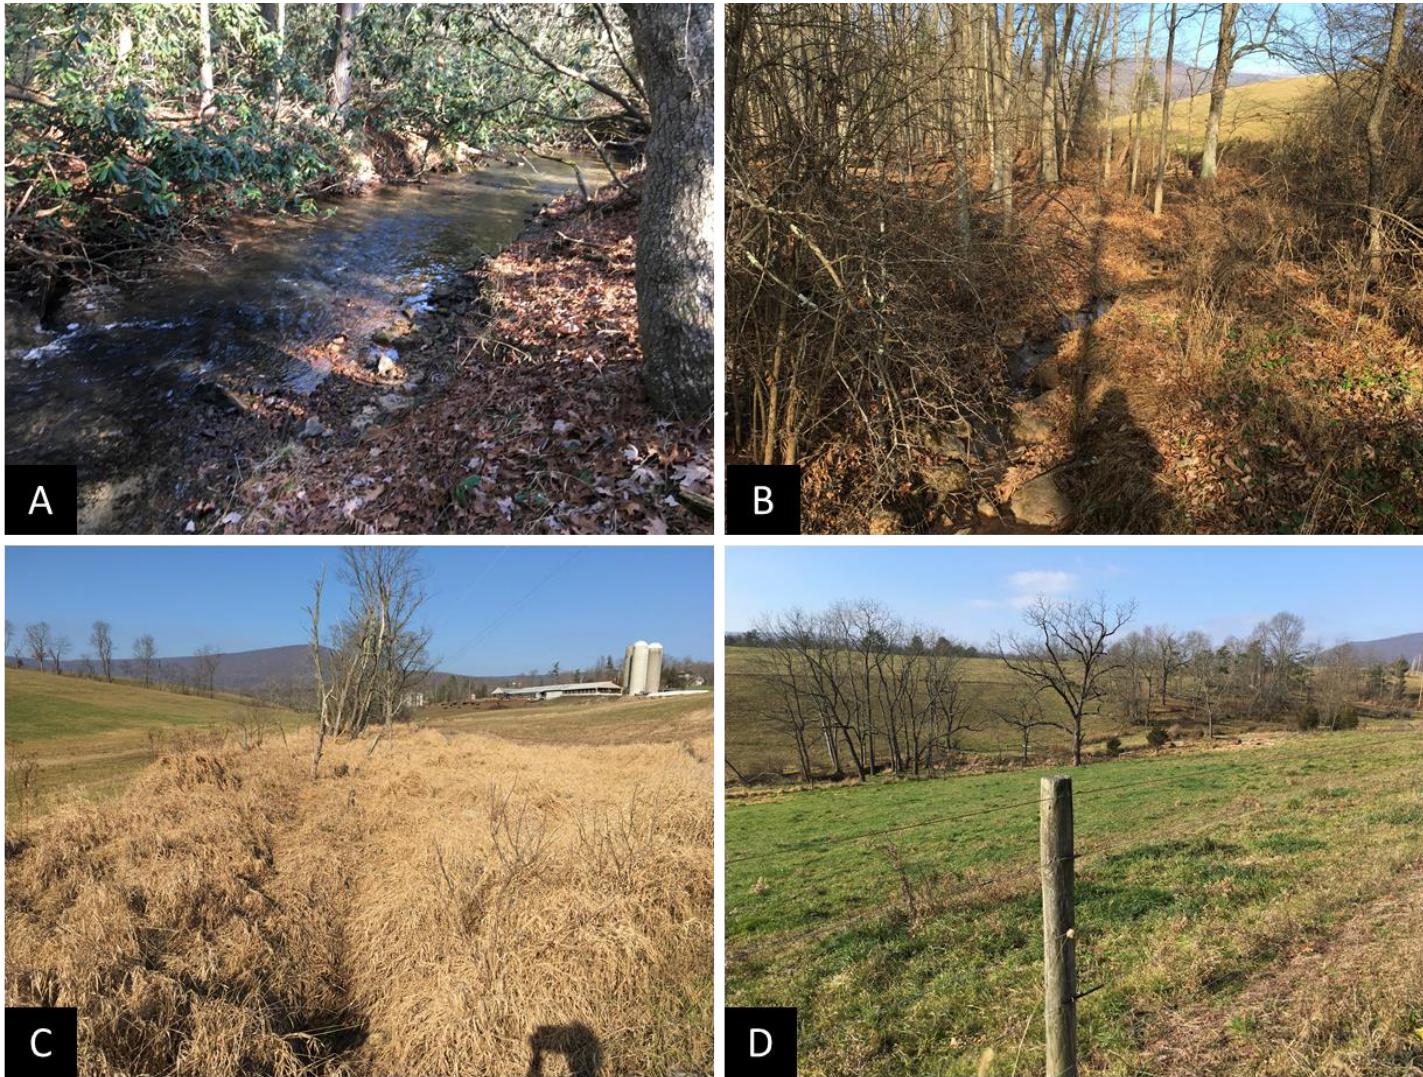
Figure 14. Conditions that may be protective of water quality within the Sideling Hill Creek Subwatershed. A major factor of the watershed's high quality was that so much of the land area was dominated by forest (A). Protective agricultural practices were also observed however, including forested and herbaceous riparian buffers (B and C), and livestock exclusion fencing along the stream (D).
