# **Pennsylvania Stormwater Best Management Practices Manual**

DRAFT - JANUARY 2005

## **Section 10 Case Studies: Innovative Stormwater Management Approaches and Practices**

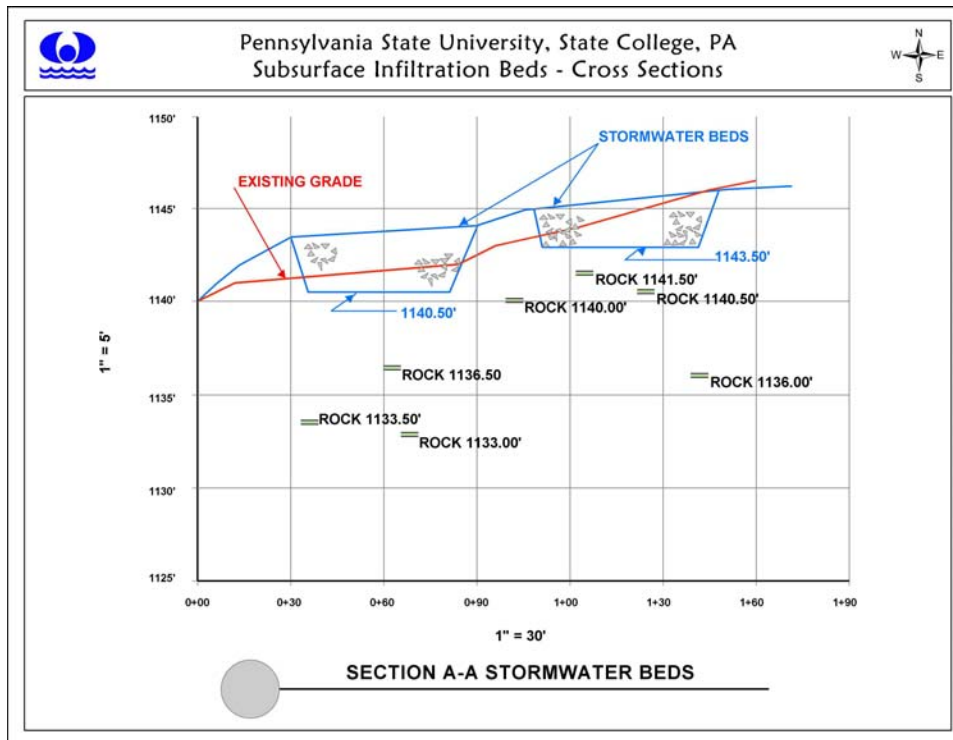
Figure 10-3 Cross-section view showing bedrock pinnacles, existing grade, and proposed stormwater infiltration beds with elevations

Using these profiles, the parking bays and infiltration beds were “fit” into the hillside, stepping down the hillside with two parking bays, and adjusting the bottoms of the infiltration beds to “step down” as well. This is shown in Figure 10-3.

Development of cross sections can be an extremely useful element in design of infiltration systems on carbonate rock. Because the beds must be carefully set with adequate soil mantle, the cross sections provide the design engineer with the information necessary for the layout. Additionally, cross sections provide the Contractor with the necessary information to build the system. In the same manner that profiles are required for utility pipe design (i.e., water, wastewater, and stormwater pipes), profiles are an important component of design of infiltration BMPs in carbonate rock. Finally, and most importantly, it was recognized at the Visitor Center that any attempt to convey stormwater from one portion of the site to another would result in stormwater pipes that would be placed in the bedrock. Given the pinnacled nature of the site, it would be inevitable that any length of pipe would be forced to traverse bedrock. To avoid this situation, stormwater is managed as close to the source as possible and a variety of measures are incorporated:

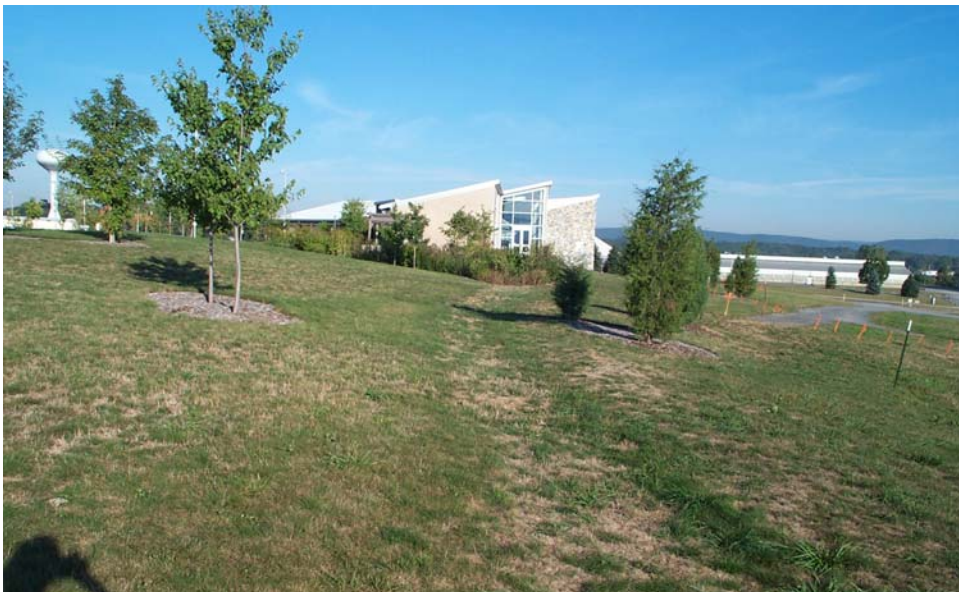
*Figure 10-4 Infiltration trench located on contour, State College, Centre County*

The **Infiltration Trench** (Figure 10-4) intercepts a portion of the entrance road runoff. To compensate for the remainder a vegetated subsurface **Infiltration Bed** (Figure 10-5) was located immediately adjacent to an existing, uncontrolled parking lot.

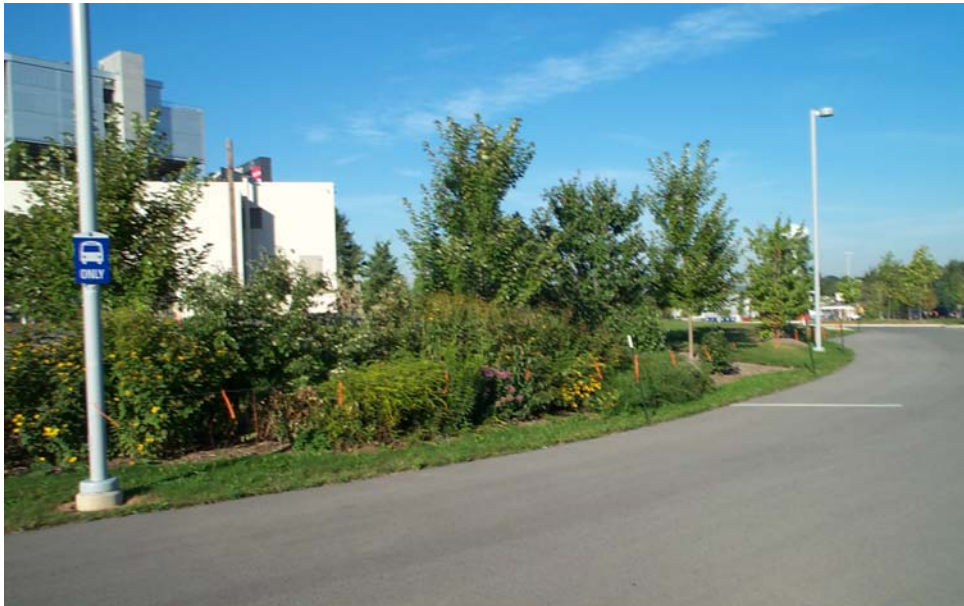
*Figure 10-5 Vegetated infiltration bed, State College, Centre County*

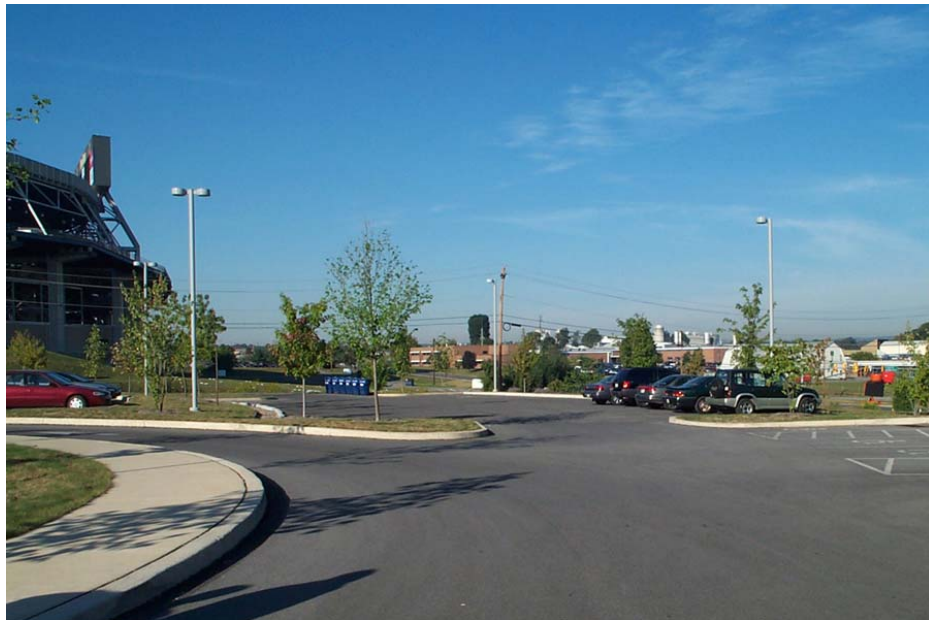
*Figure 10-6 Porous asphalt parking lot, State College, Centre County*

The runoff from the western portion of the building is conveyed to the parking lot immediately adjacent to the building where the soil mantle is suitable and the top of bedrock was much deeper (Figure 10-6). In several key locations where stormwater management was needed, small **Rain Gardens** (Figure 10-7), designed to infiltrate, were incorporated to avoid installing stormwater pipes.

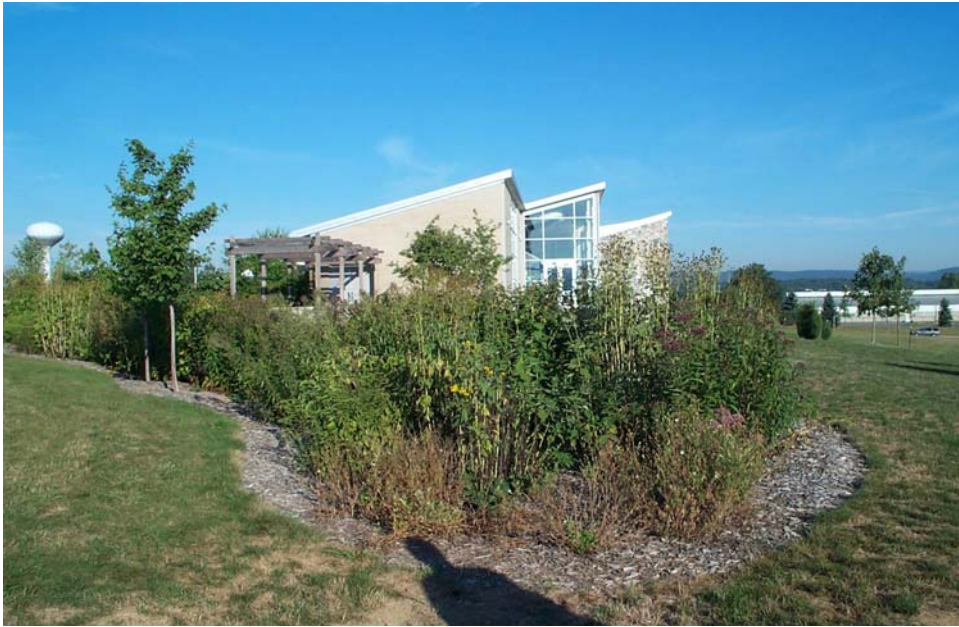
*Figure 10-7 Rain Garden, State College, Centre County*

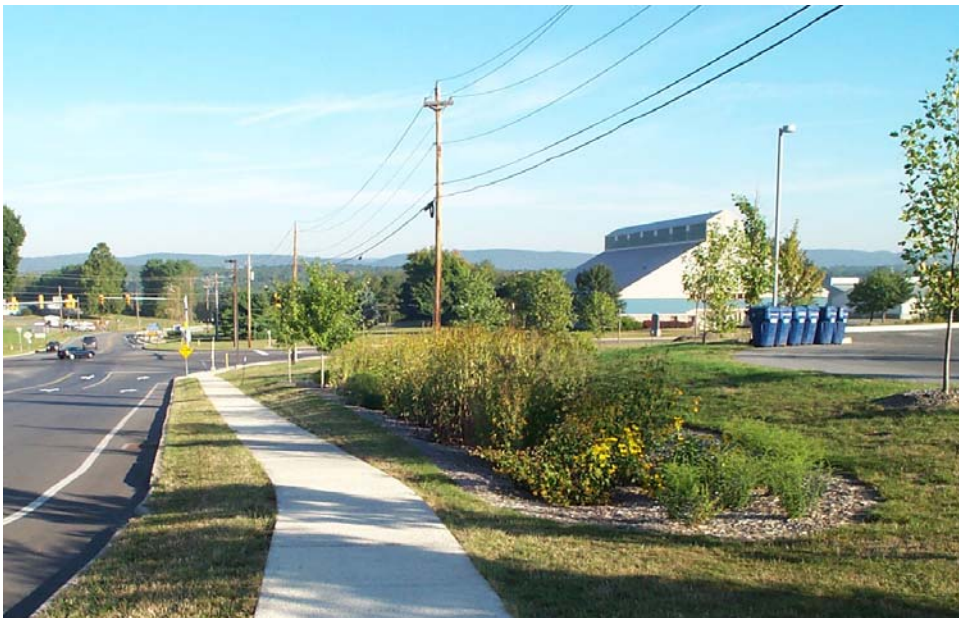
*Figure 10-8 Porous concrete sidewalks, State College, Centre County*

**Porous concrete** sidewalks that were constructed to manage the rainfall incident to them (Figure 10-8).

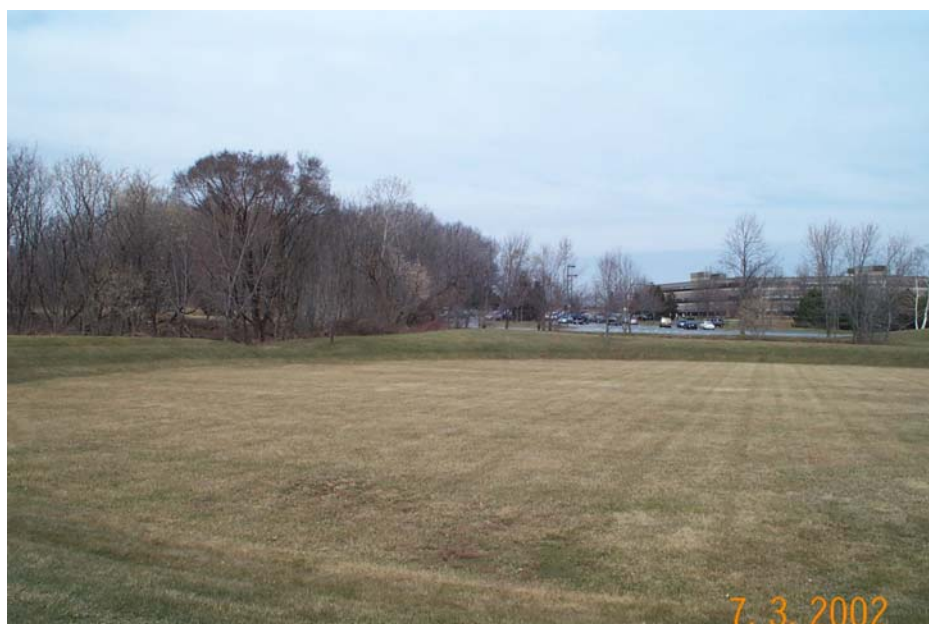
Figure 10-11. Vegetated infiltration basin in Lehigh County

Commerce Plaza III, in Upper Macungie Township and South Whitehall Township in Lehigh County, PA is a mid-rise office complex that was proposed for a 49-acre site. Figure 10-11 shows the constructed Commerce Plaza III in the Commerce Corporate Center. A major concern during the design phase was to locate elements of the site stormwater management system away from limestone formations to avoid potential sinkhole problems. The site, historically in agricultural use before subdivision, had a pre-existing sinkhole located near the area slated for stormwater management.

The vegetated infiltration basin collects stormwater runoff from one parking lot and one building, and mitigates runoff from two additional buildings nearby. The basin was designed to receive approximately two-to-three times the amount of stormwater runoff as basin size, corresponding to a high loading rate of impervious surface runoff to BMP area. Stormwater runoff sheet flows from the inlet to a concrete level spreader into the infiltration basin. The surface of the infiltration basin was graded with extreme care, creating an even basin surface elevation to receive stormwater (Figure 10-12). Figure 10-13 shows the vegetated swale inflow to the infiltration basin.

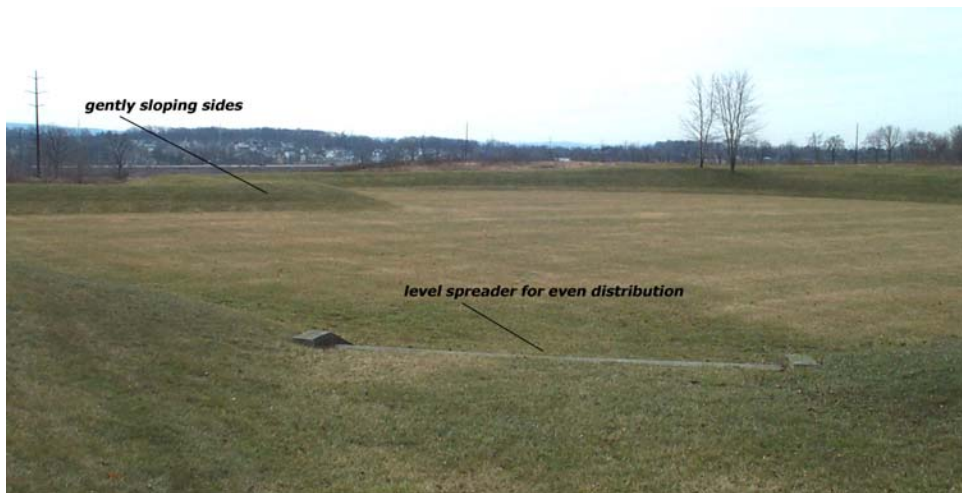
Figure 10-12 Level spreader distributes stormwater into the infiltration basin

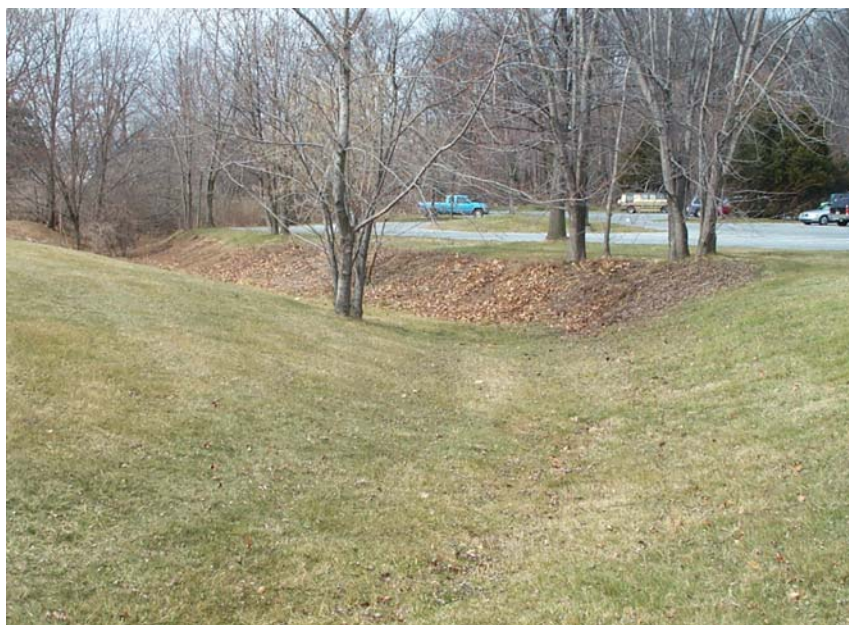
Figure 10-13 Vegetated swale

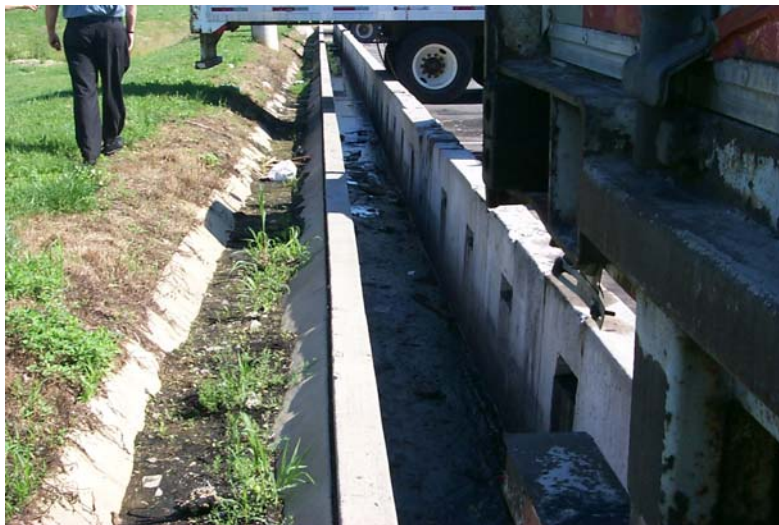
Figure 10-16 Perimeter trench drain

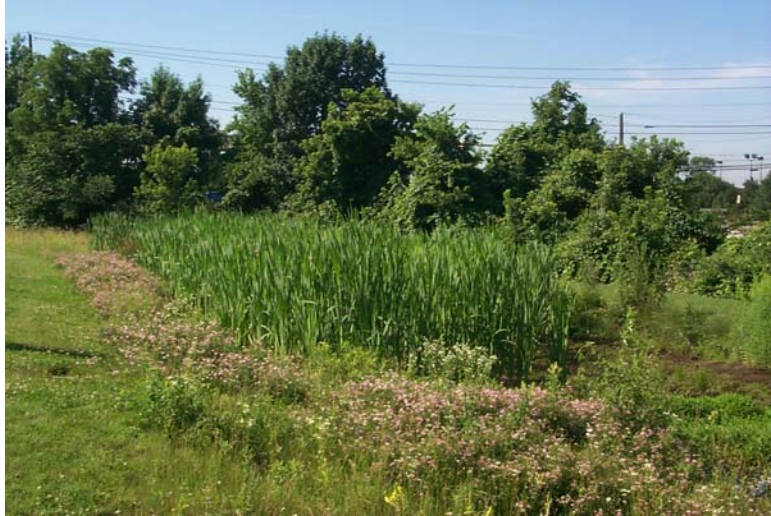
Figure 10-17 Vegetated infiltration filters

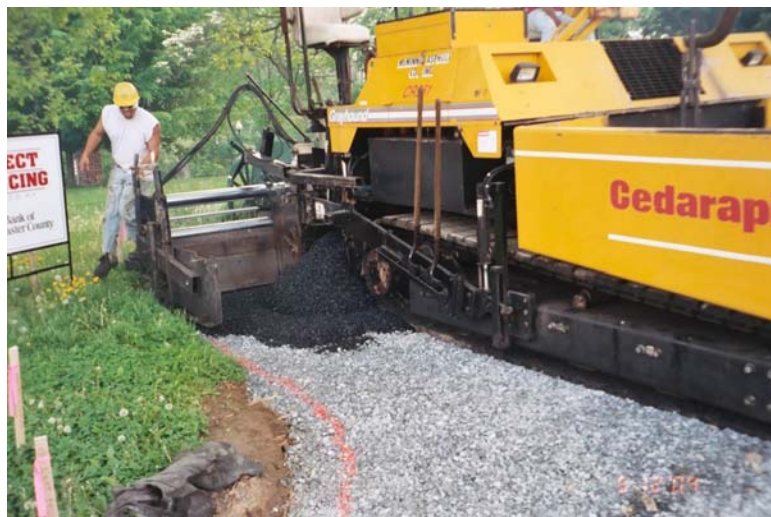
Figure 10-22 Construction of porous asphalt parking area to compliment building expansion.

The improvements at the Performing Arts Center include a new 9,200 square foot porous parking lot with vegetated bioretention swales. The parking area consists of two rows of parking which provides 40 new parking spaces. The porous parking is underlain by a stone infiltration bed with various benches ranging in depth from 18 to 48 inches and receives runoff from surrounding impervious driveways and parking areas. The bed connected to the northernmost parking row is designed to overflow to a flat grassed area, and the bed under the southern row discharges to a vegetated bioretention swale. As part of the design, a portion of the existing impervious parking area was removed and a bioretention bed was installed to promote the additional infiltration of runoff conveyed by the existing parking areas.

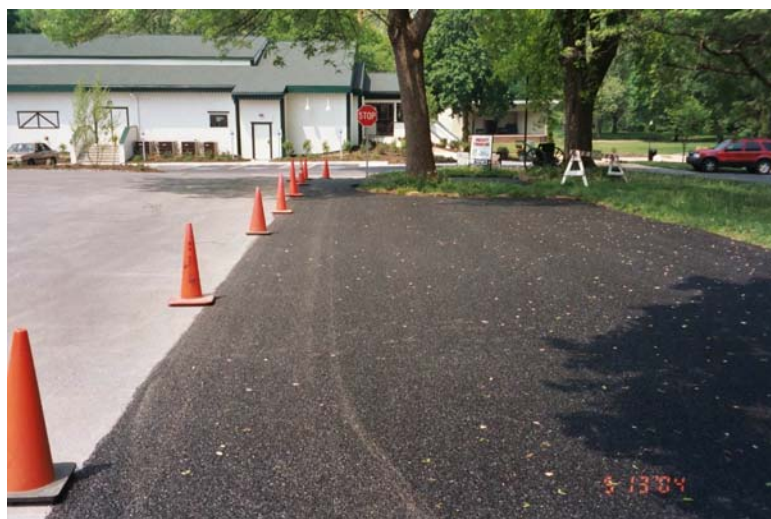
Figure 10-23 Completed porous asphalt parking lot at the Ephrata Performing Arts Center.

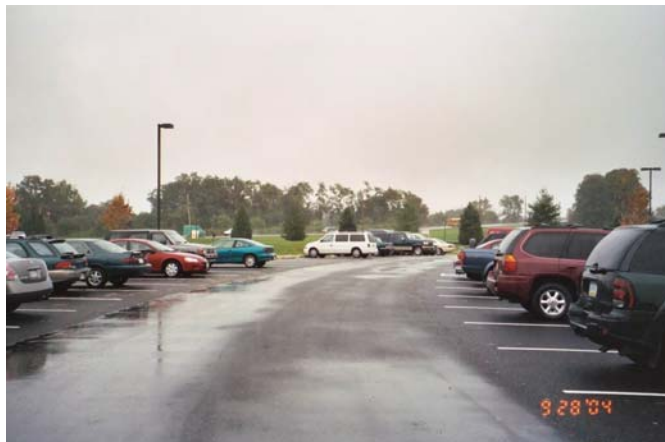
Figure 10-24 Completed porous asphalt parking lot at Lebanon Valley Conservation District

The porous pavement parking lot was installed on an existing lawn area and is underlain by a 24 - inch infiltration bed. The bed was excavated and unwoven geotextile fabric was placed on the undisturbed subsoil. Clean AASHTO #1 aggregate was placed in the bed in 12-inch lifts and lightly rolled to prevent settling. Finally, a 3-inch choker course comprised of AASHTO #57 was placed over the larger aggregate and was finish graded to prepare for the asphalt pavement.

The porous parking receives runoff from the center drive lane, which was constructed with conventional asphalt. The overflow design is comprised of four 4-inch pipes placed at the top of the infiltration bed and discharging to a well-vegetated area. Two 6-inch pipes which discharge to an existing vegetated swale on the site provide additional overflow. The project site has been observed during several high intensity storms and appears to be working successfully as there was little or no discharge apparent from the overflow pipes.

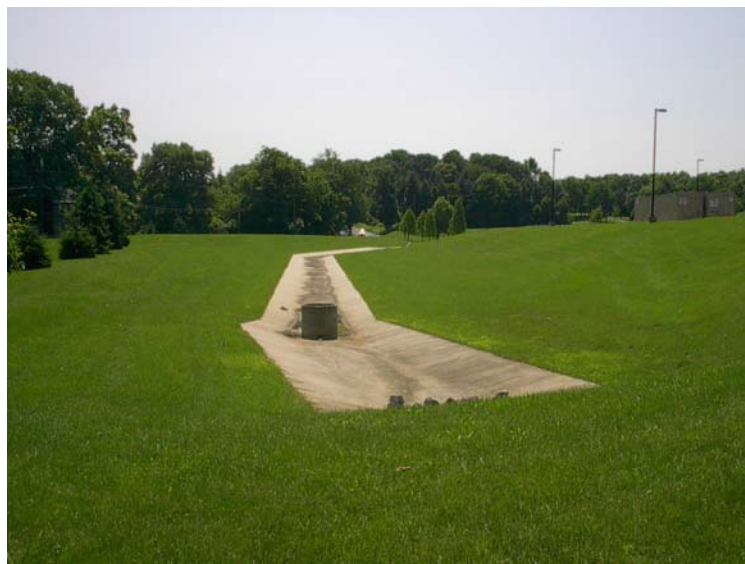
*Figure 10-25 Existing sinkhole-plagued detention basin*

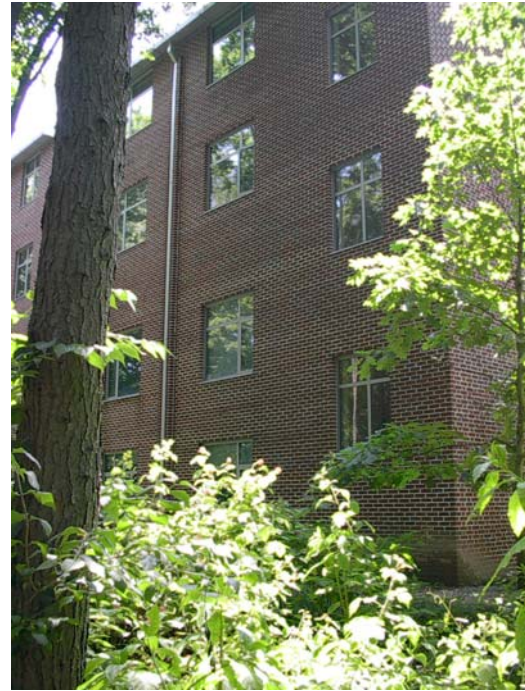
Figure 10-26 Example of minimum disturbance

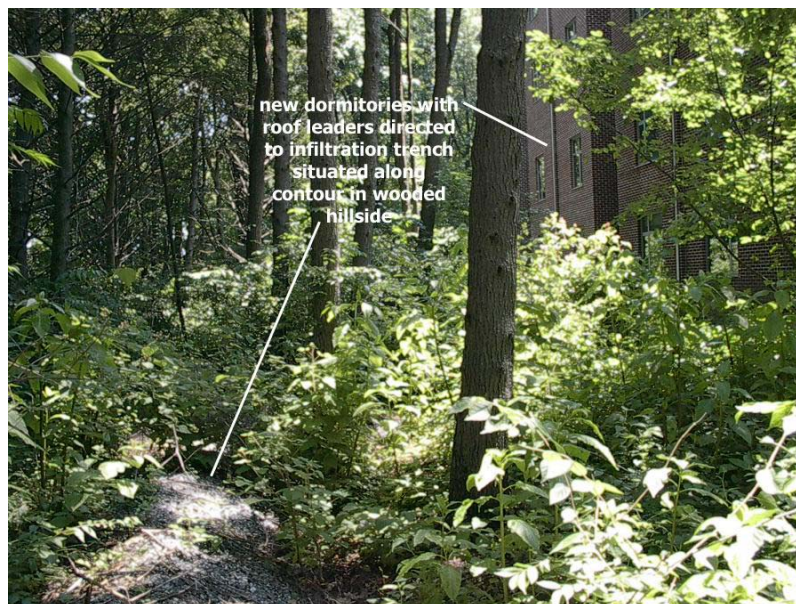
Figure 10-27 Level spreader pipe/infiltration trench in woods

The stormwater management plan for the developed site was a great improvement over the existing condition. Stormwater management for new dormitories consisted of an aggregate infiltration trench beneath a standard asphalt walkway “interior” of the complex and “exterior” level spreader perforated pipes along contours in the woods. Roof leaders on the interior halves of the dormitories were directed connected to the aggregate trench/walkway. (These walkways were stabilized beyond the standard asphalt by a “grass pavement” for fire truck access.) Likewise, roof leaders on the exterior halves were directly connected to the level spreader perforated pipes in the woods. These laterally extending pipes were designed to maintain soil moisture for the woodlands and prevent erosion or disturbance on the hillside.

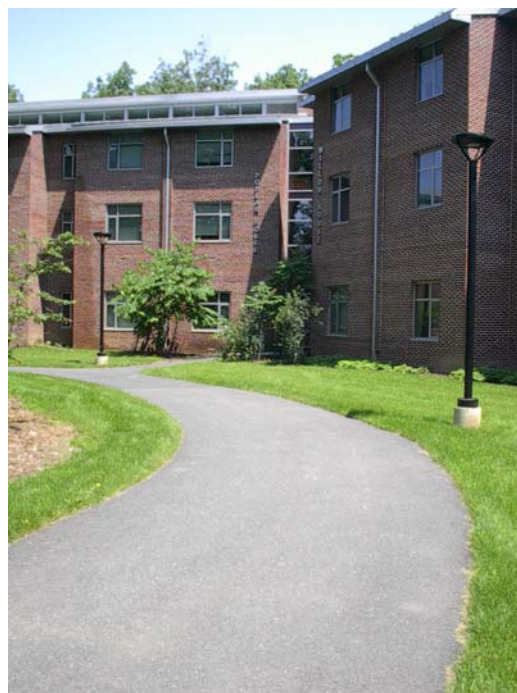
*Figure 10-28 Standard asphalt walkway w/ subsurface infiltration trench*

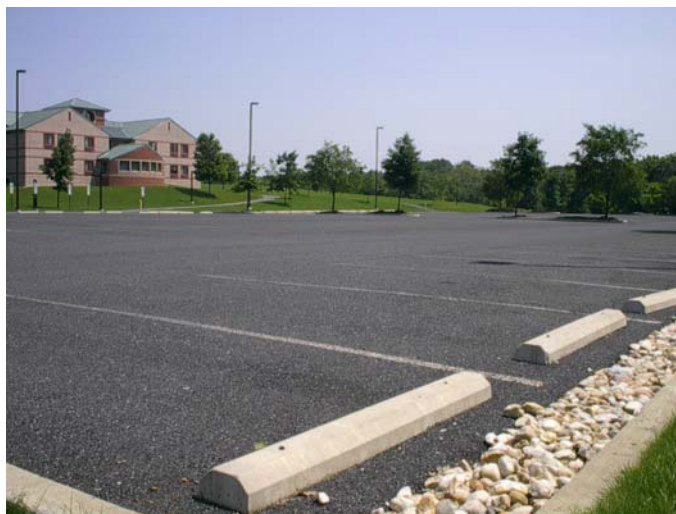
*Figure 10-29 Porous asphalt parking lot with subsurface infiltration bed*

The new porous asphalt parking lot was designed to mitigate incident rainfall and direct runoff from the nearby access road and existing dormitories. The porous parking lot has so far effectively discouraged the concentration of stormwater runoff downhill and allowed the incident rainfall to pass directly through the parking bays, slowly percolating into the soil and recharging the aquifer system. This system has also dramatically reduced discharges to the existing sinkhole-plagued basins. To date, neither the porous parking lot nor the existing basins have experienced additional sinkhole problems. Furthermore, polluted runoff from the site, usually described as nonpoint source pollution (NPS), was significantly removed by the overall plan. The new improvements at the PSU Berks County campus have had virtually zero impact on regional water resources.

The cost of the new porous asphalt parking lot with subsurface aggregate infiltration bed came to around \$1100 per space, in 1999 dollars. When all related site work (lighting, landscaping, erosion and sedimentation control, etc.) was considered, the final cost per space was around \$2200, also in 1999 dollars.

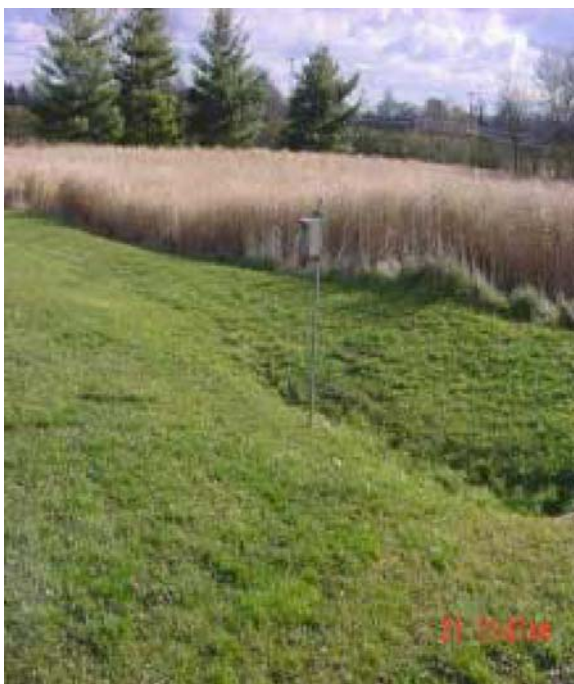
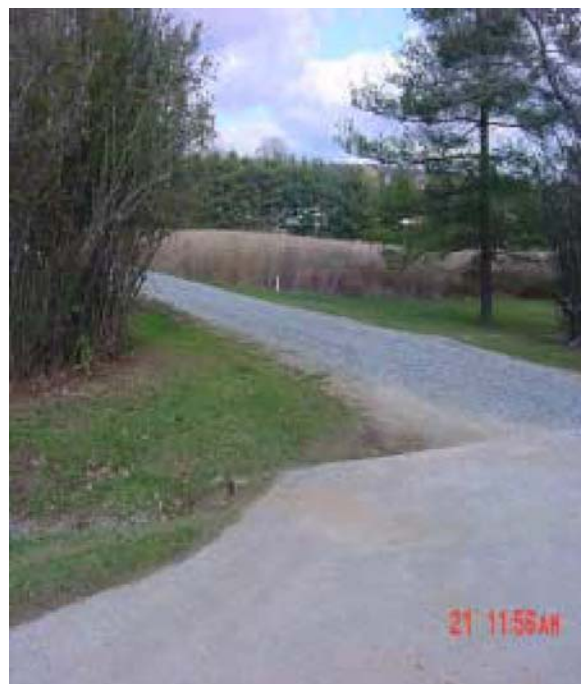
*Figures 30 & 31. Warm season native grassy meadows established at this site provide greater stormwater infiltration opportunities than maintained turf grass fields. Low maintenance meadows enhance wildlife habitat.*

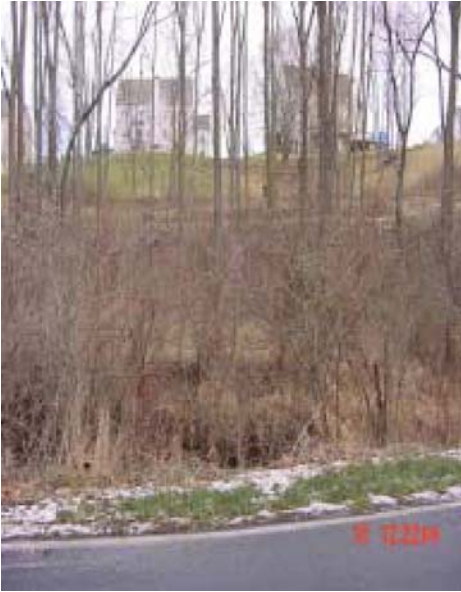
*Figure 32. View from Clay Creek Rd: trenches/berms at the base of the grassy hill in background; trenches/berms barely visible through trees as horizontal undulations.*

At the encouragement of the Township and its Municipal Engineer, an integrated system of berms and infiltration trenches was constructed. The typical berm/trench consisted of narrow, elongated, surface depressions created by built up earthen embankments, or berms, that promote stormwater infiltration. At this site, the infiltration trenches are elongated, shallow trenches on the surface that collect and temporarily store stormwater runoff from the upslope residential lots and streets and promote its infiltration (in contrast to sub-surface, excavated, fabric-wrapped, stone-filled trenches as described in Section 6). Stormwater that collects in these narrow depressions on the hillside gradually seeps through the soil into the ground and eventually into the creek and water table below. These berms/trenches follow the contours of the land in a parallel sequence. There are three 400 foot-long trenches terraced, or stepped, down the slope with one below another.

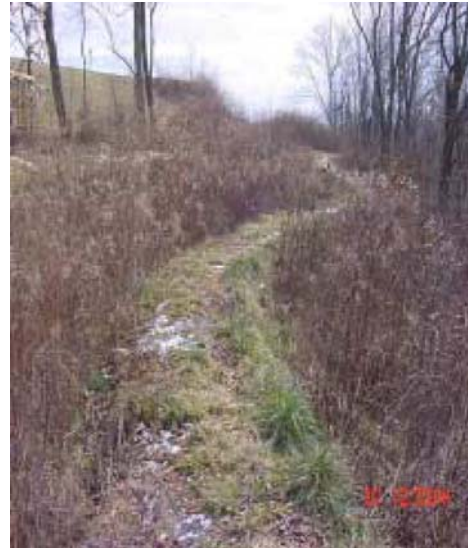
*Figure 33. This grassy path is an embankment, or berm, creating depressions for recharge trenches located to the left of the path.*

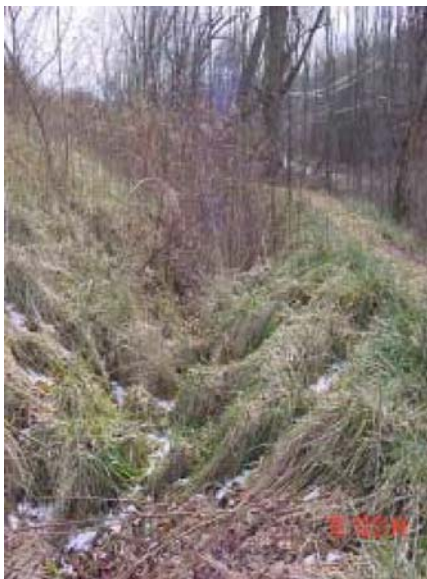
*Figure 34. Narrow, vegetated infiltration trenches/berms follow land contours and take on a naturalized appearance.*

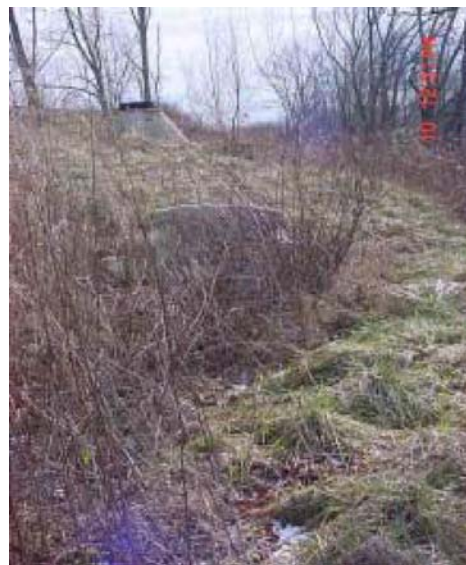
*Figure 35. This trench/berm has a subsurface energy dissipater to reduce the velocity of entering stormwater.*

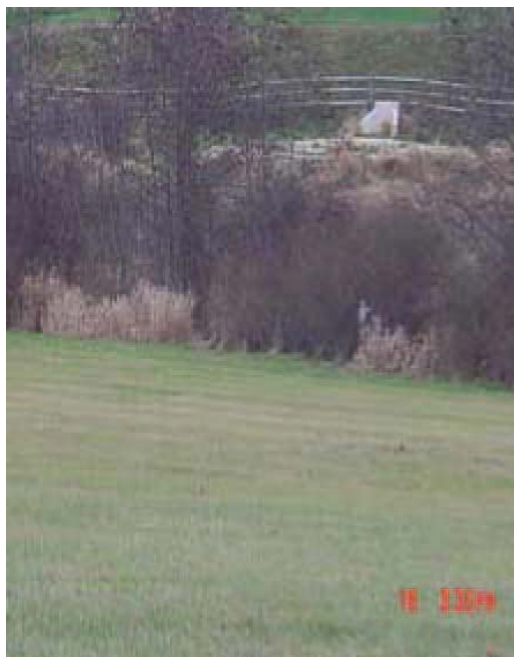
Figure 36. Constructed wetland in background

The most significant BMPs constructed as part of the strategy were a constructed treatment wetland and two wet ponds. Other stormwater measures at the golf course included grass swales, fertigation, cold-water discharges, and open space donation. The constructed treatment wetland at the site was designed primarily with water quality objectives in mind. It was constructed in a low-lying area near natural wetlands in the Ridley Creek floodplain. This allowed it to take advantage of inflows of water between storm events and to maintain sufficient soil moisture. Through physical, biological, and chemical processes, constructed wetlands can efficiently remove a great many contaminants commonly found in runoff (suspended solids, nutrients (nitrogen and phosphorus), heavy metals, toxic organics, and petroleum compounds). Wetland vegetation, algae, and bacteria allow for the biological uptake

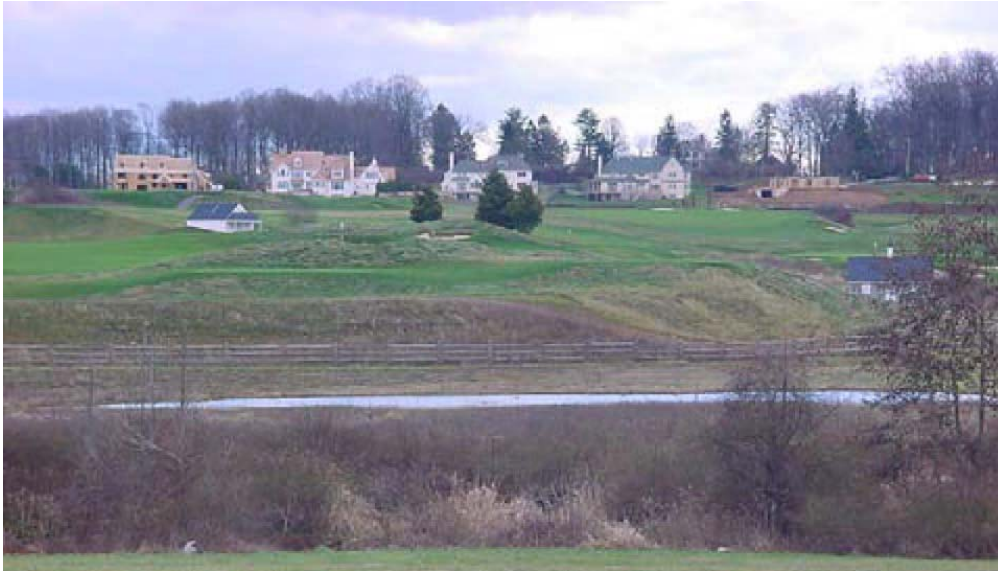
*Figure 37. Large pond, constructed wetland, managed and naturalized areas of golf course*

A wet pond is a stormwater management feature that maintains a permanent pool of water (retention) and has additional capacity for stormwater detention. Two wet ponds were constructed at the golf course as part of the improvements. The smaller of these two wet ponds has the preferable elongated shape, while the larger is comprised of two cells. When the first cell has reached capacity, water spills over into second cell. The larger pond receives treated wastewater from a nearby, township-owned wastewater treatment facility. Water is pumped from this pond and used in the site's fertigation system.

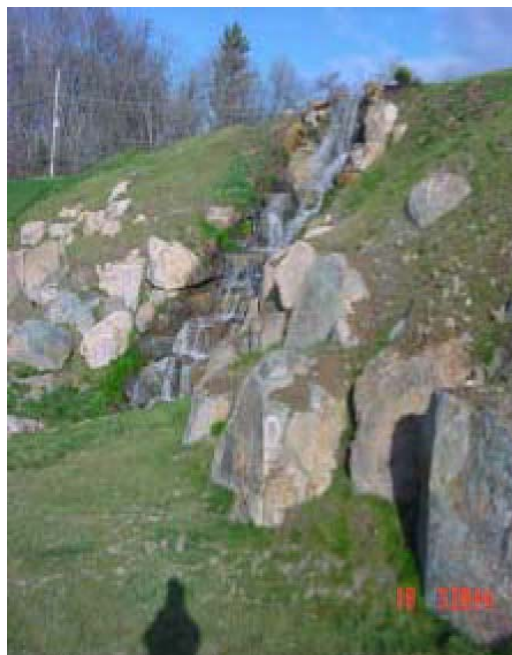
*Figure 38. Pond water is pumped up to waterfall and returns to pond through grass swales enhancing aeration*

Water from the wet pond is pumped at or near the bottom so that the coldest water is returned to Ridley Creek. This is an important consideration for the trout in the exceptional value creek. The development includes an area of wetlands of approximately 70 acres that was donated by the developer to the Township as open space. There is a conservation easement on this land, which restricts the cutting/mowing of vegetation to permit wetland plants to mature. The eased land includes the constructed wetland, the natural wetland, the stream, and its adjacent floodplains.

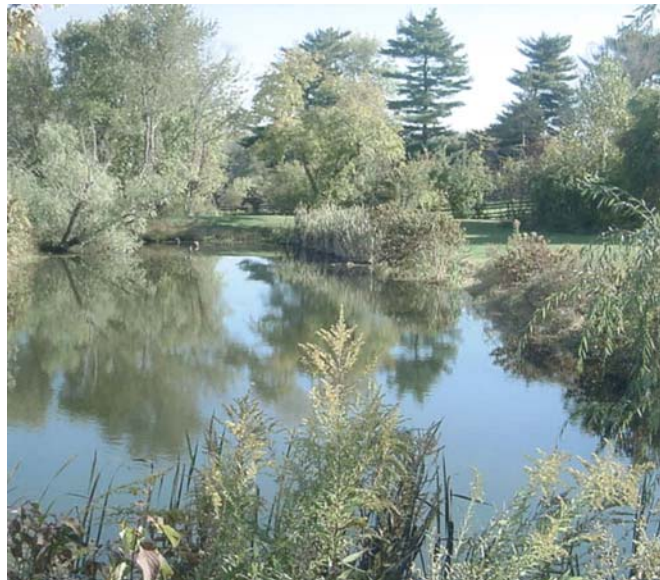
*Figure 39. The use of infiltration to control stormwater runoff volume helps to protect water quality in the existing pond at the Swan Lake Drive development.*

Vegetated infiltration beds were constructed to manage the rooftop runoff from each individual lot as well as runoff generated by driveway and road areas from a large portion of the development. The remaining runoff on site was conveyed to the existing pond. Shallow subsurface infiltration beds (no greater than 2.5 feet deep) were installed on all eight lots and rooftop runoff from each home is conveyed to the onsite infiltration bed. A larger infiltration bed was constructed to manage the runoff from driveways and Swan Lake Drive. Stormwater overflow and some overland flow is directed into the existing pond at the bottom of the site. The infiltration systems on the site provide capacity to store/infiltrate approximately 11,000 cubic feet of runoff over a 24-hour period
